Home Inspection Report

11 Western Road, Laingholm, Auckland

Inspection prepared for: Jackie Van Beek
Date of Inspection: 20/3/2020 Time: 9:00 AM
Age of Home: Mixed
Weather: Showers

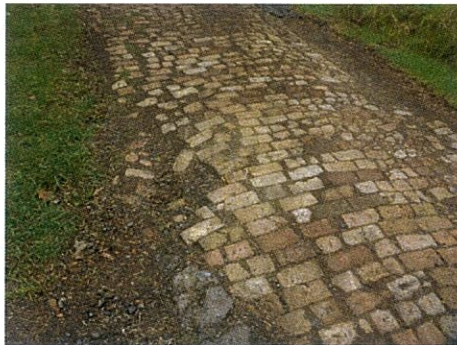
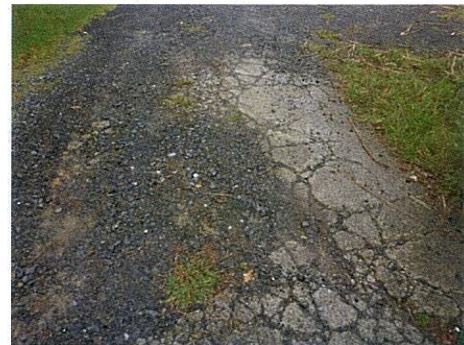
2. Condition

- Average condition

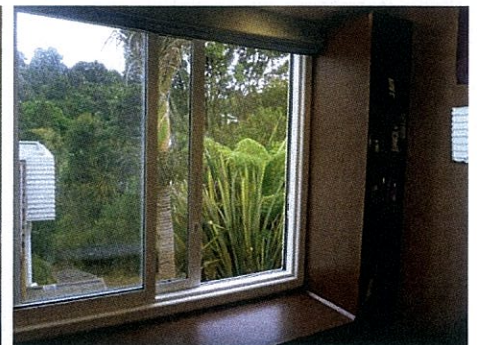
3. Operation and fit

- Satisfactory

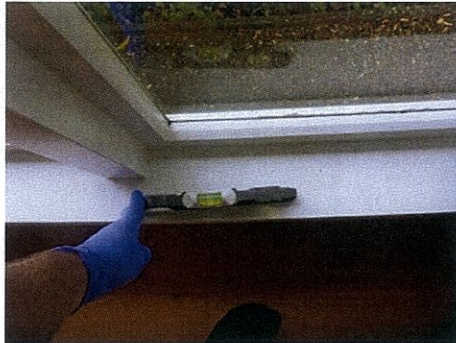
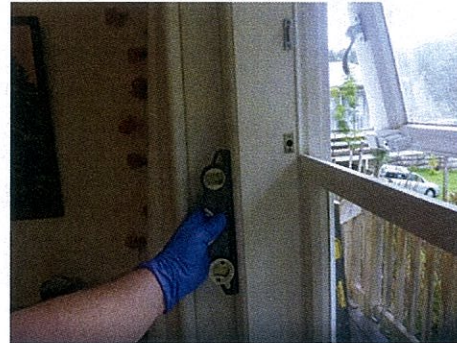
1. Verticality and alignment

- Satisfactory

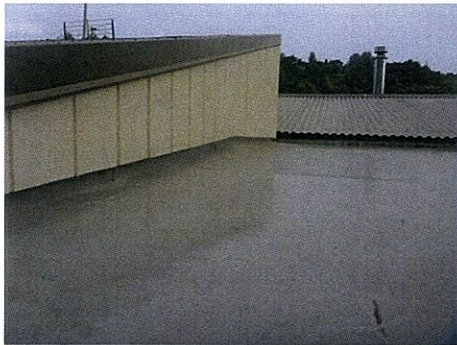
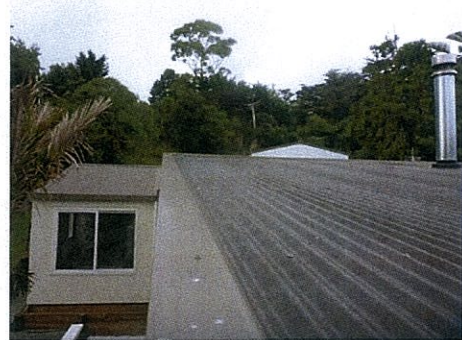
3. Surface damage and deterioration

- No surface damage apparent

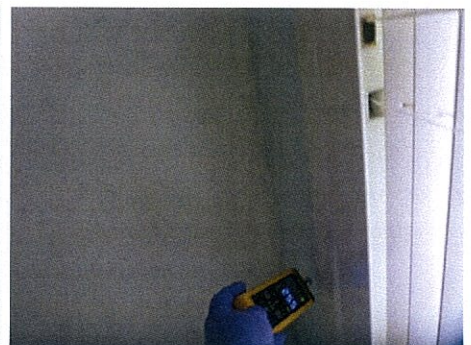
4. Moisture Readings

- Several readings were taken and all were within the acceptable range and indicate the room to be DRY.

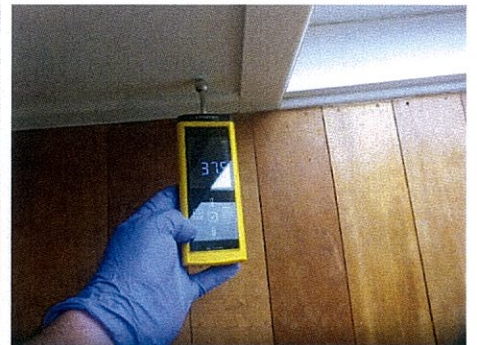
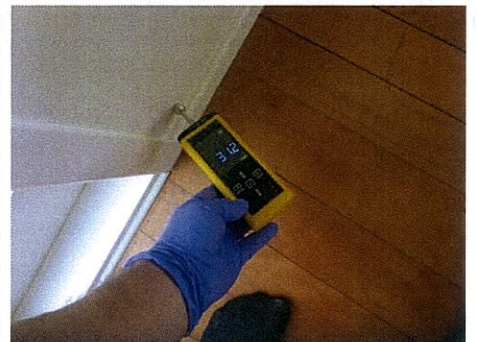
4. Moisture Readings

- Several readings were taken and all were within the acceptable range and indicate the room to be DRY.

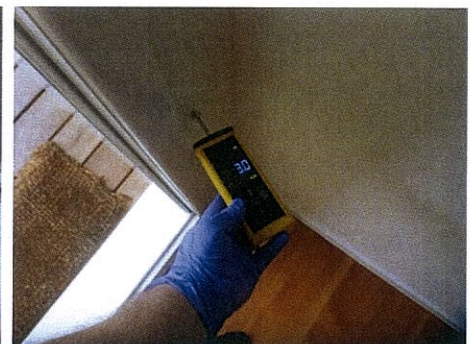
6. Moisture Readings

- Several readings were taken and all were within the acceptable range and indicate the room to be DRY

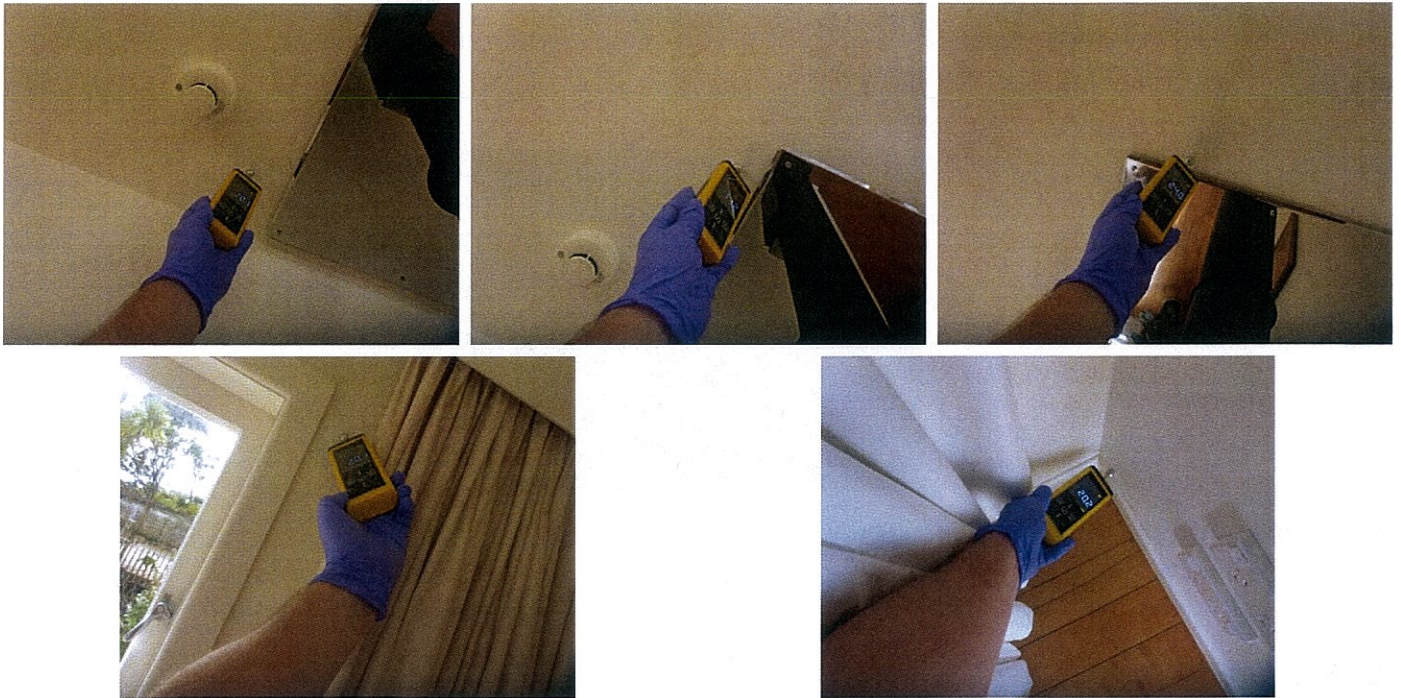
5. Moisture Readings

- Several readings were taken and all were within the acceptable range and indicate the room to be DRY.

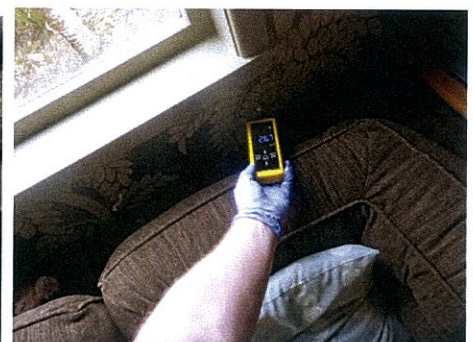
5. Moisture Readings

- Several readings were taken and all were within the acceptable range and indicate the room to be DRY

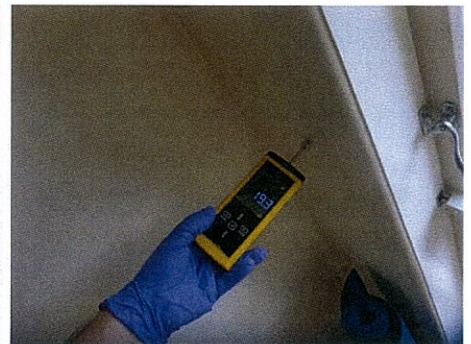
6. Moisture Readings

- Several readings were taken and all were within the acceptable range and indicate the room to be DRY.

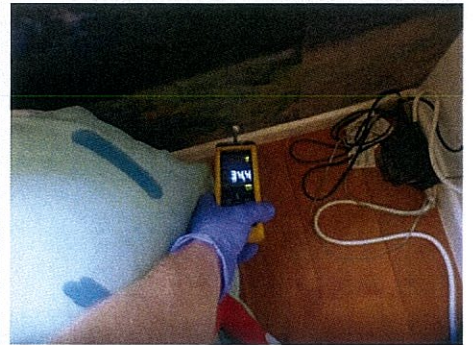
6. Moisture Readings

- Several readings were taken and all were within the acceptable range and indicate the room to be DRY.

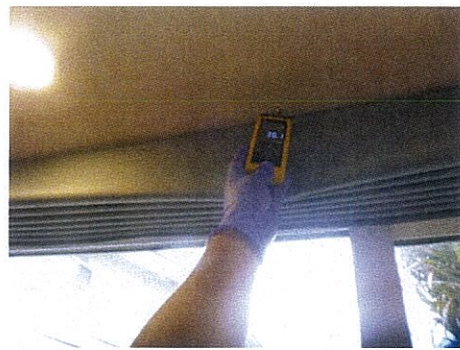
6. Moisture Readings

- Several readings were taken and all were within the acceptable range and indicate the room to be DRY.

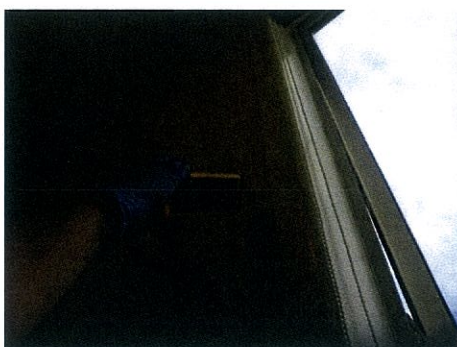
6. Moisture Readings

- Several readings were taken and all were within the acceptable range and indicate the room to be DRY.

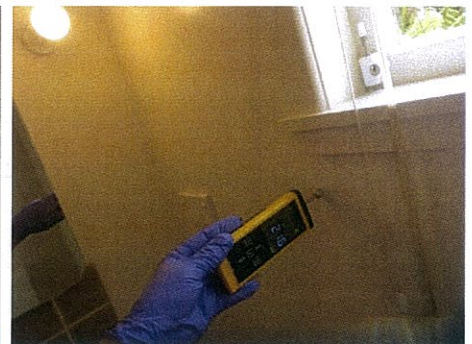
**3. Moisture Readings**

- Several readings were taken and all were within the acceptable range and indicate the room to be DRY.

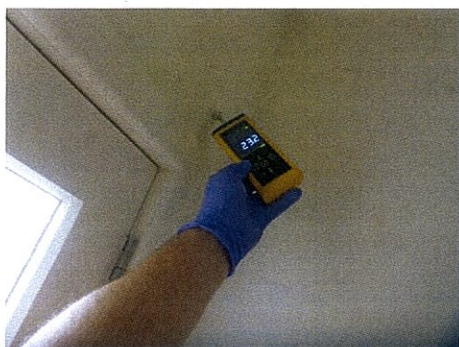
6. Moisture Readings

- Several readings were taken and all were within the acceptable range and indicate the room to be DRY
