Non Invasive Cladding Assessment

**6 Crowther Street
Blockhouse Bay
Auckland District**

Inspection Date: 6/05/2020

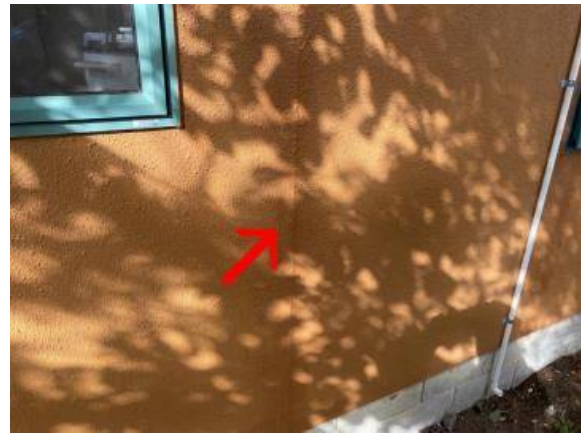
Evidence of repair to monolithic cladding cracks. Repairs appear to be well sealed and awaiting re coat. We recommend coating with a suitable elastomeric coating to ensure further protection. Unable to confirm the condition of internal framing.

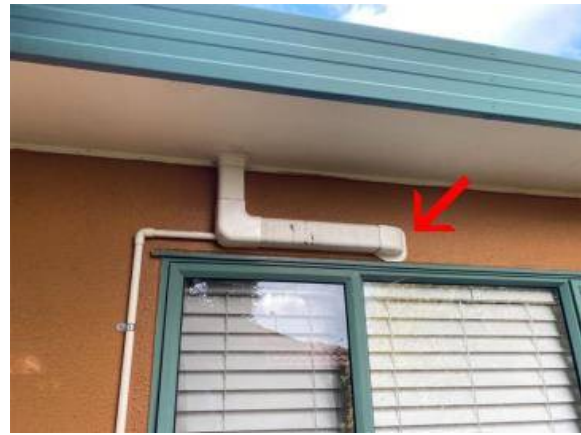
Conduit penetrates exterior cladding. This is considered a high risk detail. Where possible we recommend avoiding cladding penetrations. We recommend monitoring this penetration to ensure a weathertight seal is maintained. As conduit appears to penetrate window head, structural members may have been compromised. We recommend, further inspection to ensure Window lintel has not been compromised.

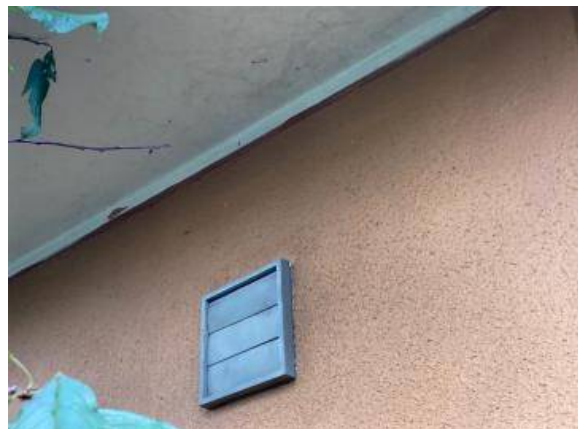
Exhaust vent penetrates exterior cladding. Poor seal to penetration. This is a high risk ingress point. We recommend sealing penetration to reduce the risk of ingress. Unable to confirm the condition of internal framing.

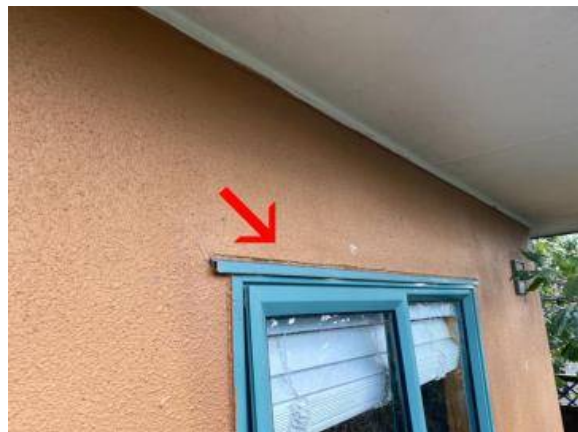
No evidence of a sufficient anti capillary gap above head flashings. A minimum anti capillary gap of 10mm is recommended to reduce the risk of moisture wicking behind cladding by providing adequate drainage. We recommend engaging a cladding specialist to modify this detail where required to meet minimum recommendations.

No evidence of a sufficient anti capillary gap above head flashings. A minimum anti capillary gap of 10mm is recommend to reduce the risk of moisture wicking behind cladding by providing adequate drainage. We recommend engaging a cladding specialist to modify this detail where required to meet minimum recommendations.

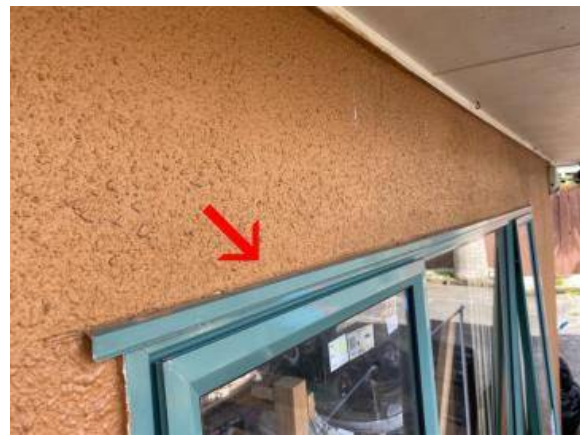
No evidence of a sufficient anti capillary gap above head flashings. A minimum anti capillary gap of 10mm is recommended to reduce the risk of moisture wicking behind cladding by providing adequate drainage. We recommend engaging a cladding specialist to modify this detail where required to meet minimum recommendations.

No evidence of a sufficient anti capillary gap above head flashings. A minimum anti capillary gap of 10mm is recommend to reduce the risk of moisture wicking behind cladding by providing adequate drainage. We recommend engaging a cladding specialist to modify this detail where required to meet minimum recommendations.

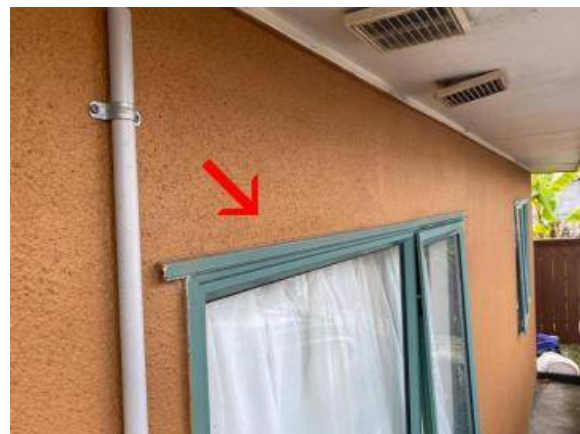
No evidence of a sufficient anti capillary gap above head flashings. A minimum anti capillary gap of 10mm is recommend to reduce the risk of moisture wicking behind cladding by providing adequate drainage. We recommend engaging a cladding specialist to modify this detail where required to meet minimum recommendations.
