Home Inspection Report

15 Pooks Road, Ranui, Auckland

Inspection prepared for: Sophia de Fossard
Date of Inspection: 20/5/2019 Time: 9:00 AM
Age of Home: 2002 Size: 150m2
Weather: Fine

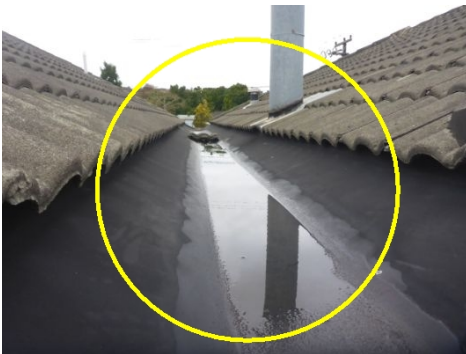
- Membrane roofing has a limited lifespan of 15-20 years, while there is currently no elevated moisture readings in the rooms below this area the membrane is in below average condition, I suggest having the roof checked by a professional experienced in membrane roofing and repaired if required

Ponding

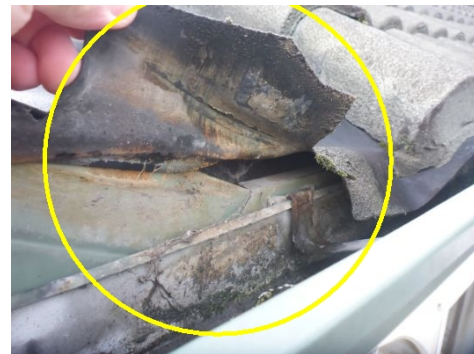
Failed adhesive

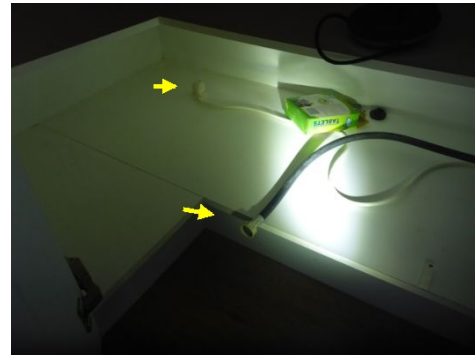
- Unable to operate at the time of inspection

Not connected

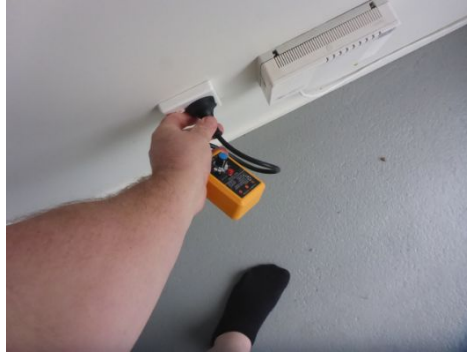
- Does not appear functional

Does not appear functional
