Home Inspection Report

14 Hollywood Avenue, Titirangi, Auckland

Inspection prepared for: Alexandre Vartzbed
Date of Inspection: 27/9/2021 Time: 11:00 AM
Age of Home: Mixed, Size: 144m²
Weather: Fine

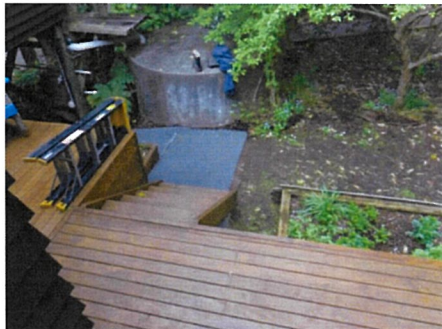
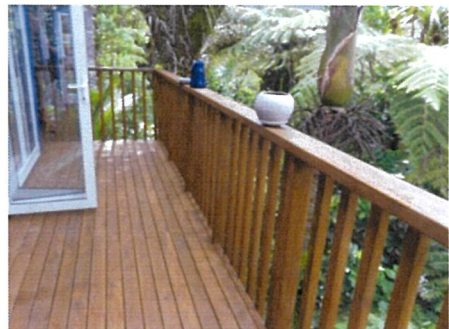
The lack of balustrades in some areas presents a fall hazard

Fall hazard

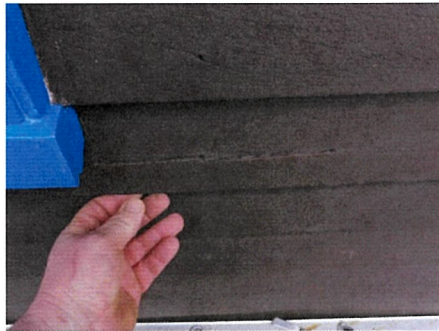
Some splitting present

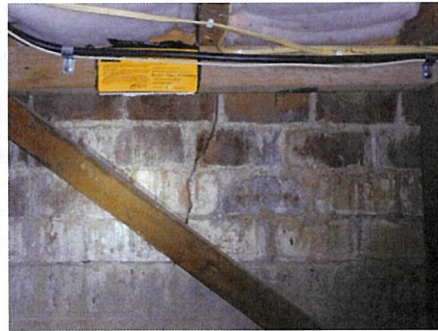
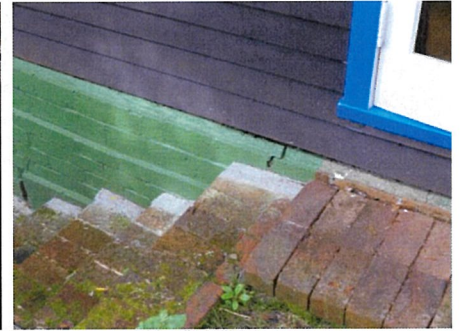
Some cracking present

Cracking present

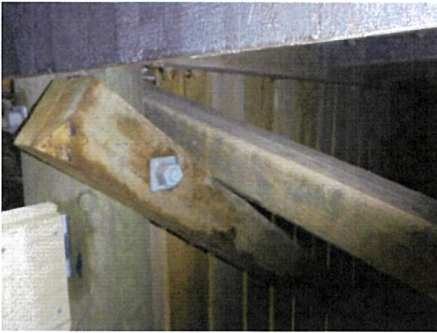
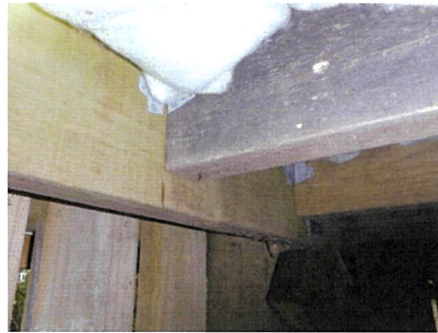
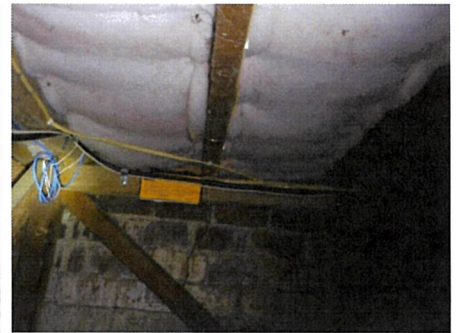
- Appears satisfactory however joist hangers should be installed beneath the workshop area.

- Bracing has been installed beneath the lounge/kitchen indicating movement has taken place, while appearing stable future movement can not be ruled out

Correct joist hangers recommended

Additional bracing has been installed

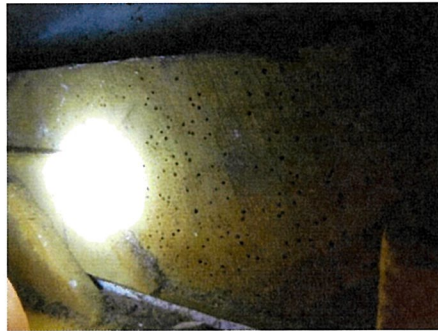
- Evidence of borer, this is not unusual for a home of this age in this location, while no active borer is visible periodic fumigation should be carried out to prevent infestation

Insect damage

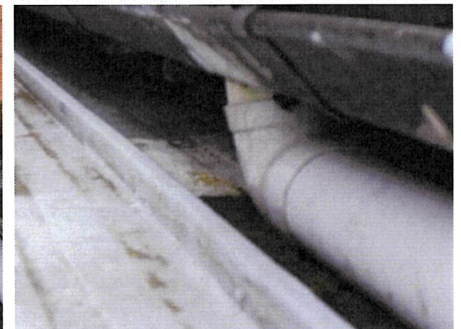
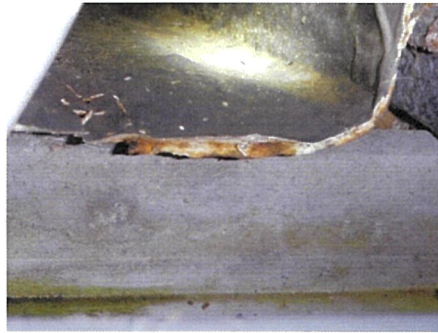
- The clay tile roofing is in average condition consistent with the age of the home
- The homes metal roofing is showing signs of damage and corrosion, this roof likely has a limited lifespan

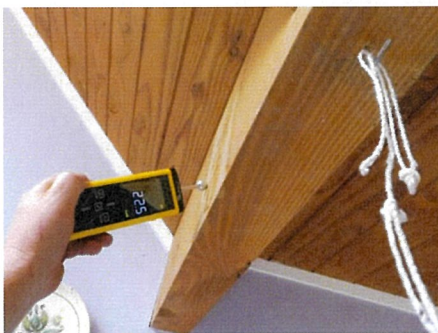
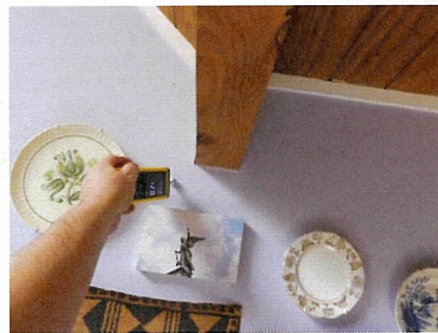
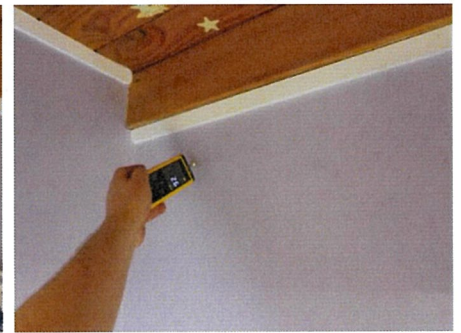
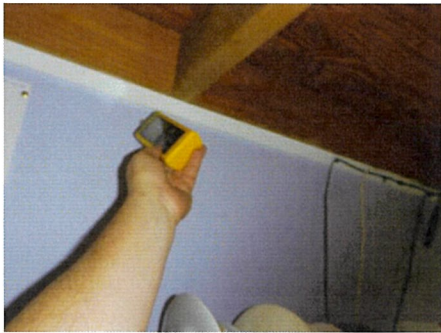
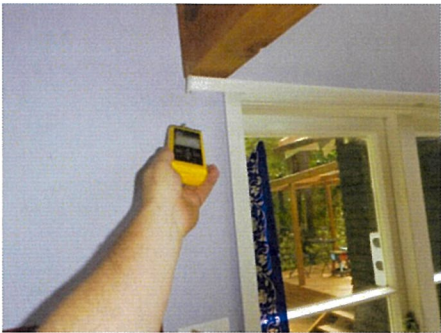
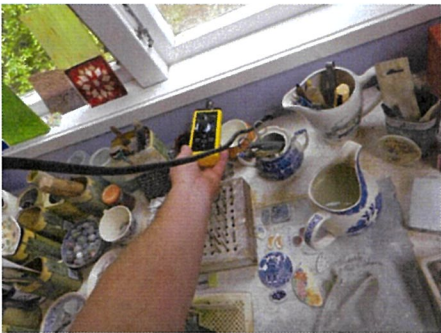
- Several readings were taken and all were within the acceptable range and indicate the room to be DRY however moisture staining on the ceiling may indicate intermittent or historic roof leaks

Water staining

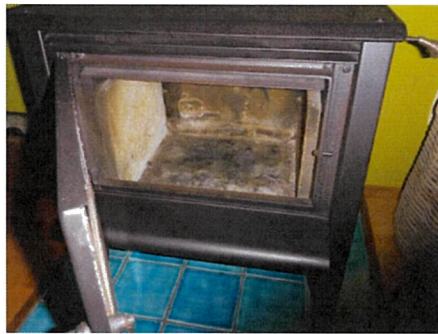
- The woodburner and open fireplace should be checked and cleaned by a fireplace professional prior to use

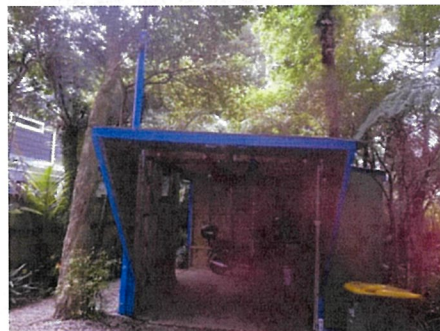
- Fiber cement, due to the age of the home it is possible the fibre cement sheeting contains asbestos. In this form it is not considered a health risk unless disturbed by being sawn, drilled, sanded or water blasted.

Likely contains asbestos
