# Building Report

6 Crowther Street, Blockhouse Bay

# PRE-PURCHASE BUILDING REPORT

Property Address	6 Crowther Street, Blockhouse Bay		
Client	Craig Murphy		
Date of Inspection	26th June 2022	Time	9:00 am
Inspector	Rob Sodeau Peer reviewed by LBP 133644		
LBP Number	Peer reviewed by LBP 133644		
Inspection Type	Pre-Purchase Report		
People Present	Inspector, Owner		
House Occupied	Yes

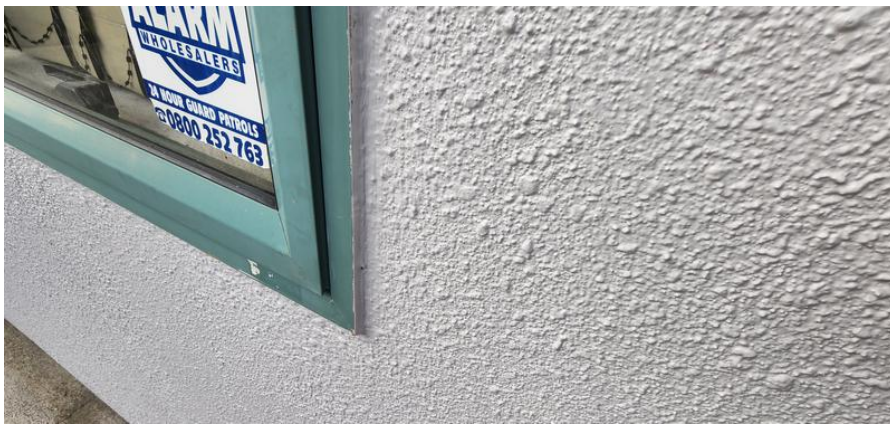
Photo 10

Sample photo of the cladding to joinery junction, ensure these areas are monitored and maintained for continued weather tightness

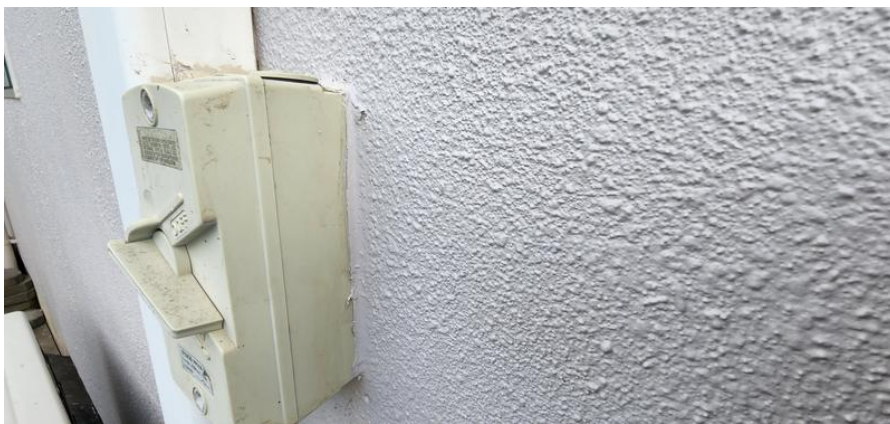
Photo 12

Sample photo of cladding penetration with correct sealing, recommend these areas are monitored and maintained

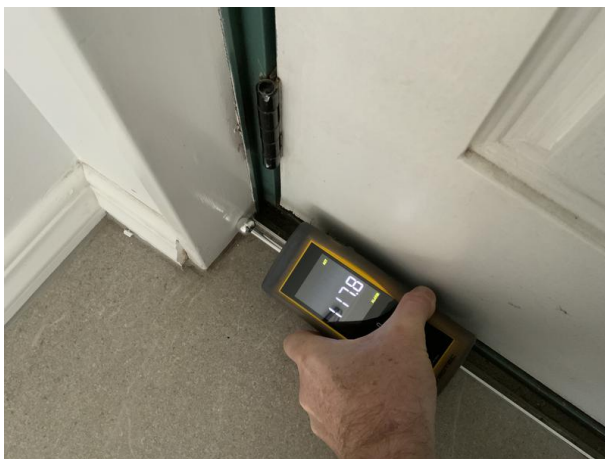
Photo 21

Photo shows a high moisture reading of 117.8 on the lower left side of the front door, further investigation recommended, the reading should be below 50

Defects - Elevated moisture reading in the front door trim.

Have a specialist in exterior joinery investigate and report on maintenance and repairs required. Higher than normal moisture readings were indicated that might be due to condensation or the joinery leaking. Further investigation will be required to locate the source of moisture and repair as necessary.

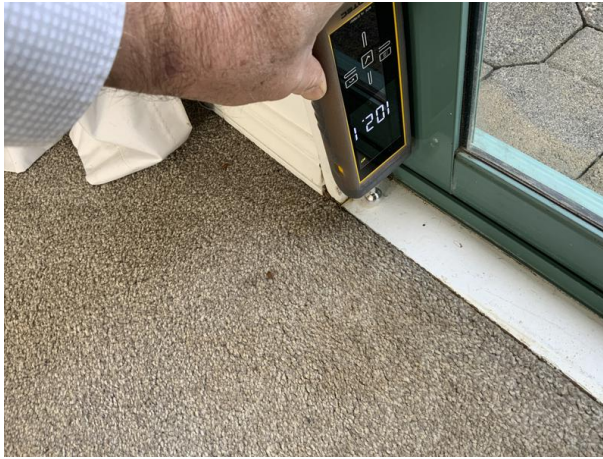
Photo 22

Photo shows high moisture reading of 102.1 in the lower left side of the dining room sliding doors, further investigation by joinery specialist is recommended, the reading should be below 50

Defects - Elevated moisture reading in the joinery trim.

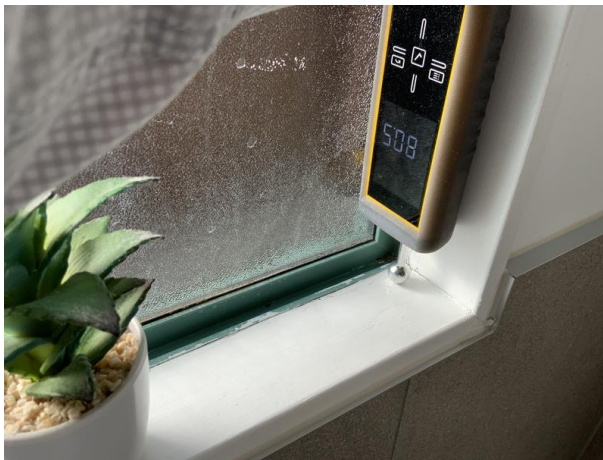
Photo 23

Photo shows elevated moisture reading of 80.5 in the lower right side of the bathroom joinery, further investigation by joinery specialist recommended, the reading should be below 50

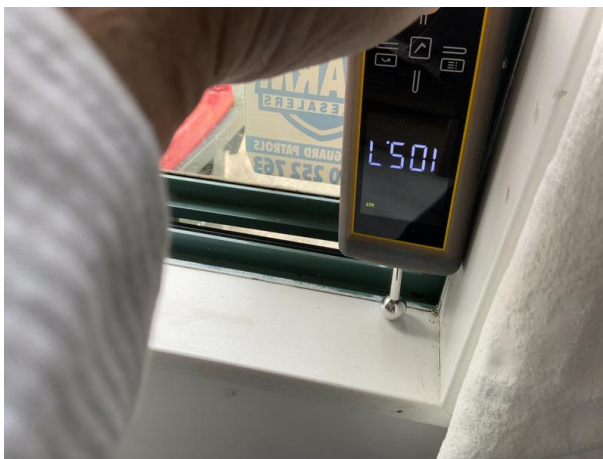
Photo 24

Photo shows high moisture reading of 105.7 in the lower right corner of bedroom three joinery, further investigation by a joinery specialist is recommended, the reading should be below 50

Defects - Elevated moisture readings in bedroom three joinery.

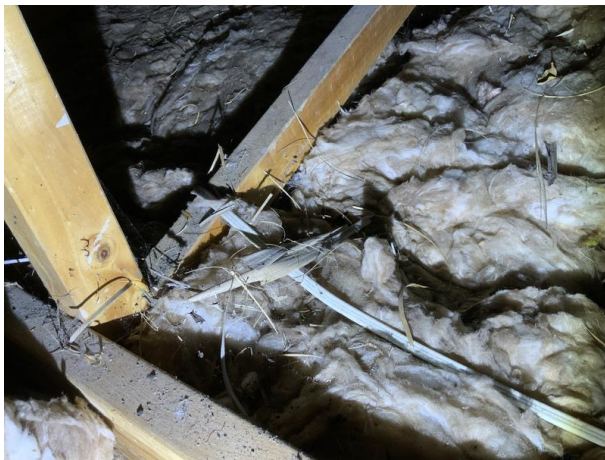
Photo 34

Condition - Old bird nesting materials visible.

Sample photo of roof insulation and old birdsnest material

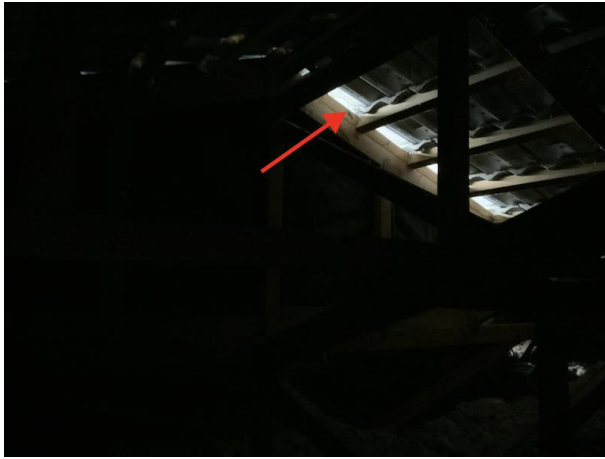
Photo 36

Photo shows an area above the front door with an excessive amount of light coming through, further investigation by roof specialist is recommended

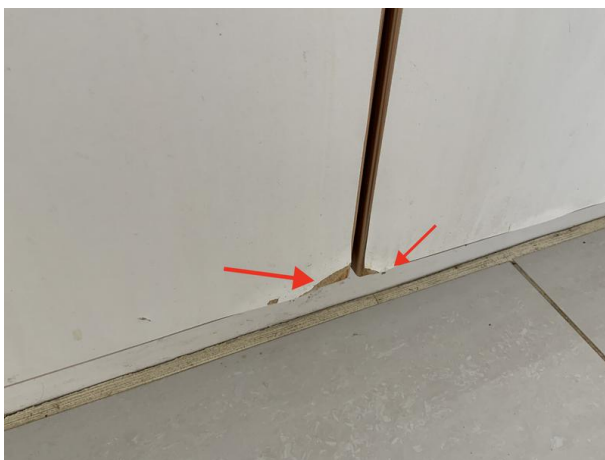
Photo 44

Photo shows old historic moisture staining on the kitchen cabinets

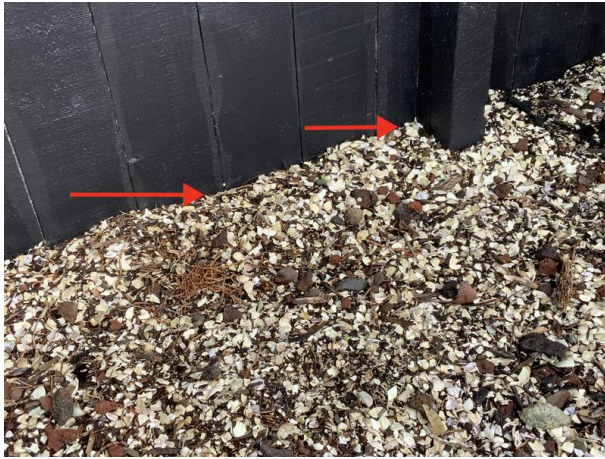
Photo 60

Photo shows vegetation pushed up against the fence, recommend this is pulled back

The average height of the boundary fencing is approximately 1.8 metres. General upkeep and maintenance, keep vegetation and soils clear of timbers as these timbers are only exterior treated and will rot if vegetation or soils are up against them. Some palings may need replacement.

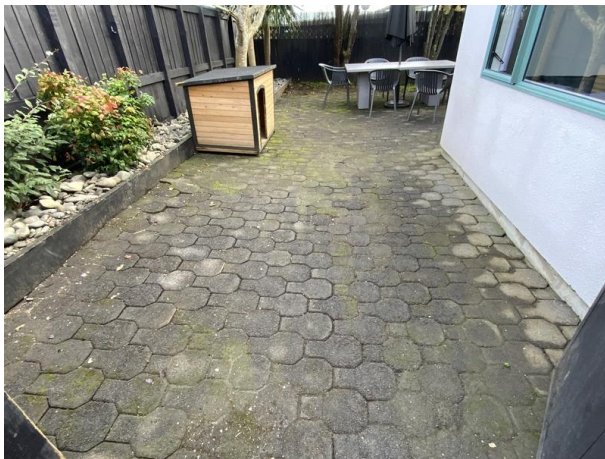
Photo 61

Patio on the north west side of the property, recommend this area is cleaned down

Clean down to remove slip hazard and keep free of debris. General upkeep and maintenance.
