## **Non Invasive Cladding Assessment**

**6 Crowther Street  
Blockhouse Bay  
Auckland District**

**Inspection Date: 6/05/2020**

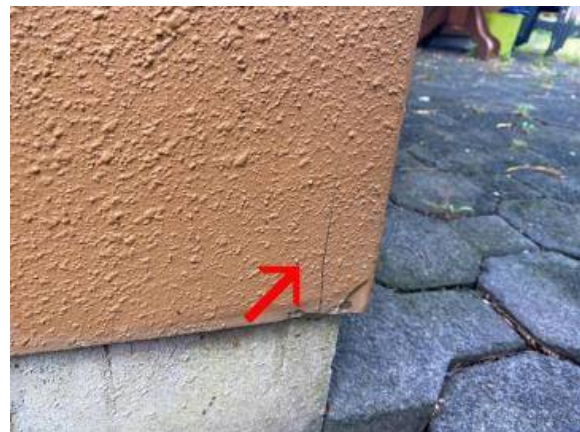
Visible cracks to Monolithic cladding system. Cladding cracks may increase the risk of moisture damage to cladding substrate and internal framing. We recommend engaging the services of a suitably experienced cladding specialist to repair cladding in these areas as required. Unable to confirm the condition of internal framing.

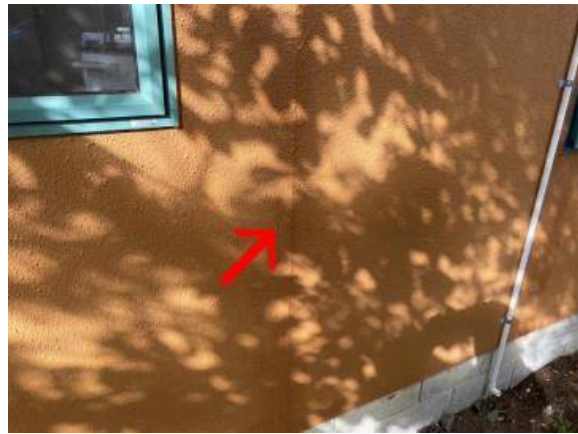
Evidence of repair to monolithic cladding cracks. Repairs appear to be well sealed and awaiting re coat. We recommend coating with a suitable elastomeric coating to ensure further protection. Unable to confirm the condition of internal framing.

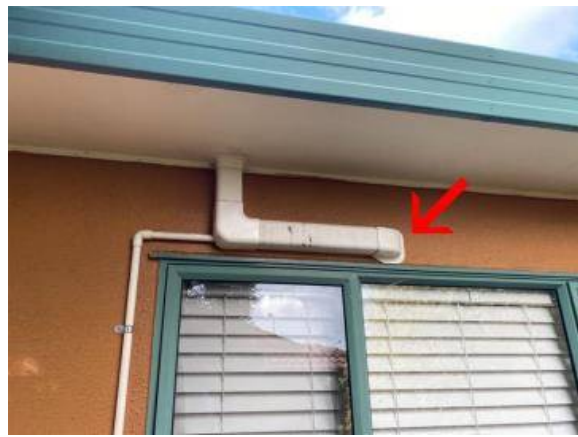
Conduit penetrates exterior cladding. This is considered a high risk detail. Where possible we recommend avoiding cladding penetrations. We recommend monitoring this penetration to ensure a weathertight seal is maintained. As conduit appears to penetrate window head, structural members may have been compromised. We recommend, further inspection to ensure Window lintel has not been compromised.

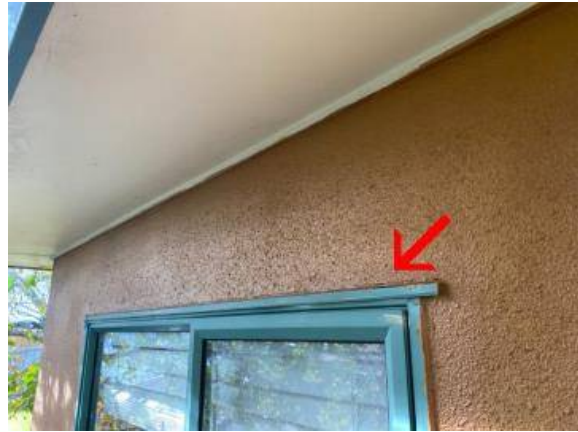
No evidence of a sufficient anti capillary gap above head flashings. A minimum anti capillary gap of 10mm is recommend to reduce the risk of moisture wicking behind cladding by providing adequate drainage. We recommend engaging a cladding specialist to modify this detail where required to meet minimum recommendations.

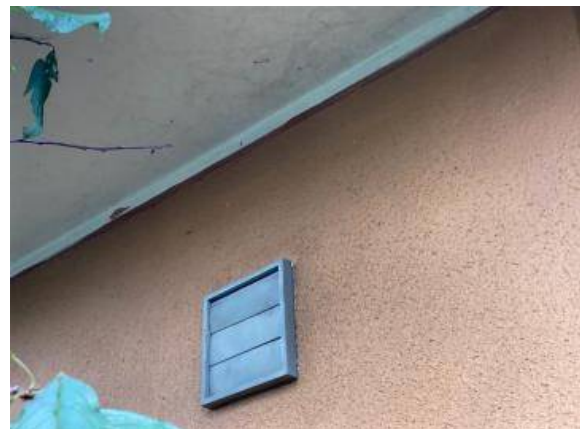
Exhaust vent penetrates exterior cladding. Poor seal to penetration. This is a high risk ingress point. We recommend sealing penetration to reduce the risk of ingress. Unable to confirm the condition of internal framing.

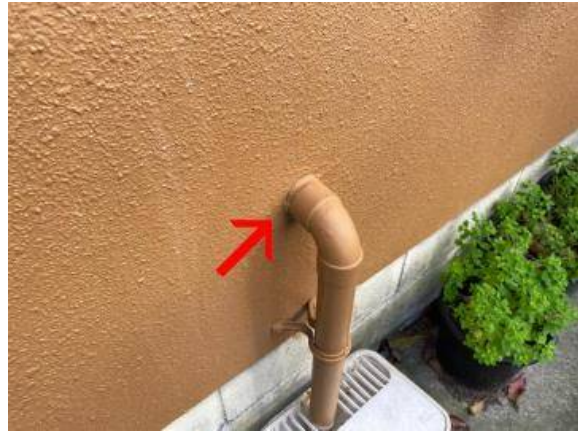
Waste pipe penetrates exterior cladding. Poor seal to penetration. This is a high risk ingress point. We recommend sealing penetration to reduce the risk of ingress. Unable to confirm the condition of internal framing.

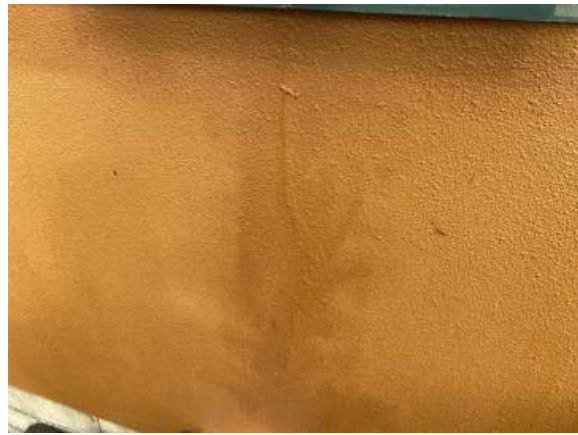
Evidence of repair to monolithic cladding cracks. Repairs appear to be well sealed and awaiting re coat. We recommend coating with a suitable elastomeric coating to ensure further protection. Unable to confirm the condition of internal framing.

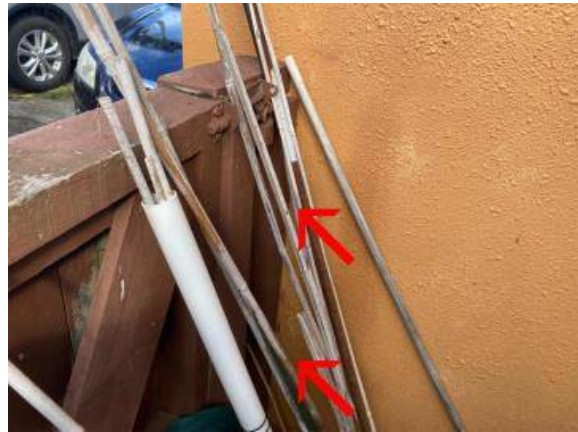
Timber fence direct fixed to cladding. Fixings penetrate cladding, no visible drainage gap. Cladding penetrations increase the risk of ingress. A minimum cladding clearance of 12mm is recommended to ensure adequate cladding drainage. We recommend modifying this detail. Unable to confirm the condition of internal framing.

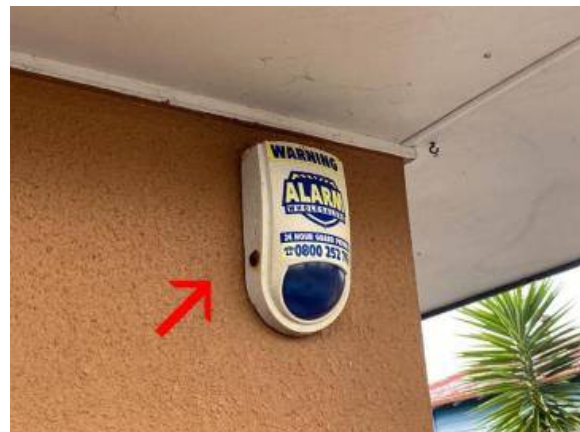
Alarm signal fixings penetrate exterior cladding. This is a high risk ingress point. We recommend monitoring this area. Where possible we recommend modifying installation location to soffit.

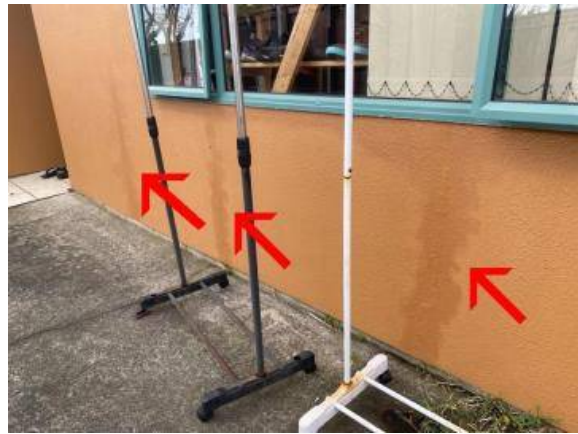
Evidence of repair to monolithic cladding cracks. Repairs appear to be well sealed and awaiting re coat. We recommend coating with a suitable elastomeric coating to ensure further protection. Unable to confirm the condition of internal framing.

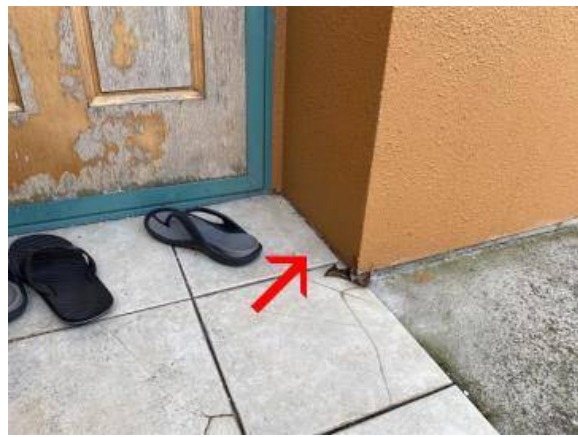
Paved ground level in close proximity to cladding base. A clearance of 100mm is recommended from cladding base to paved ground level to allow adequate cladding drainage. We recommend modifying paving height to meet minimum recommendations and reduce the risk of damage to cladding. Unable to confirm the condition of internal framing in this area at the time of inspection.

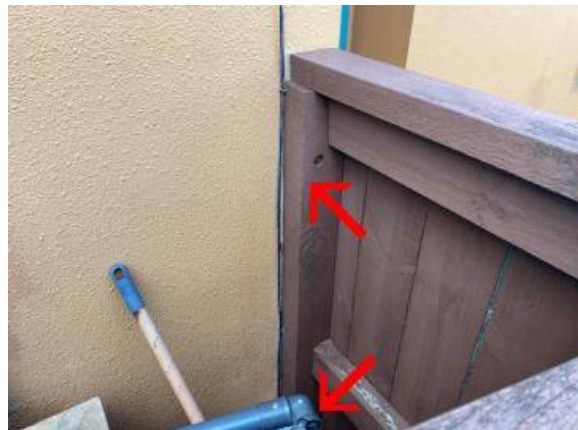
Timber fence direct fixed to cladding. Fixings penetrate cladding, no visible drainage gap. Cladding penetrations increase the risk of ingress. A minimum cladding clearance of 12mm is recommended to ensure adequate cladding drainage. We recommend modifying this detail. Unable to confirm the condition of internal framing.

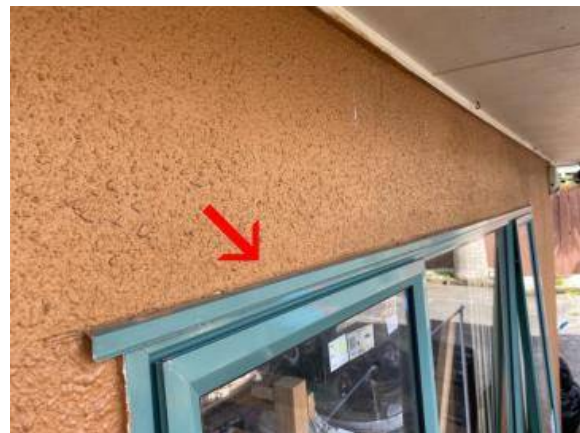
No evidence of a sufficient anti capillary gap above head flashings. A minimum anti capillary gap of 10mm is recommended to reduce the risk of moisture wicking behind cladding by providing adequate drainage. We recommend engaging a cladding specialist to modify this detail where required to meet minimum recommendations.

No evidence of a sufficient anti capillary gap above head flashings. A minimum anti capillary gap of 10mm is recommend to reduce the risk of moisture wicking behind cladding by providing adequate drainage. We recommend engaging a cladding specialist to modify this detail where required to meet minimum recommendations.

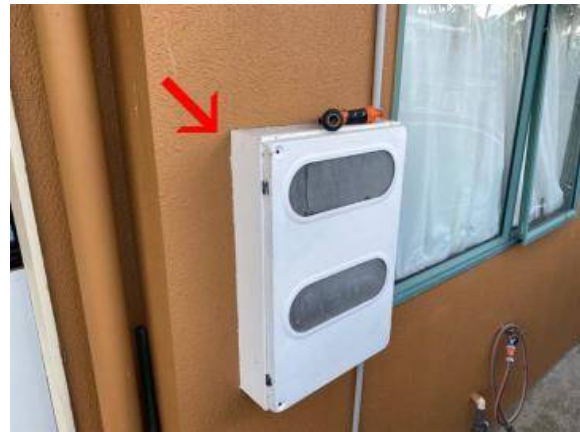
Meter box penetrates exterior cladding. No head flashing detail. This is considered a high risk detail. Where possible we recommend engaging the services of a suitably experienced cladding specialist to modify this detail and ensure the appropriate flashing details are installed.

Meter box penetrates exterior cladding. No head flashing detail. This is a considered a high risk detail. Where possible we recommend engaging the services of a suitably experienced cladding specialist to modify this detail and ensure the appropriate flashing details are installed.

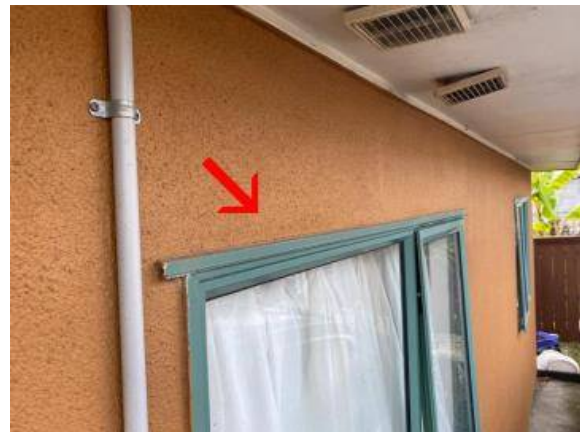
No evidence of a sufficient anti capillary gap above head flashings. A minimum anti capillary gap of 10mm is recommend to reduce the risk of moisture wicking behind cladding by providing adequate drainage. We recommend engaging a cladding specialist to modify this detail where required to meet minimum recommendations.
