Natural Disaster Land Damage Assessment - Landslip

394 Huia Road, Titirangi, Auckland

CCL Project No: 17119-148

15/09/2023

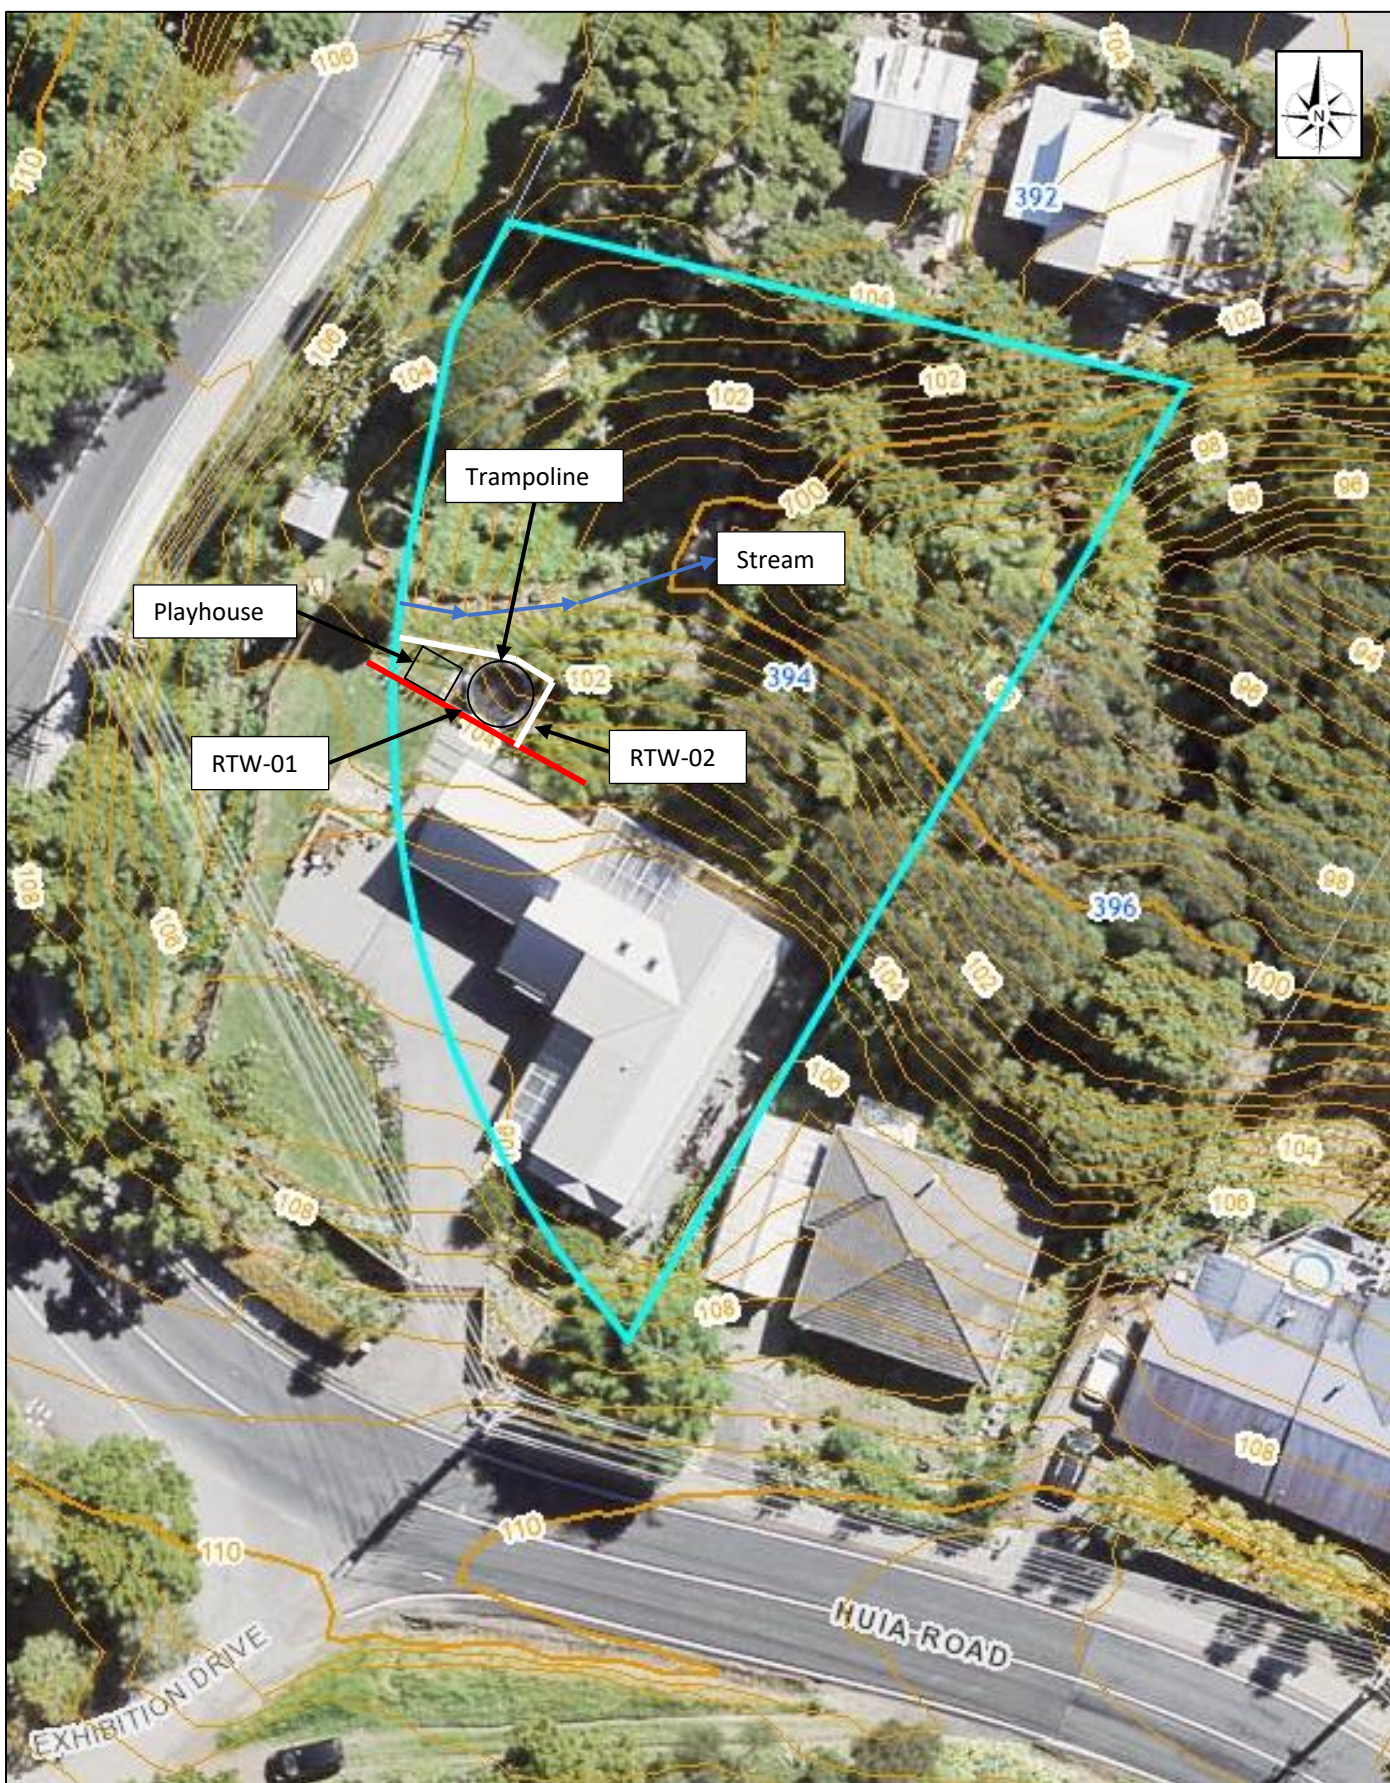
Two timber post retaining walls are located north of the dwelling. RTW-01 supports the path along the north side of the dwelling, and RTW-02 supports a flat area for the playhouse and trampoline. A stream is located directly north of RTW-02. There is a fence attached to the top of RTW-02, that continues beyond the western end of RTW-02. Figure 1 shows an aerial view of the property and the approximate location and extent of RTW-01 and RTW-02. Dimensions and properties of the retaining walls are summarised in Table 1 below.

Figure 1: Aerial view showing approximate location of retaining and appurtenant structures (Auckland Council GeoMaps, 2023).

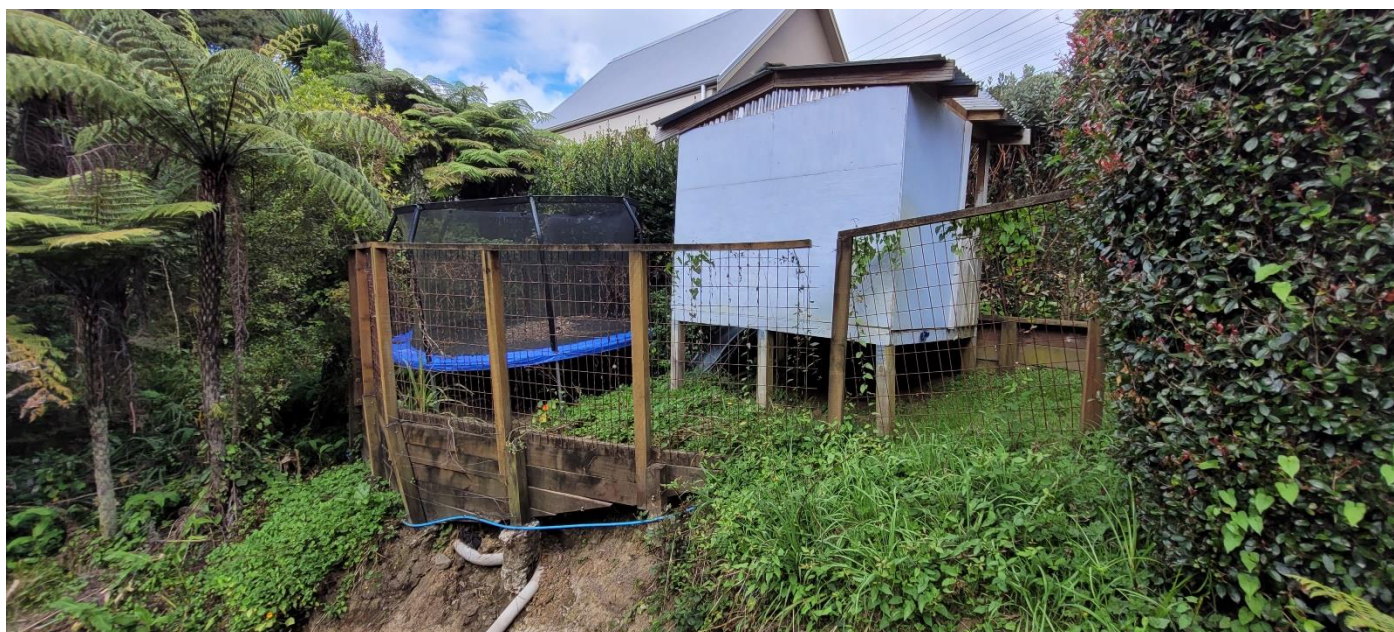
Photo 1: RTW-02, playhouse, and trampoline, looking southeast.

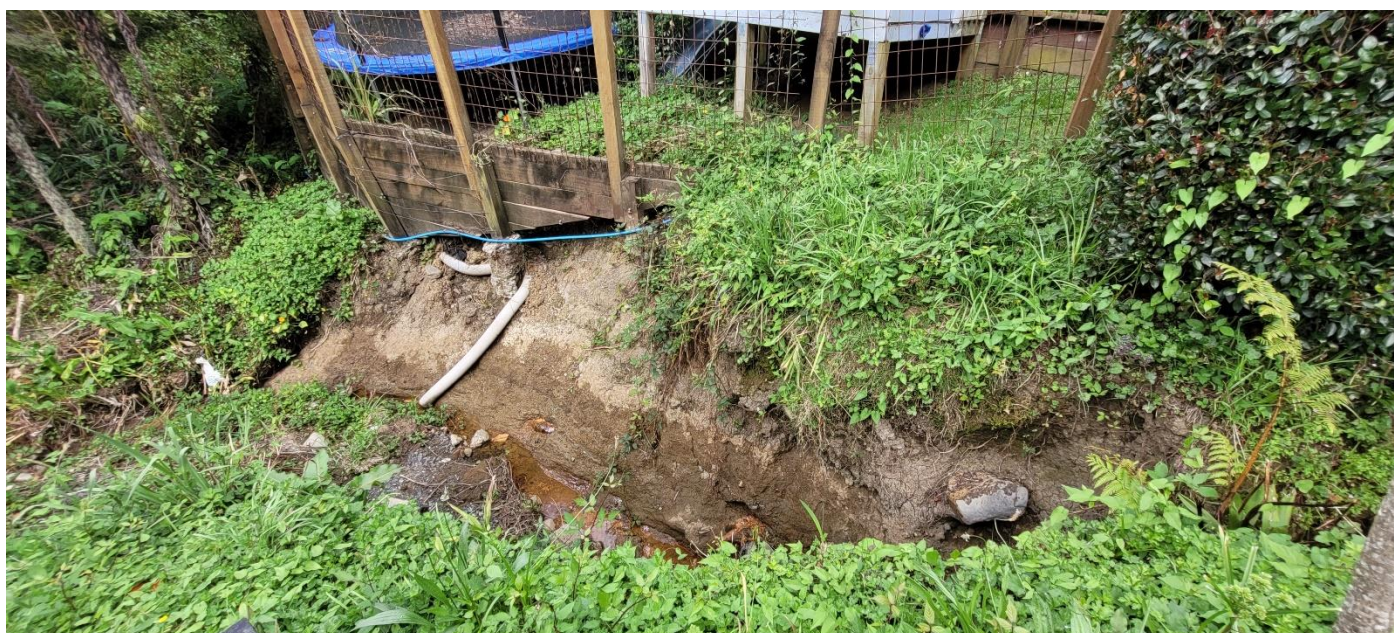
Photo 2: Northern elevation of RTW-02, looking southeast.

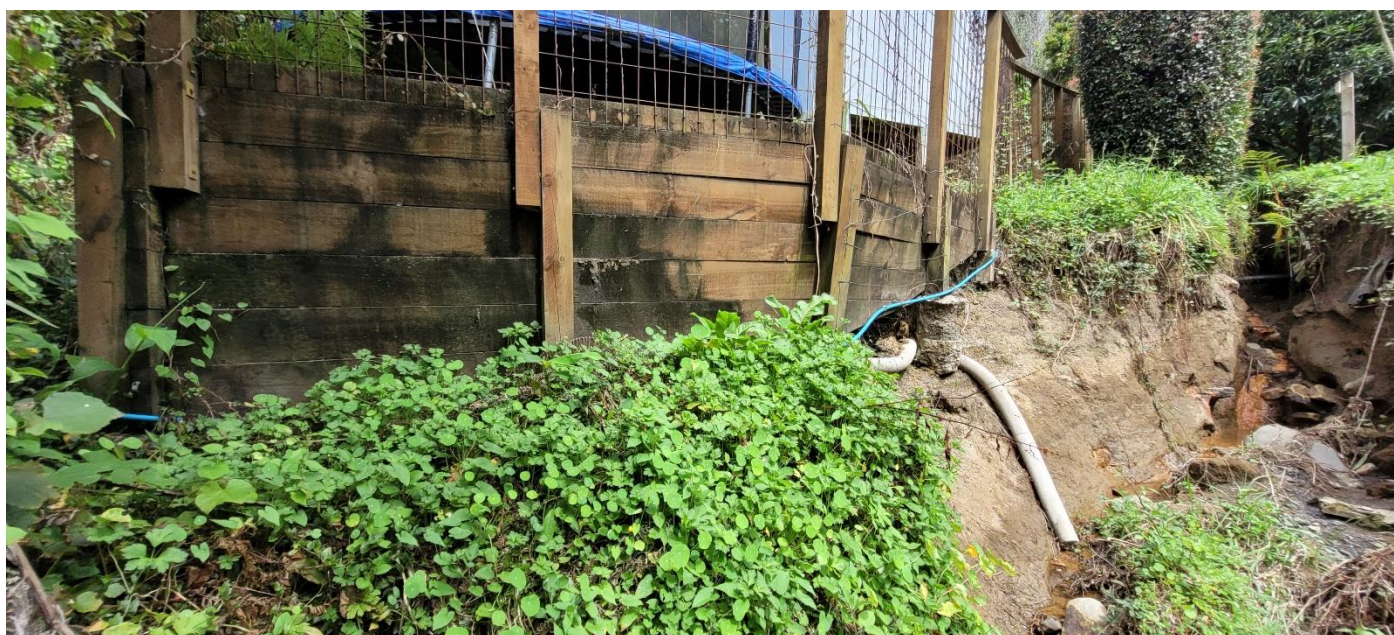
During the heavy rain event, water flow flooded the small creek that runs along the north side of the dwelling. A landslip has occurred upslope on the south side of the creek, north of RTW-02, causing two posts of RTW-02 to be entirely undermined, with another two posts rotating outwards. Scouring behind RTW-02 has also occurred, and fill was observed in the landslip face. Tension cracking was also observed behind RTW-02 beneath the trampoline.

Given that the retained height of RTW-02 is greater than its embedment depth, we conclude that the embedment depth for RTW-02 was not sufficiently designed. Given that the retained height of RTW-02 is less than 1.5 m, a building consent would not have been required for this wall. This did not cause the natural disaster damage or make it worse.

Photo 3: Rotated and undermined sections of RTW-02, looking south.

3. Remove the affected retaining wall (5 posts, 5.6 m length) and dispose of it off-site.
4. Construct a timber pole retaining wall with the following dimensions and properties:

- a. 5.6 m long wall, tied into the existing undamaged section of RTW-02.
 - b. 2.7 m maximum retained height.
 - c. Minimum pole embedment of 2.7 m, for a total pole length of 5.4 m.

- d. 300 mm diameter H5-treated SED timber poles at 1.4 m centres.
 - e. 200 mm x 50 mm H4-treated timber lagging.
 - f. Drainage metal wrapped in A29 Bidim filter cloth (geotextile).

- g. 110 mm diameter Novaflo drain wrapped in filter fabric connected to an existing stormwater system.
5. Install six new playhouse piles comprising 125X125 SG8 H4 treated timber piles embedded in 400W x 400L x 400 mm deep 25 MPa concrete footings, on minimum 500 mm compacted AP40 hardfill compacted with a minimum of 95% MDD in max 150mm layers (0.48 m³ total).

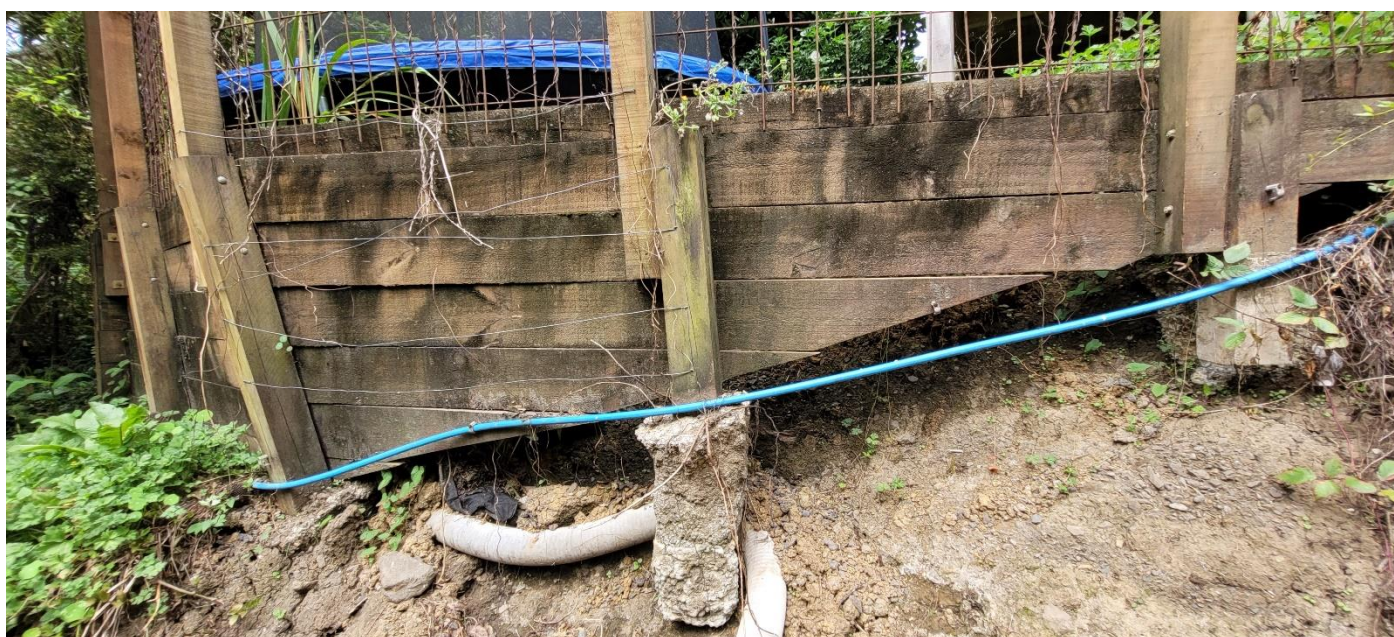
Photo 4: Undermined section of RTW-02, looking south.

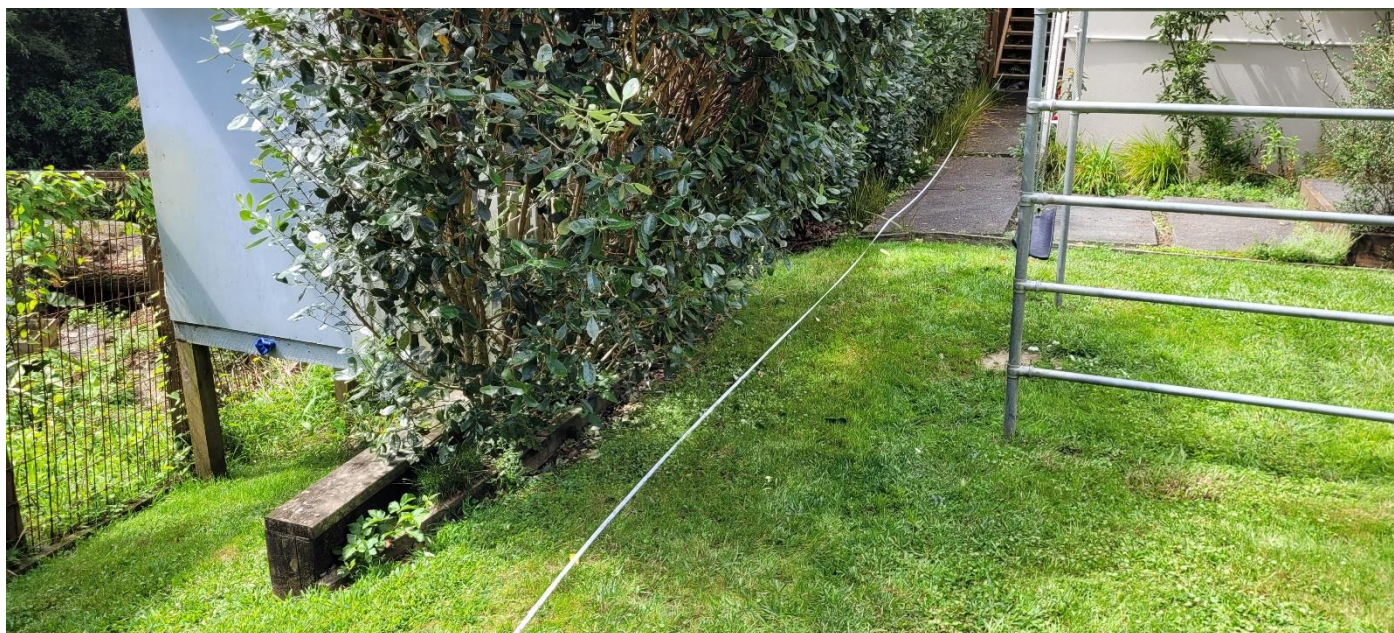
Photo 5: Looking southeast towards the playhouse and west end of RTW-01 to the north of the dwelling.

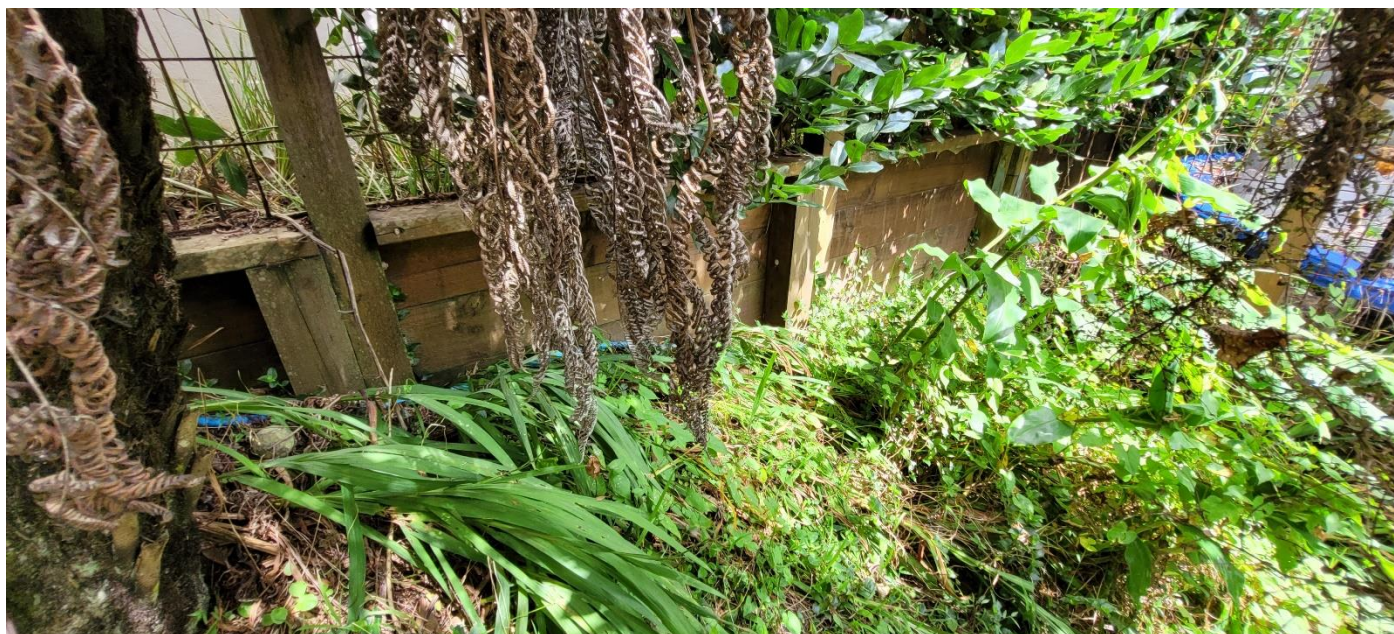
Photo 6: Looking southwest towards the east end of RTW-01.

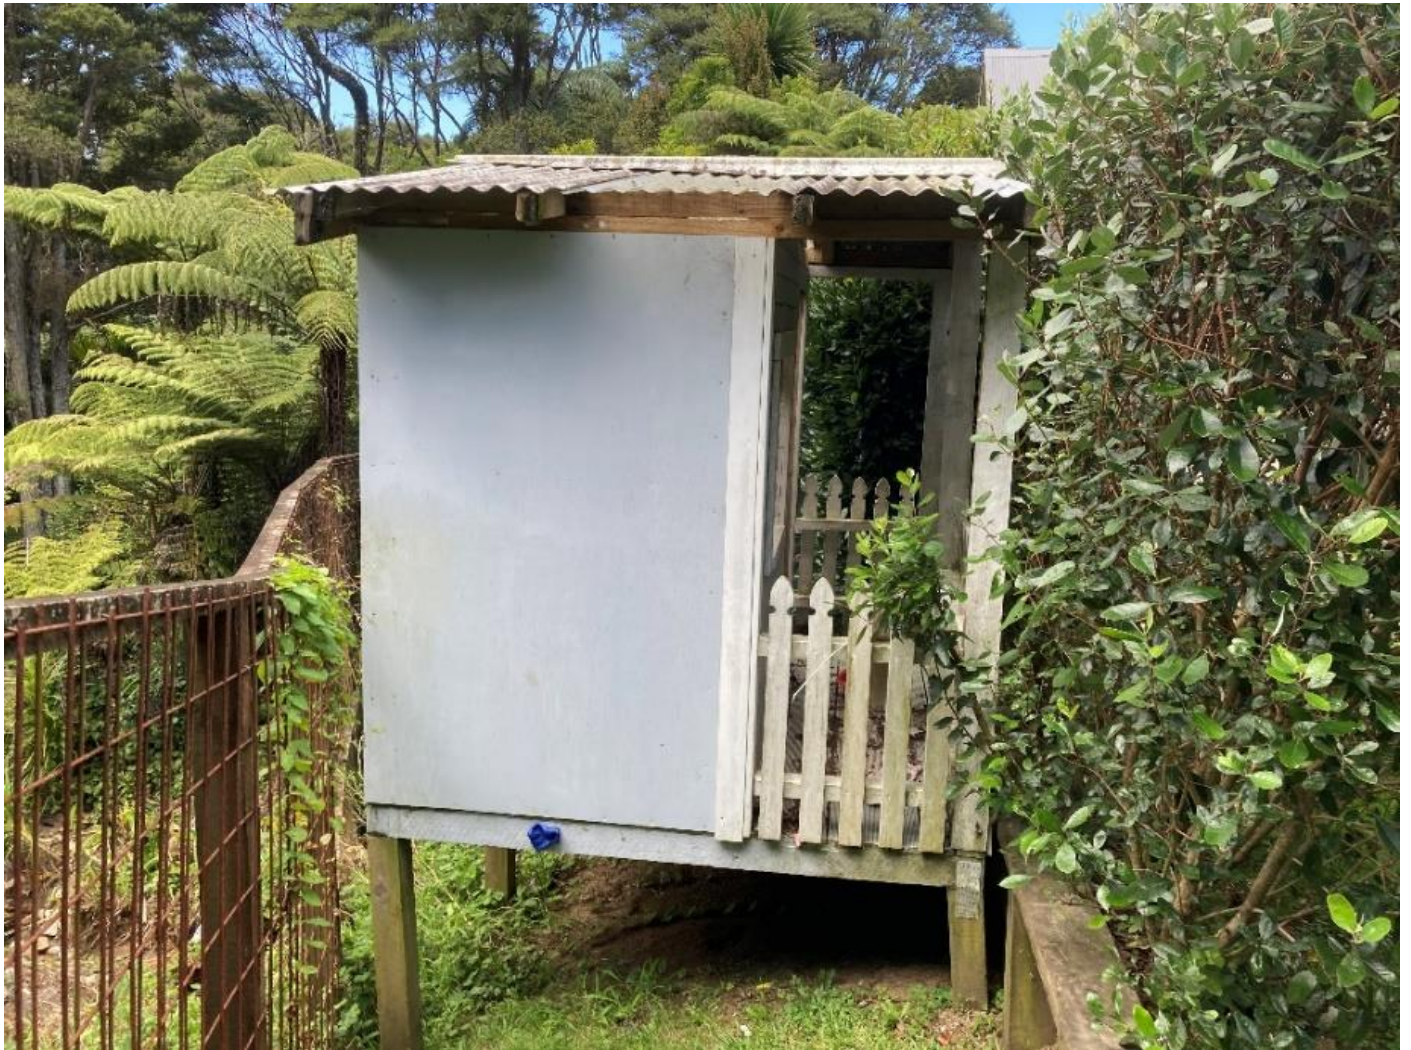
There is observed structural damage to the playhouse. This damage consists of subsidence to the northern three piles of the playhouse, which in turn has caused the playhouse to shift to the north, rotating on all six of its piles. The identified imminent risk of ongoing ground creep due to the release of horizontal support from the land will impact the playhouse.

The playhouse has been damaged and is considered to be at imminent risk of collapse as a direct result of the natural disaster (landslip) that has occurred. Should the imminent risk be realised, then the playhouse would likely collapse and become a total loss.

Photo 7: Western elevation of the playhouse, looking east.

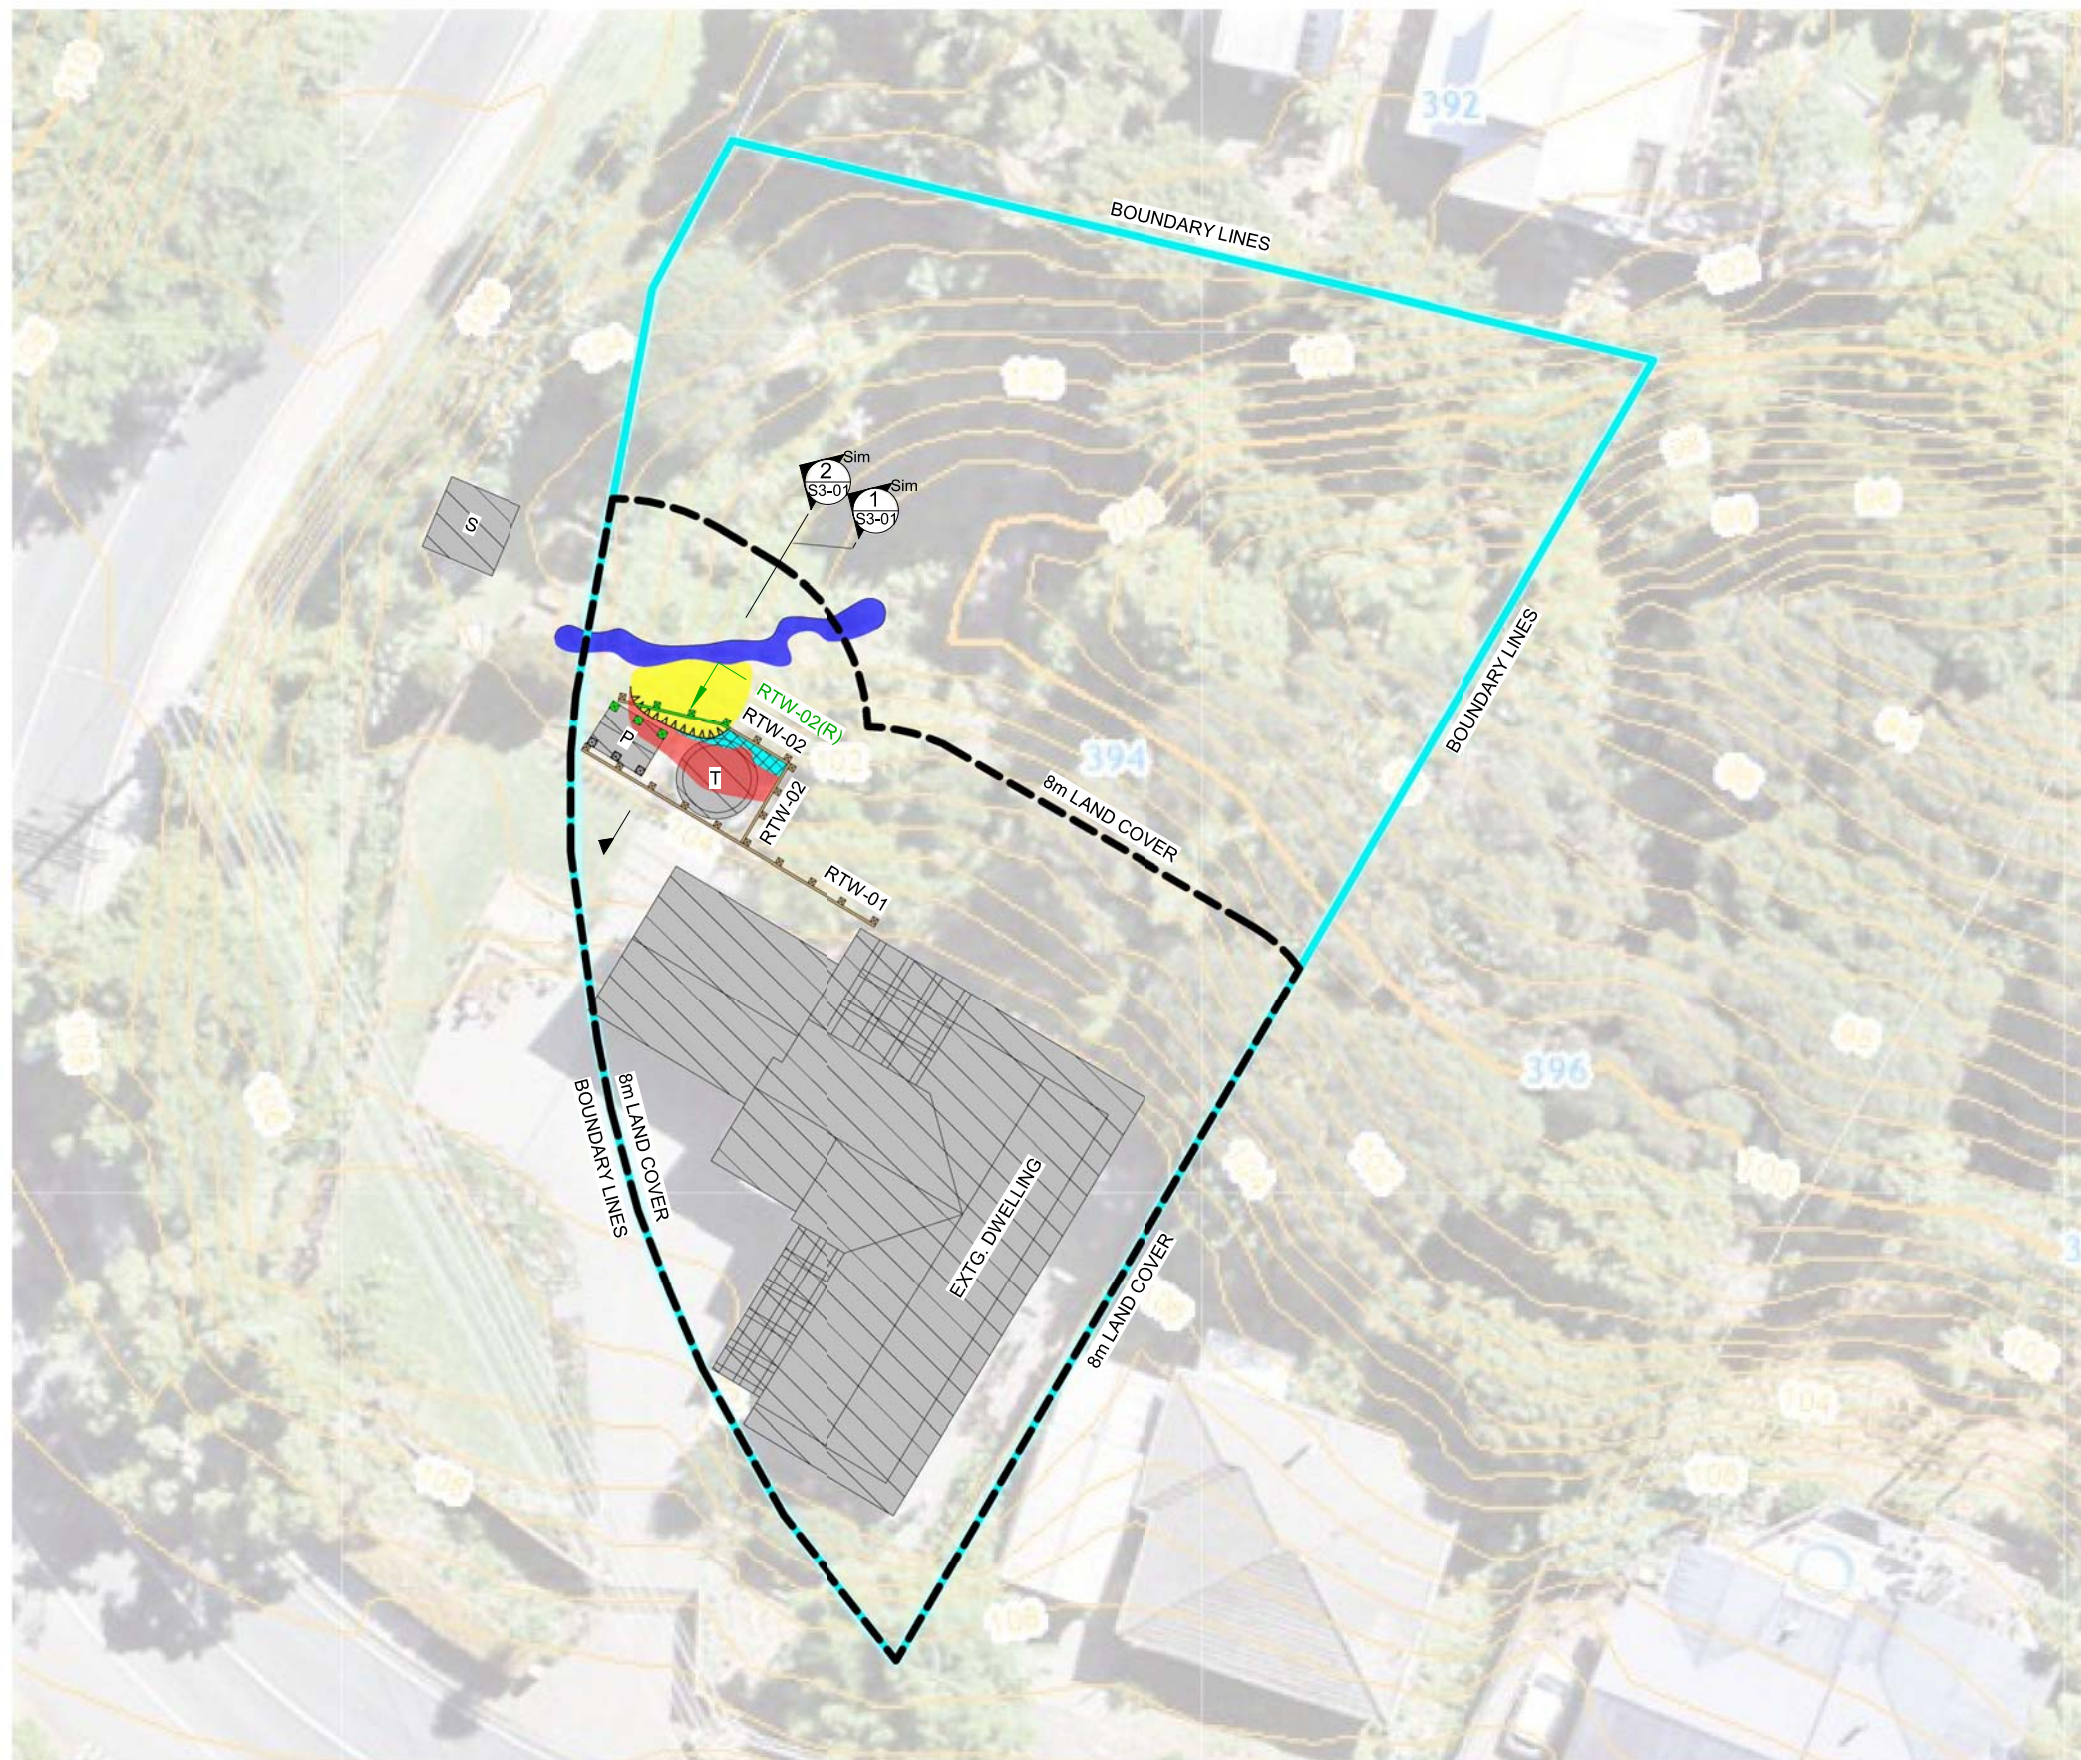
A LANDSLIP DAMAGES PLAN
1 : 300

LANDSLIP DAMAGES LEGEND	
	LAND WITHIN 8m COVER
	EXISTING SITE BOUNDARY LINES
	LANDSLIP HEADSCARP (INDICATIVE)
	EXISTING STREAM / CREEK (INDICATIVE)
	SCOUR BEHIND RTW-02(R) & RTW-02 DUE TO THE LANDSLIP (INDICATIVE)
	AREA OF EVACUATED LAND FROM THE LANDSLIP (INDICATIVE)
	AREA OF IMMINENT RISK OF FURTHER EVACUATION (INDICATIVE)
	EXISTING DWELLING UNDAMAGED FROM THE LANDSLIP, NO WORKS REQUIRED
	RTW-01: EXISTING TIMBER PILE RETAINING WALL PARALLEL TO NORTHERN SIDE OF EXISTING DWELLING, UNDAMAGED FROM THE LANDSLIP, NO REPAIRS REQUIRED
	RTW-02: EXISTING TIMBER PILE RETAINING WALL SECTIONS (TRANSITIONS TO TIMBER FENCE @ WEST END) THAT ARE UNDAMAGED FROM THE LANDSLIP, NO REPAIRS REQUIRED, ALLOW TO TIE INTO PROPOSED TIMBER POLE RETAINING WALL
	RTW-02(R): EXISTING SECTION OF THE TIMBER PILE RETAINING WALL THAT ROTATED FROM LANDSLIP SOIL EVACUATION AND SCOUR (BEHIND), WALL INTEGRITY HAS SINCE BEEN COMPROMISED AND REQUIRES A PROPOSED REMEDIAL WALL

T: EXISTING TRAMPOLINE UNDAMAGED FROM THE LANDSLIP, NO REPAIRS REQUIRED
	S: EXISTING SHED OUTSIDE OF THE PROPERTY BOUNDARY LINES
	P: EXISTING PLAYHOUSE FOUNDED ON TIMBER PILES. THE NORTHERN 3 PILES (SHADED GREEN) SUSTAINED LANDSLIP DAMAGES AND IS TILTING. ALLOW TO PROP, REMOVE AND REPLACE THE DAMAGED PILES, REINSTATE AND MAKE GOOD

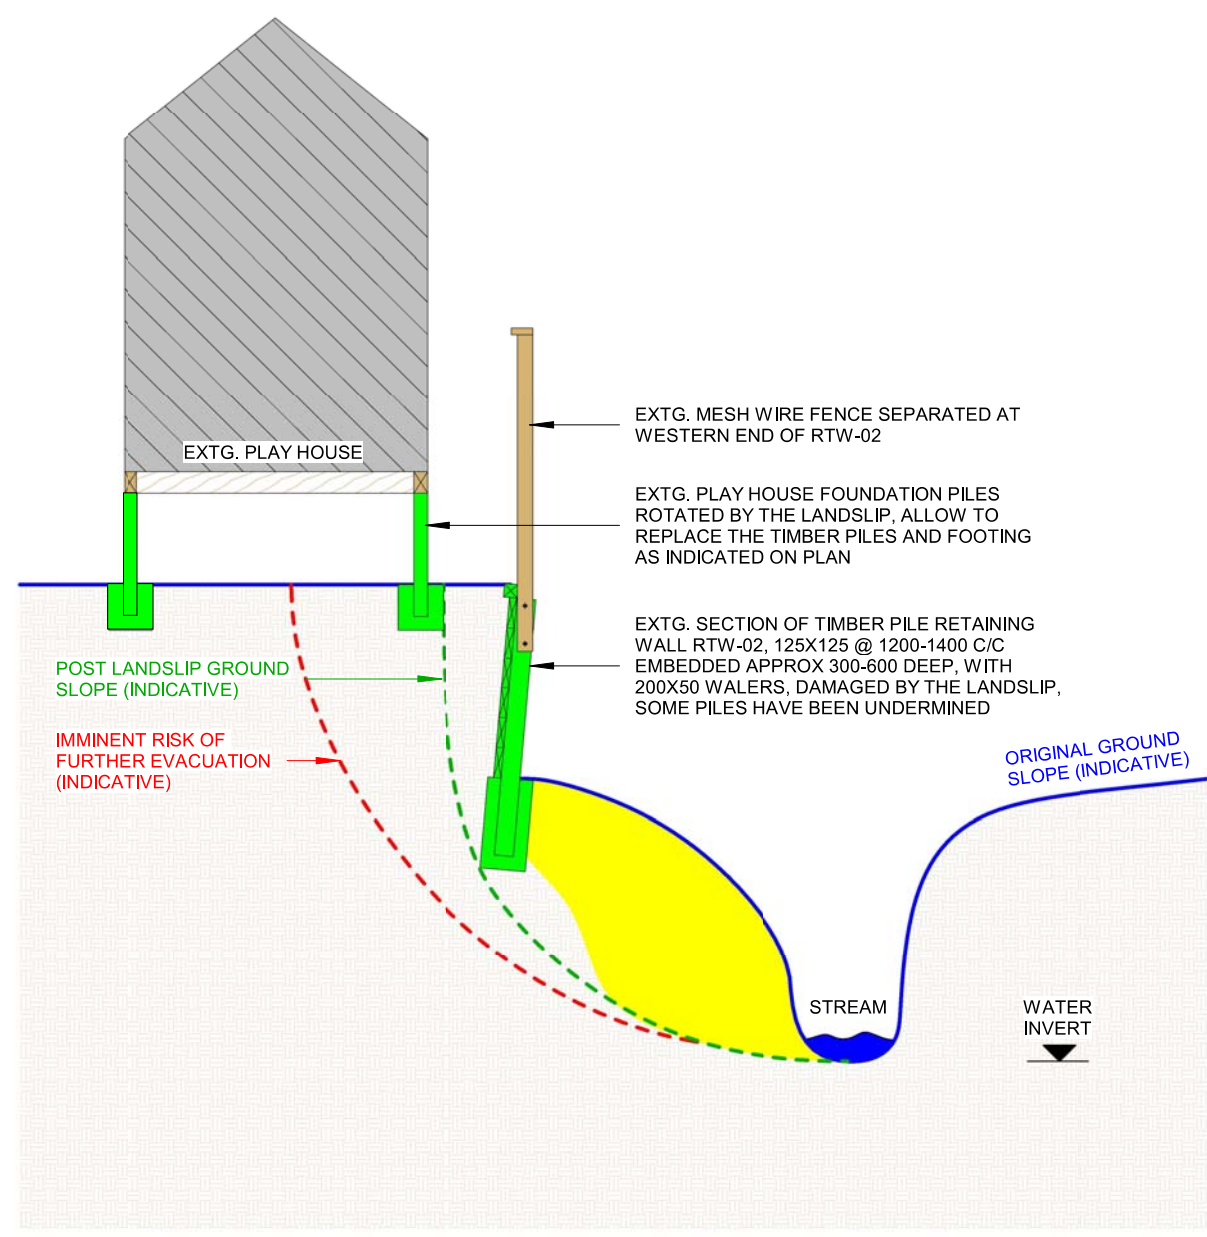
1 LANDSLIP DAMAGE SECTION
S2-01 1 : 50

The damage to the property consists of a 5.6 m wide, 2.7 m high landslip adjacent to the northern side of RTW-02, which has resulted in:

1. Evacuation of insured land;
2. Undermining and rotation of a 5.6 m length of RTW-02; and
3. Rotation of the playhouse piles.
