BCO10068260 Residential final Inspection
 Inspection checklist outcome statement 18-04-2024
 26 Kauri Point Road Laingholm
 Inspection Address : 26 Kauri Point Road Laingholm

Inspection Details	
Inspection Type Code	Residential final(IF1)
Date of Inspection	18-04-2024
Building name	N/A
Floor/Units (Multi Unit only)	N/A
Lot	N/A
Start time	13:57:00
Scope	Full
Partial description mandatory	N/A
Does the checklist need to be completed?	N/A
Site safety	Safe
Unsafe site	N/A
Comment - Site Safety (Near Miss)	N/A
Consent documents on site	Yes
Previous inspection history checked	Yes
Involves restricted building work	No
LBP information	N/A

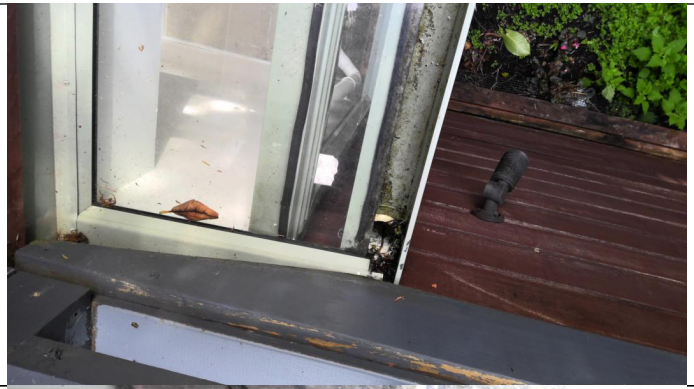
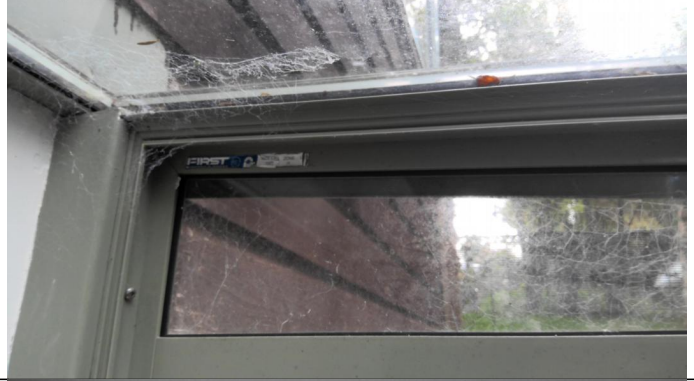
Checklist Item	Result	Comment
Final inspection scope	Final	*
Residential final scope	Other	To check a Conservatory, items recorded in notes
Smoke alarms installed and tested	Pass	*
