Property Address: 30 Sylvan Valley Avenue, Titirangi

RECOMMENDATIONS REPORT

Inspection 9029
Customer Marc Capp
Property Address 30 Sylvan Valley Avenue, Titirangi
Date 12/02/2025

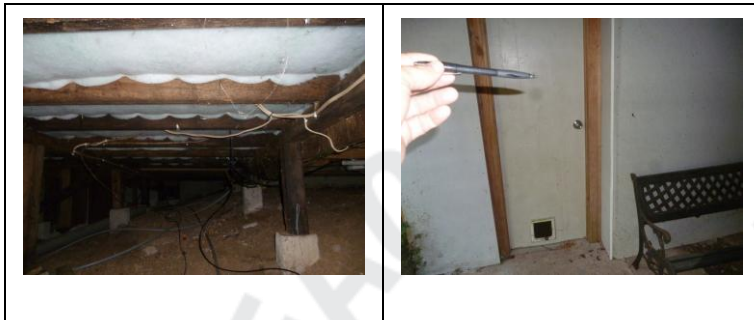
Under bathroom areas found to be dry with no signs of leaks at time of inspection.

Note: Unable to gain access inside basement shed due to been locked.

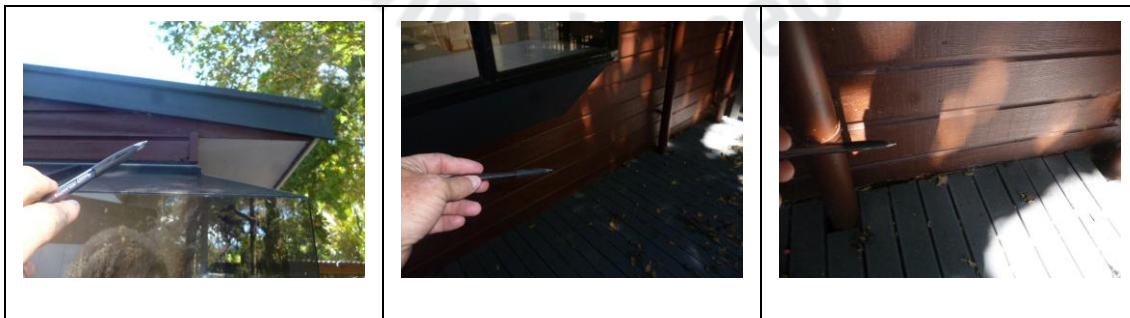
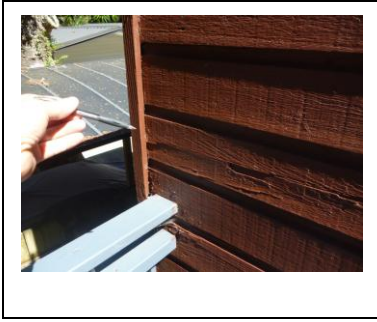
Note: Rot sighted on north-west corner weatherboard over kitchen bay window and along north, west and south sides of house where deck is in contact with cladding (refer to notes under “Decks”). Damage and minor rot to north-east corner of house.

Recommend all these areas have further investigation carried out with all repairs/replacements being undertaken by an LBP builder.

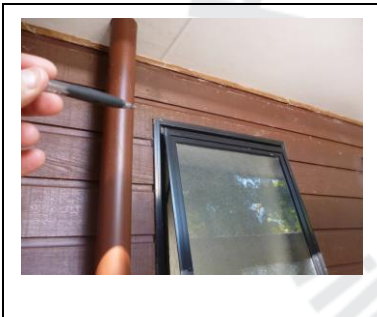
- 1 Several windows on west side of house have no head flashings and are reliant on soffit for cover. All windows / doors require mechanical head flashings.
- 2 Sides of joinery are reliant on wedges/foam or silicone to seal.

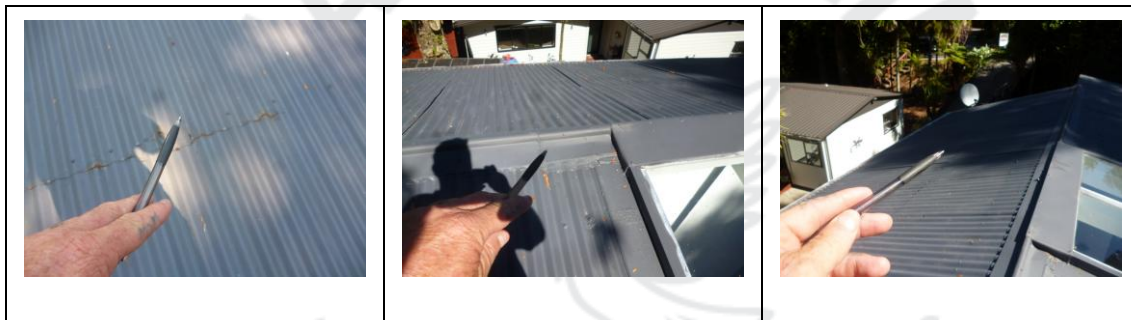
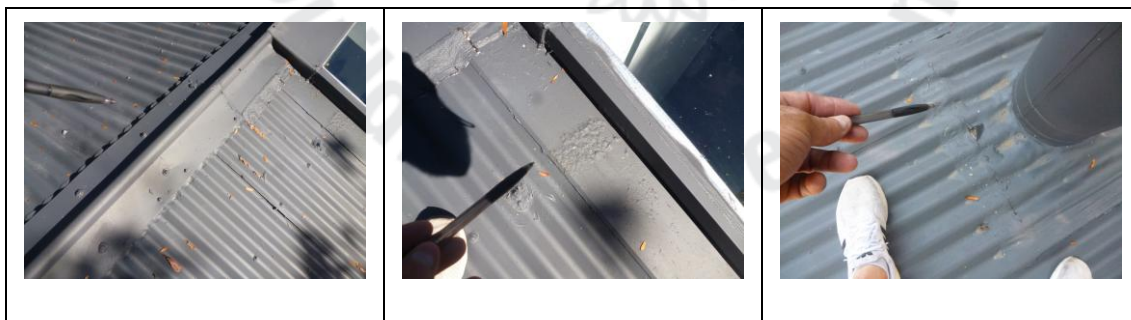
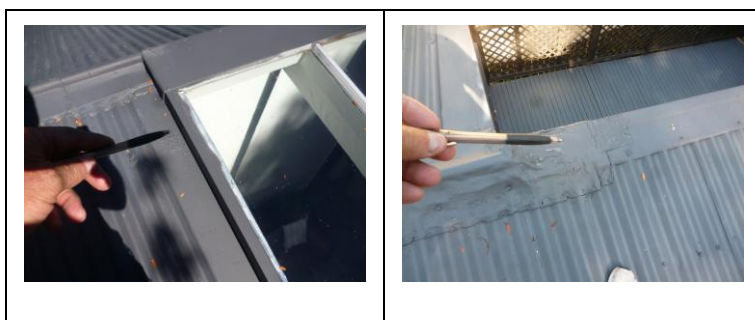
- 1 Short sheet galvanised lead head fixed roofing requires fixings replaced with screw fixings with fibrous washers and any rust in roof treated. Recommend a professional roof company check and carry out all repairs to ensure watertight or replace as necessary.
- 2 Aluband tape used in areas of roof and around skylight flashings. Recommend professional repairs or replace as necessary.

Recommend yearly checks to clean and carry out any necessary maintenance which may be required to ensure watertight. Note:

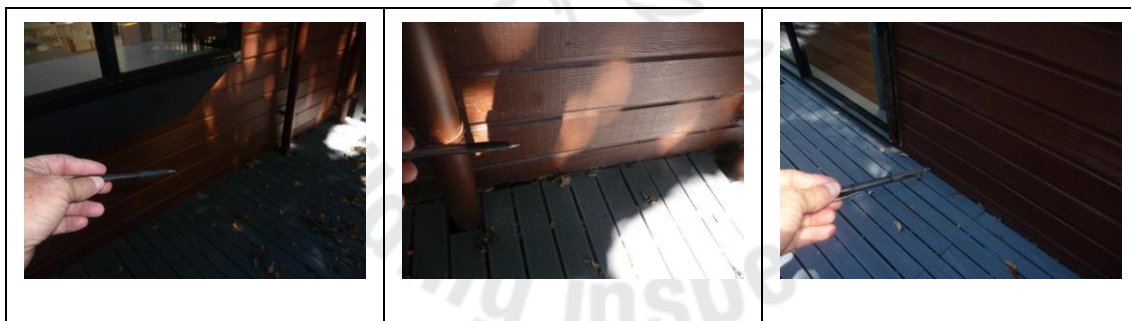
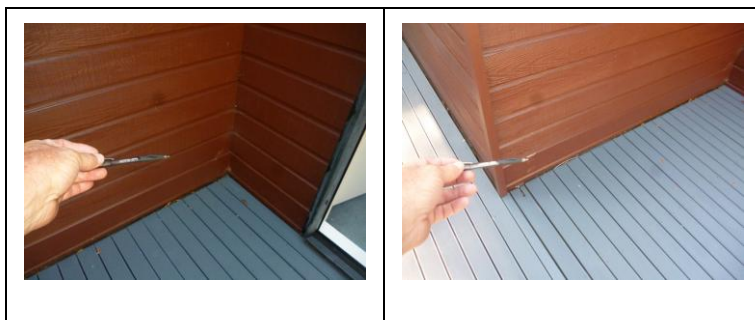
Note: All decking requires a minimum 12 mm gap to cladding to prevent moisture being trapped. Damage to bottom timber shiplap on both decks due to moisture transfer from decking areas.

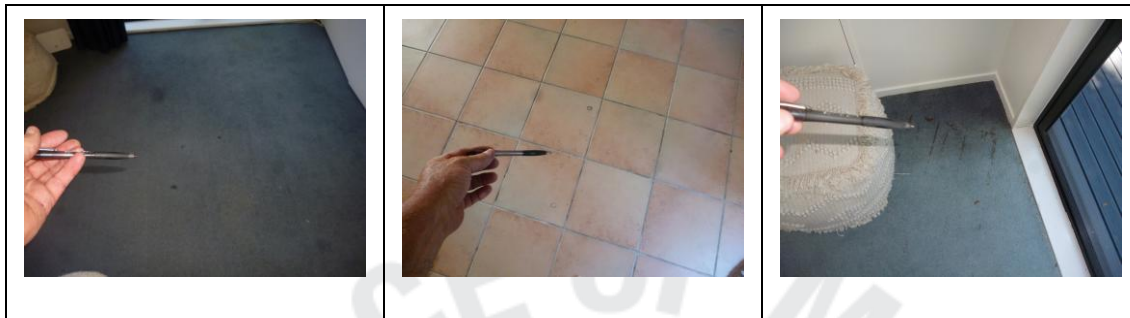
Note: Lived-in marks to carpets in bedrooms and several holes in tiles in lounge.

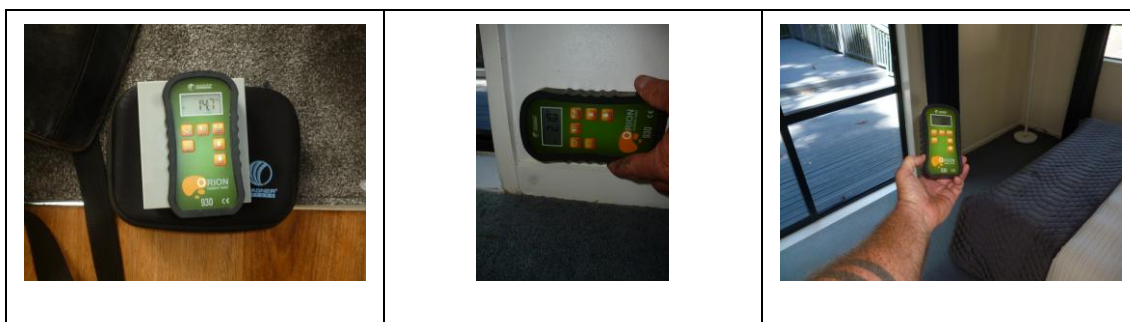
Note: Elevated moisture readings recorded on north wall of master bedroom on bottom plate area, south and west walls of lounge area around windows and bottom plate and east wall of lounge. Refer to notes under "Roof", "Decking" and "Foundation Walls". Further investigation required in these areas.

Elevated moisture readings were detected and noted in report, otherwise appears to be normal at time of inspection. (Below 16 Orion 930 considered normal)

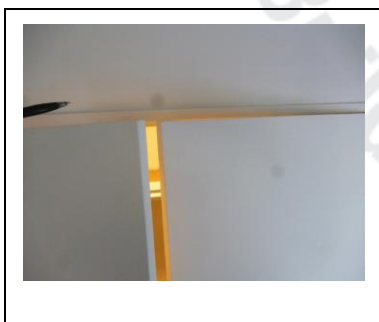
Note: Hardware missing from master wardrobe and several doors require easing so function correctly.

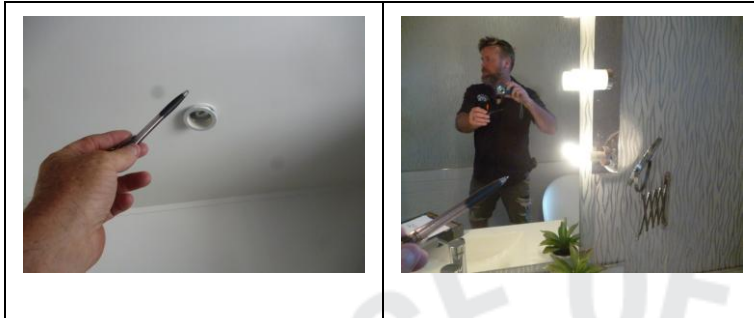
- 1 Bedroom three, one light requires refitting correctly.
- 2 Glass cover missing from vanity lights.

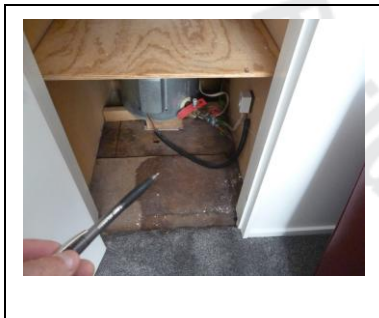
Note: Historical moisture damage to floor in hot water cupboard. Tested dry at time of inspection.

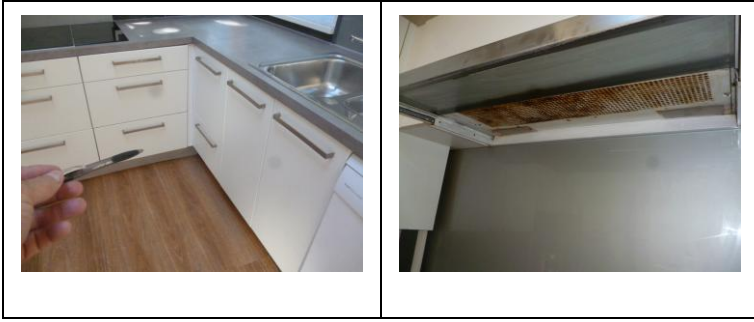
Note: Loose kitchen cabinet kickboards, several holes in cabinets from screws. Lights not working on exhaust fan.

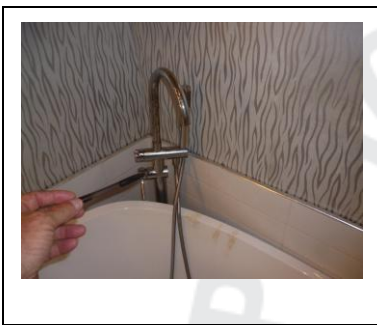
Note: Damage to bath, surface rust to mixer tower, loose mixer tower and one bracket broken on towel rail.

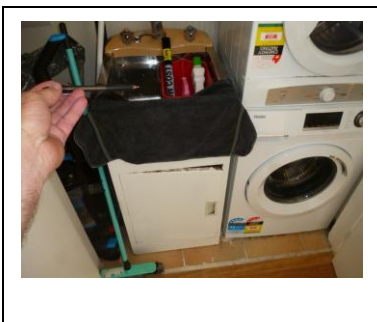
Note: Recommend super tub is fixed in place. Cabinet has surface rust.

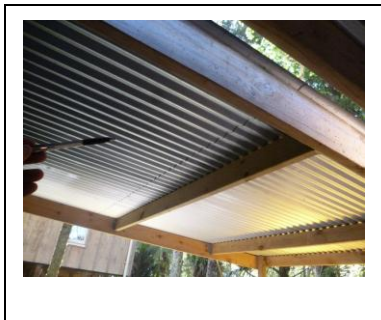
Note: No cross roof bracing on carports, movement in construction.

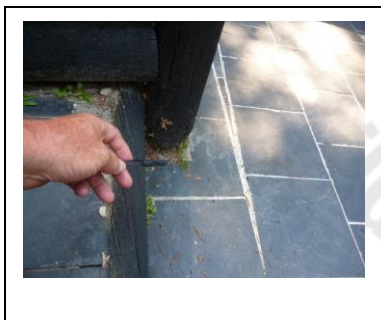
Note: Noticed areas of rot to retaining wall and posts.
