Pre-purchase HOUSE inspections

RECOMMENDATIONS REPORT

Inspection 9089
Customer Jessica Justice
Property Address 33A Landing Road, Titirangi
Date 14/03/2025

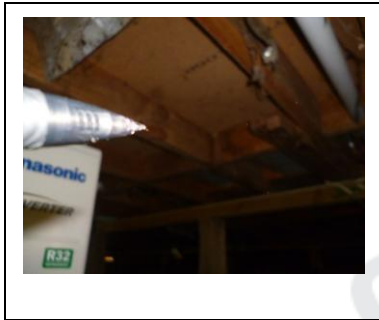
Basement

Access located on west side of house. Foundation walls are timber posts in concrete. Piles are timber posts in concrete. Sub-floor bracing and fixings, bearers and floor joists all appear to be in good condition. Floor is particle board with breather foil and no insulation.

Under bathroom areas found to be dry with no signs of leaks at time of inspection.

Note: Recommend batts or foam insulation for better insulation qualities.

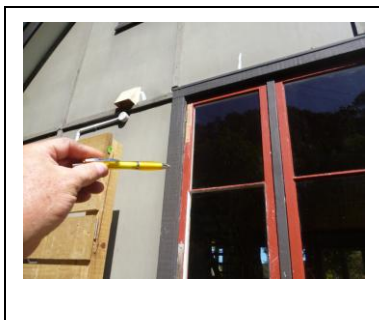
Joinery

Note: Remedial work has been undertaken to east side lower window, painting maintenance required to finish.

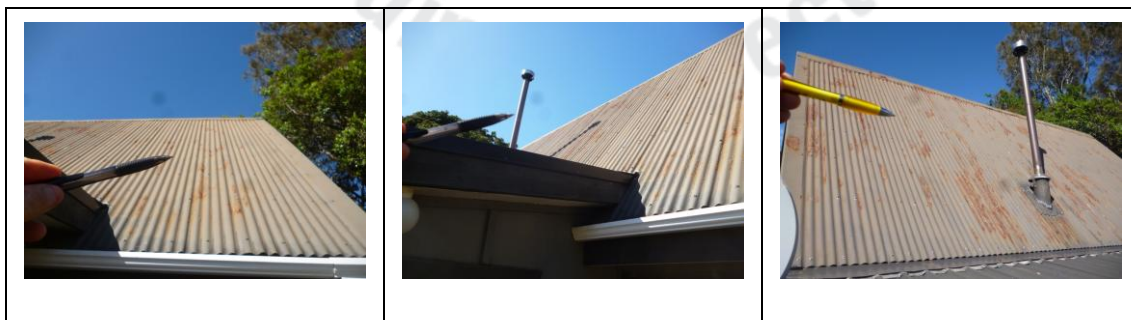
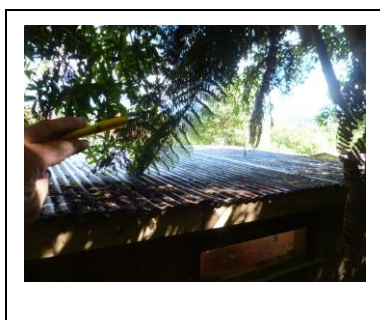
Roof

Corrugated iron roofing and long-run coloursteel. Roof, ridges, valleys and roof flashing appeared to be in good to poor condition at the time of inspection.

Recommend yearly checks to clean and carry out any necessary maintenance which may be required to ensure watertight. We were unable to fully inspect top roof area due to excessive height (over 3 meters).

Note: Recommend a professional roof company check and carry out all repairs to ensure watertight or replace as necessary, mainly on north side of upper roof and sleep-out.

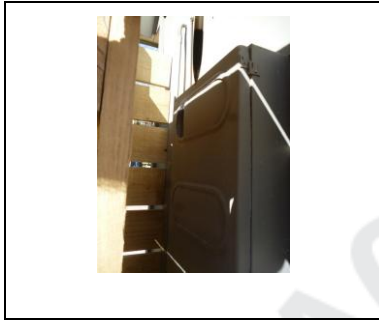
Electric Power Main (Meter Box)

Located on east side of house. Earth pipe and connection seen.

Note: Viewing screen broken.

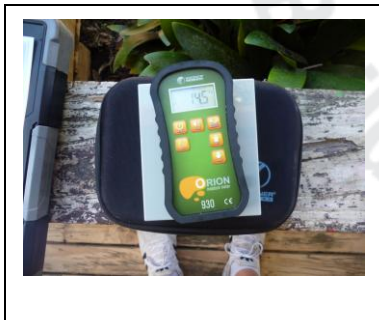
Orion Gauge Used

Readings were taken from a minimum of three points from inside of all exterior walls and wet areas i.e. Around all windows, doors, bottom plates and wet areas.

No elevated moisture readings were detected at time of inspection.

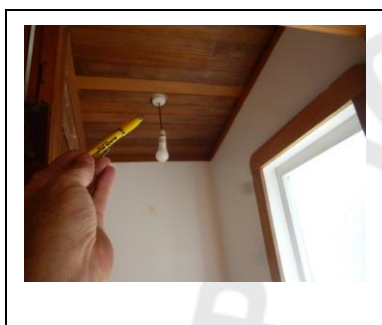
Lights

Fittings all appear to be in good condition. No damaged switches. Light bulbs all working at the time of inspection other than bulb in toilet.

Recommend all lights are working at time of possession to eliminate not bulb only issue.

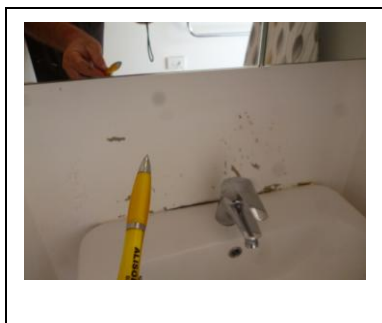
Bathroom (downstairs)

Bath with mixer and spout, tiled shower with curtain over bath. Pedestal basin with mixer. Washing machine outlets. All operational. No leaks found at the time of inspection. One heated towel rail. All appears to be in good condition.

Note: Painting and silicone maintenance recommended above basin.

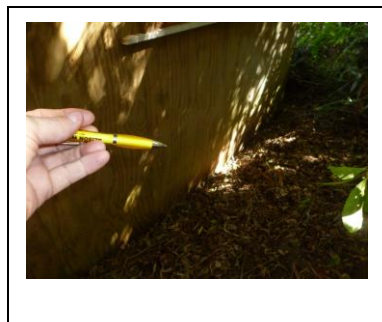
Sleep-out

Timber weatherboards and timber plywood with corrugated iron roof. All in good to fair condition at time of inspection. Note:

- 1 Refer to notes under "Roof".
- 2 Remedial work being undertaken to sleep-out at time of inspection.
- 3 Recommend foliage and ground level be lowered to sleep-out cladding on east side.
