# Third Party Report (Safe & Sanitary)

10 Rauhuia Crescent, Parau, Auckland

Inspection prepared for: Bruce Courtney  
Date of Inspection: 3/11/2025 Time: 8:30 AM

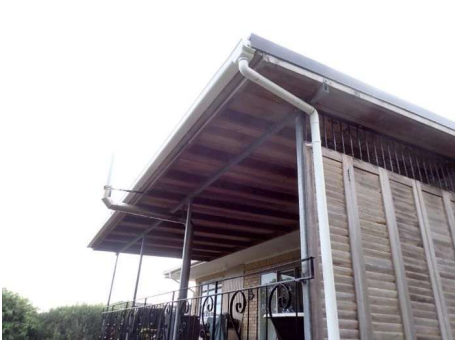
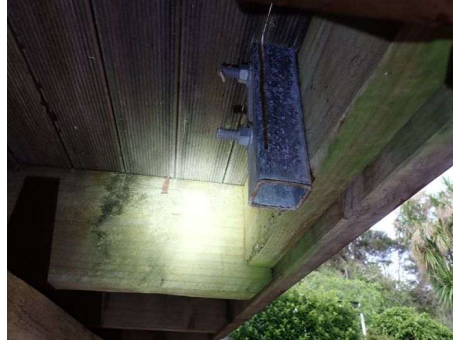
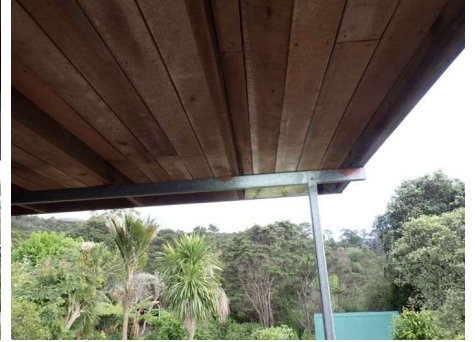
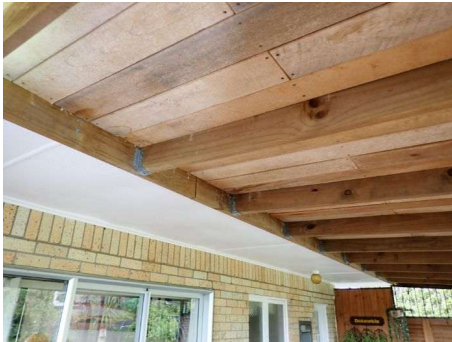
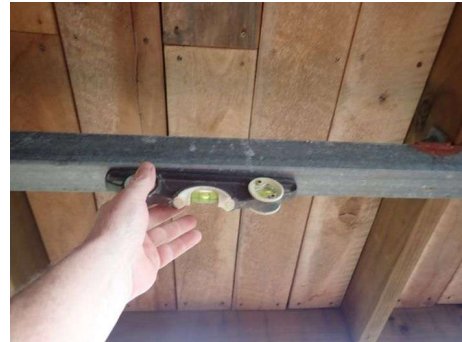
- Appears well constructed and in good condition

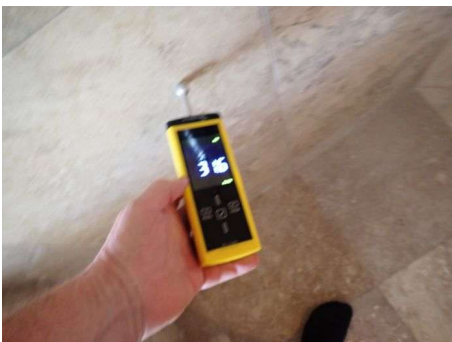
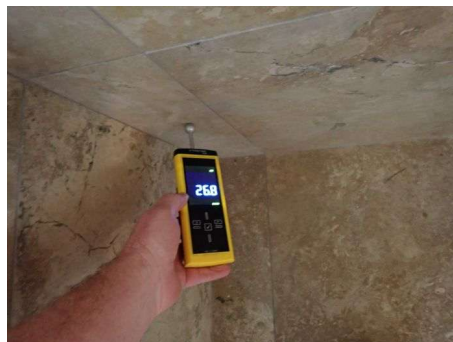
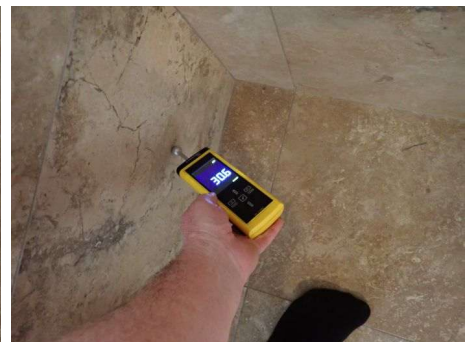
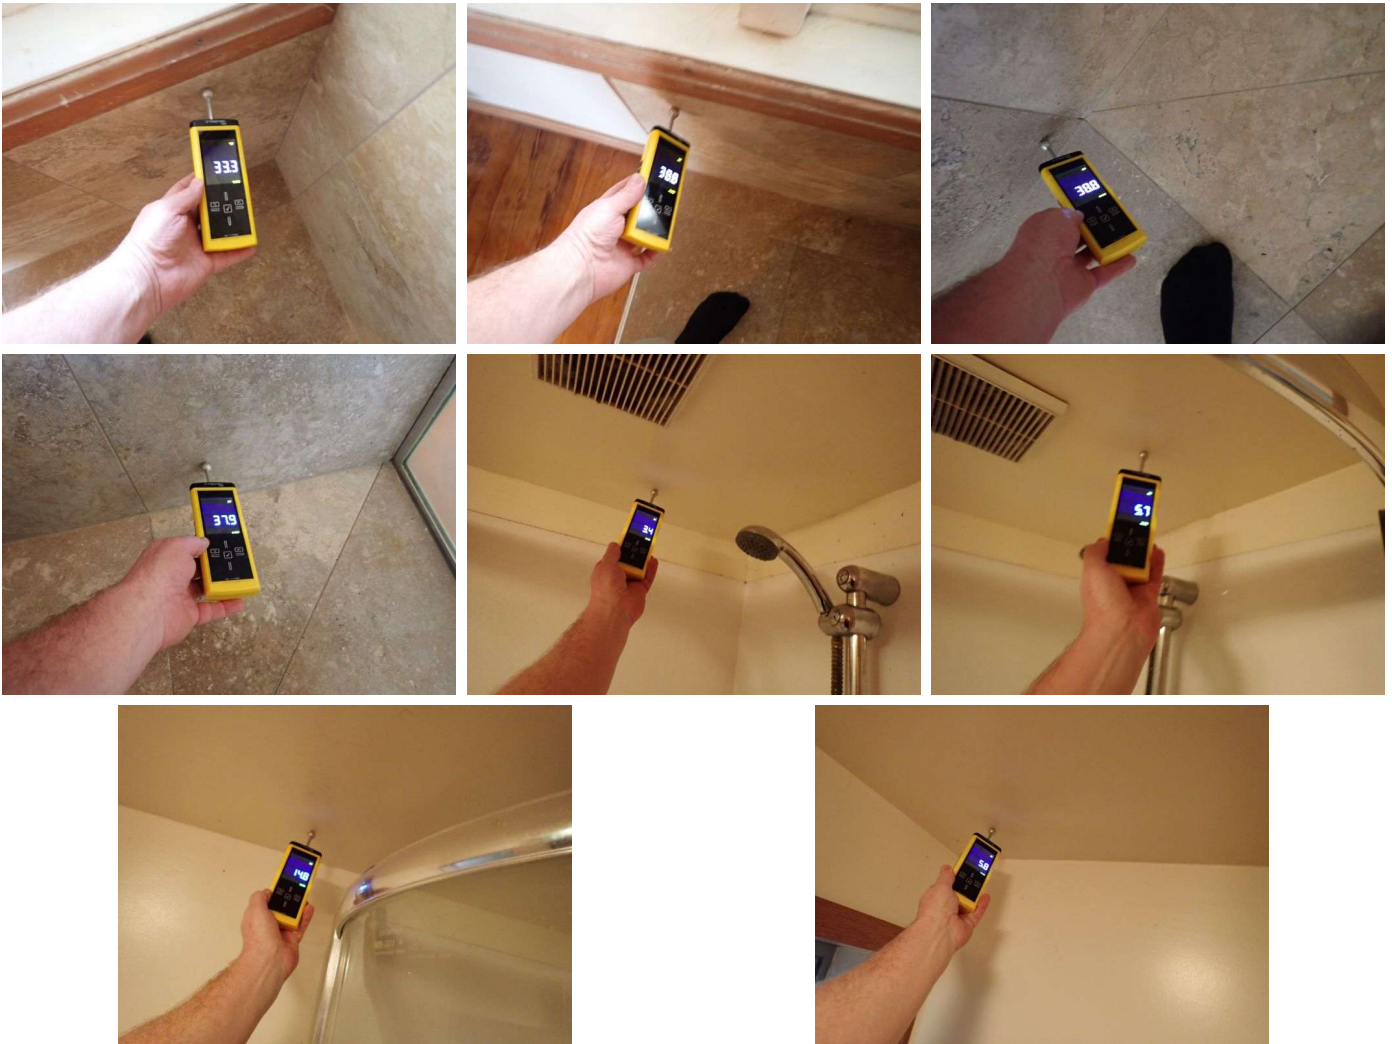
- Several readings were taken and all were within the acceptable range and indicate the room to be DRY within the shower including beneath the shower

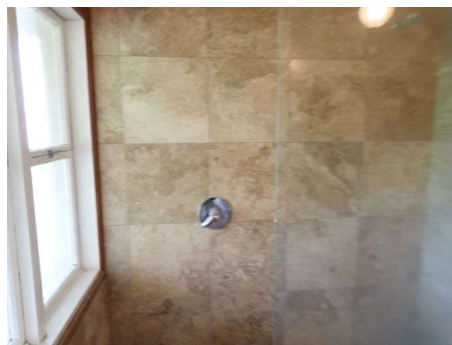
- M D NI • Tile pan and surround in good condition

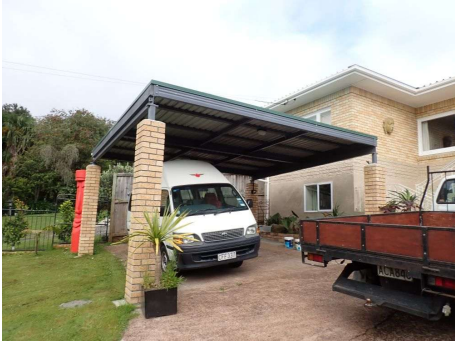
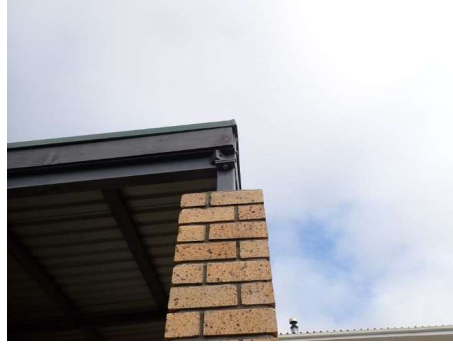
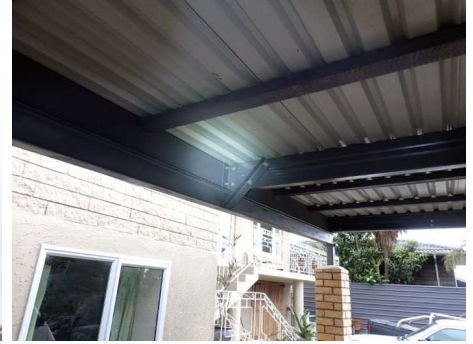
- M D NI • Appears well constructed and in good condition

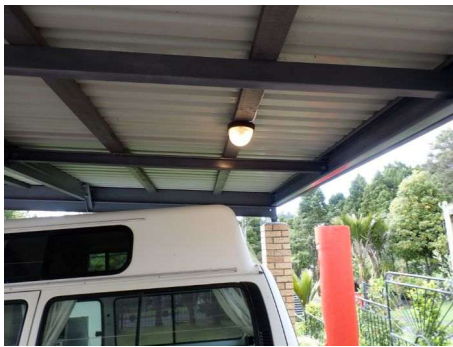
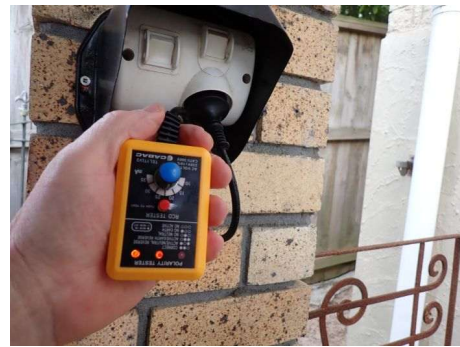
- M D NI • The lights and power outlet are functional, the outlet is earthed and wired correctly
