Non Invasive Cladding Assessment

**6 Crowther Street
Blockhouse Bay
Auckland District**

Inspection Date: 6/05/2020

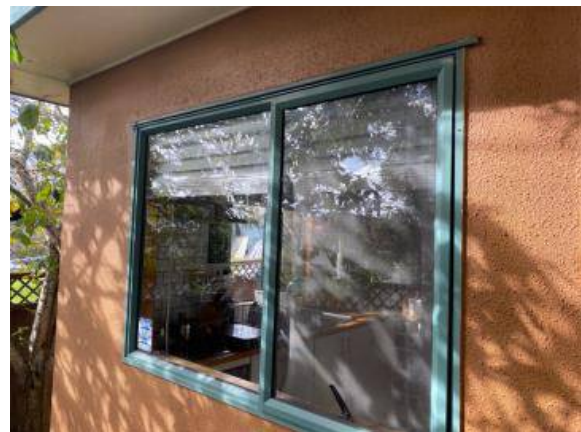
No evidence of a sufficient anti capillary gap above head flashings. A minimum anti capillary gap of 10mm is recommend to reduce the risk of moisture wicking behind cladding by providing adequate drainage. We recommend engaging a cladding specialist to modify this detail where required to meet minimum recommendations.

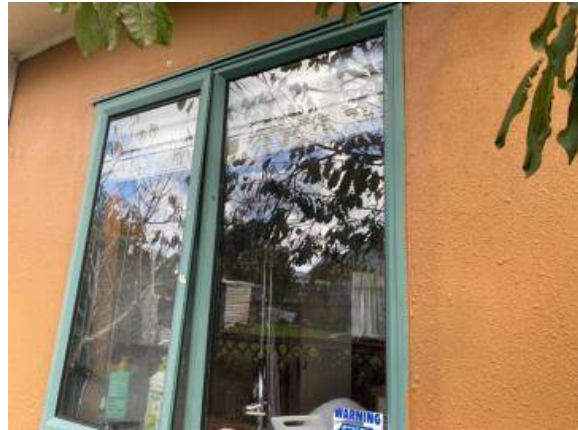
No evidence of a sufficient anti capillary gap above head flashings. A minimum anti capillary gap of 10mm is recommend to reduce the risk of moisture wicking behind cladding by providing adequate drainage. We recommend engaging a cladding specialist to modify this detail where required to meet minimum recommendations.

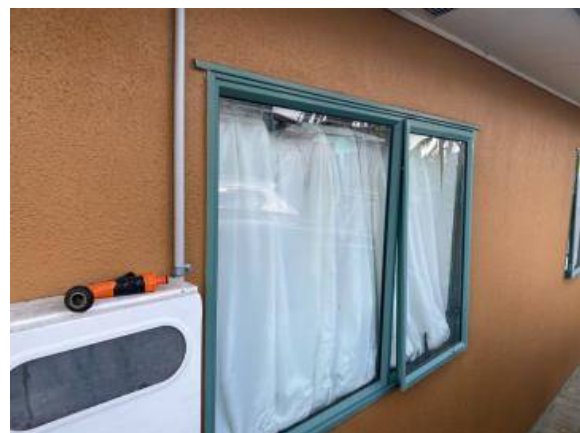
No evidence of a sufficient anti capillary gap above head flashings. A minimum anti capillary gap of 10mm is recommend to reduce the risk of moisture wicking behind cladding by providing adequate drainage. We recommend engaging a cladding specialist to modify this detail where required to meet minimum recommendations.

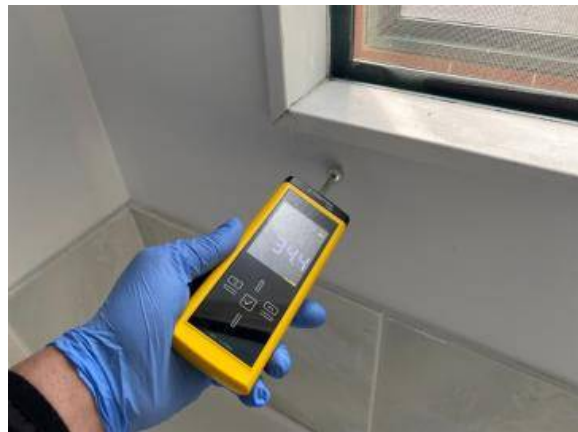
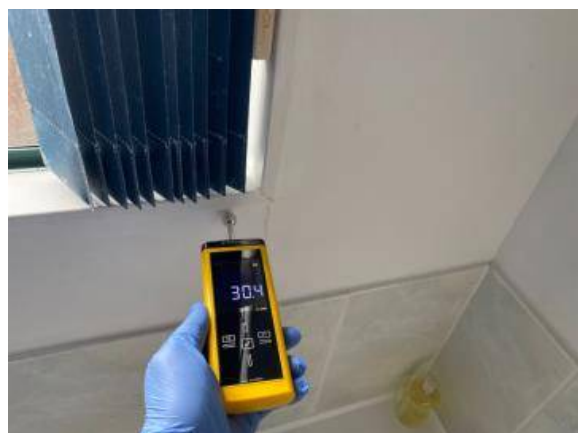
Indicative moisture readings taken to internal wall linings were below 40 digits at the time of inspection. Values below 40 digits are considered dry for typical NZ conditions.

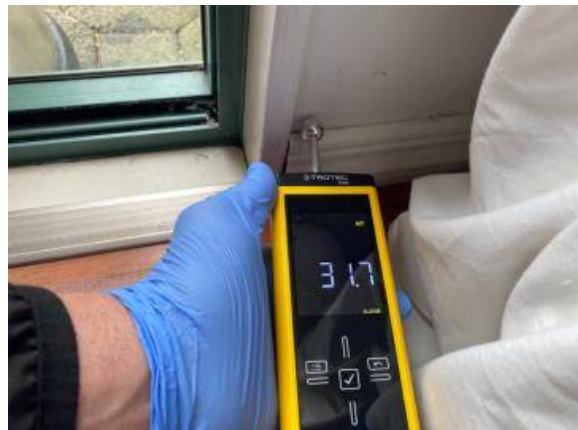
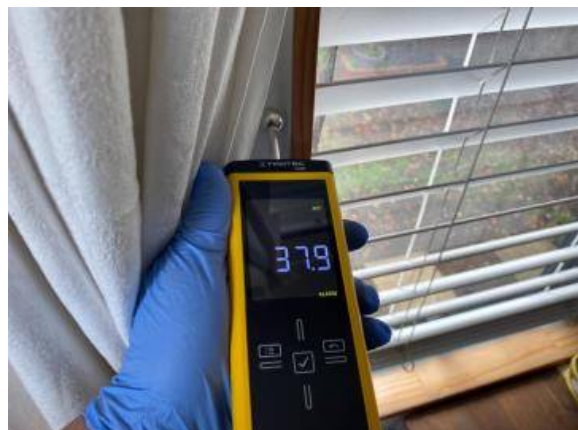
Indicative moisture readings taken to internal wall linings were below 40 digits at the time of inspection. Values below 40 digits are considered dry for typical NZ conditions.

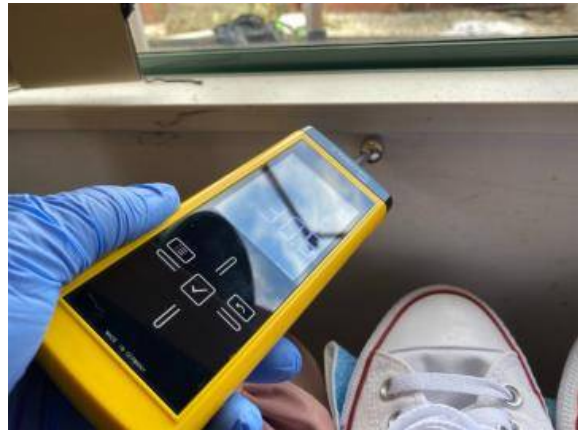
Indicative moisture readings taken to internal wall linings were below 40 digits at the time of inspection. Values below 40 digits are considered dry for typical NZ conditions.
