Home Inspection Report

15 Pooks Road, Ranui, Auckland

Inspection prepared for: Sophia de Fossard
Date of Inspection: 20/5/2019 Time: 9:00 AM
Age of Home: 2002 Size: 150m2
Weather: Fine

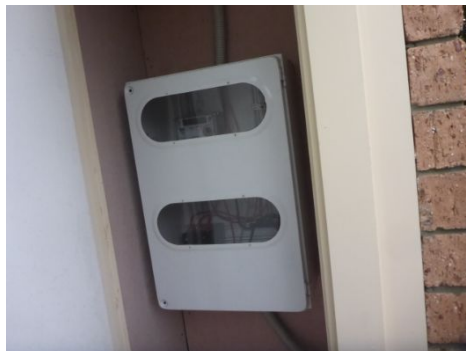
1. Meter box condition

M D NI
• Good condition

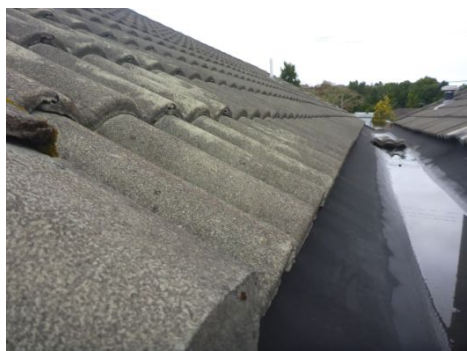
- Appropriate for this material type

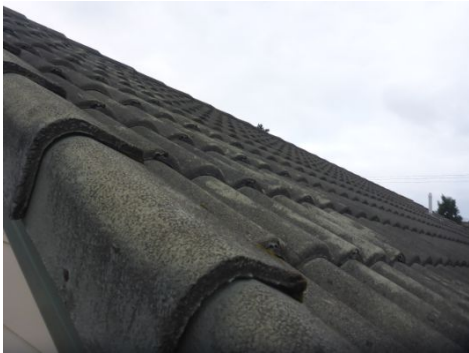
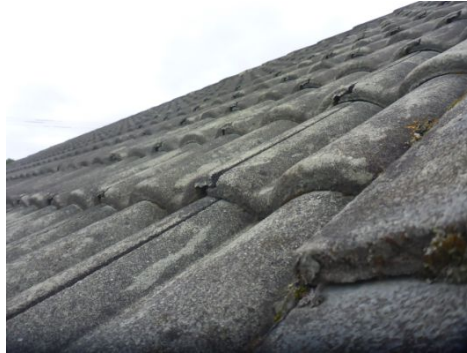
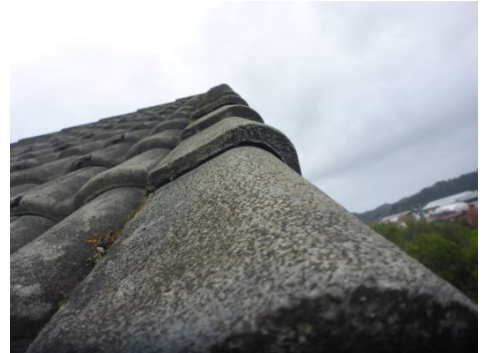
3. Surface damage and deterioration

- No surface damage apparent

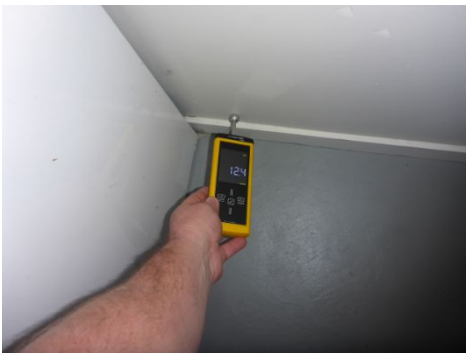
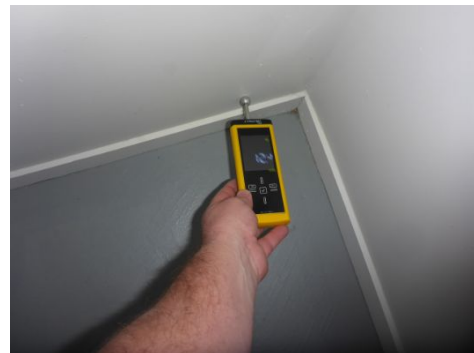
4. Moisture Readings

- Several readings were taken and all were within the acceptable range and indicate the room to be DRY.

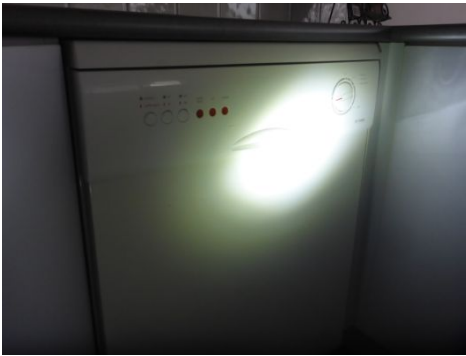
- Unable to operate at the time of inspection

Not connected

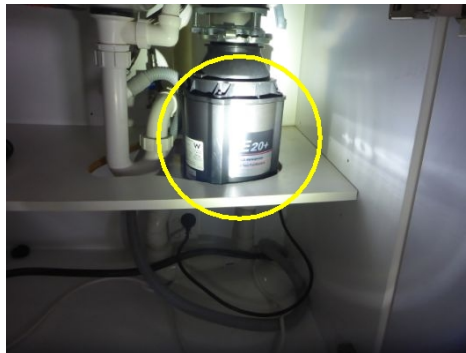
- Unable to operate

Unable to operate

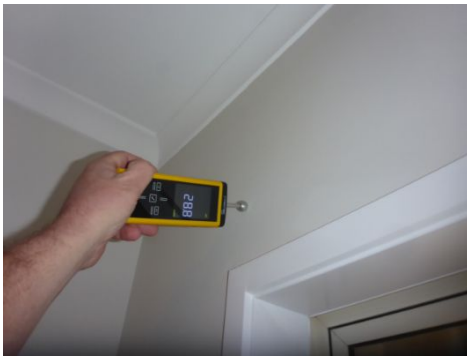
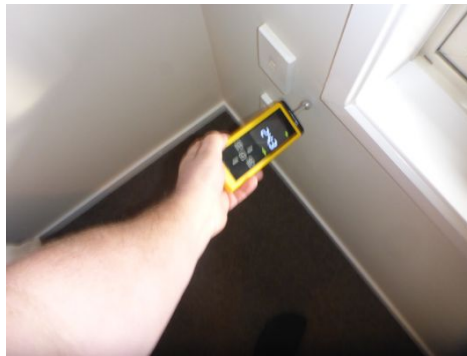
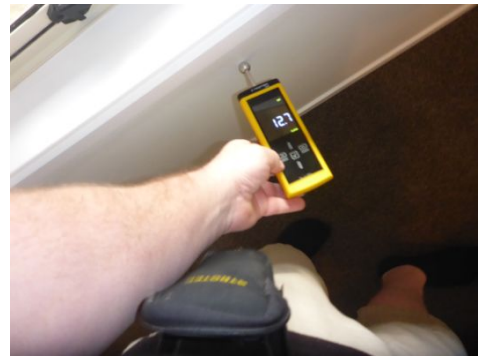
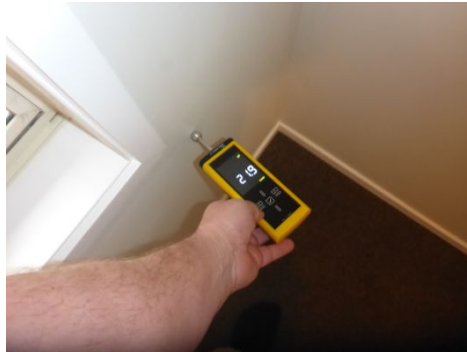
6. Moisture Readings

- Several readings were taken and all were within the acceptable range and indicate the room to be DRY.

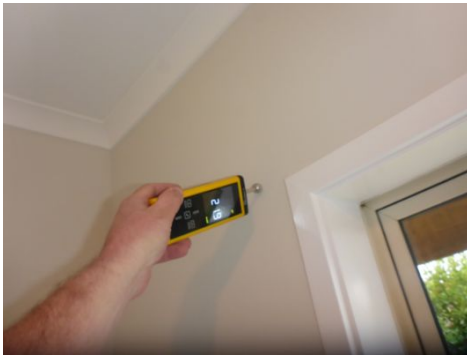
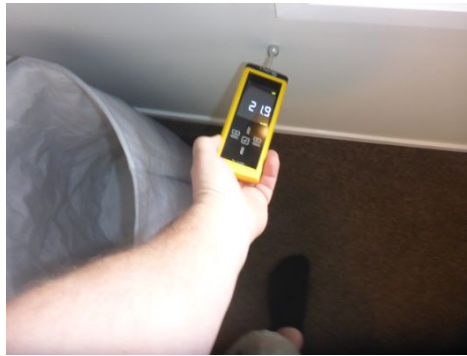
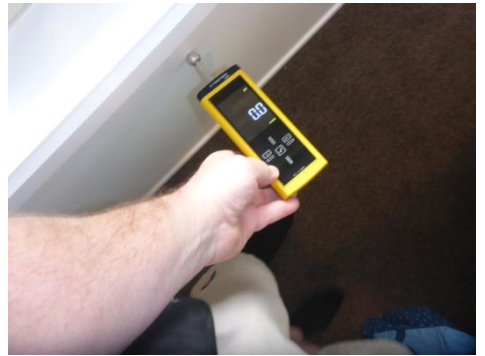
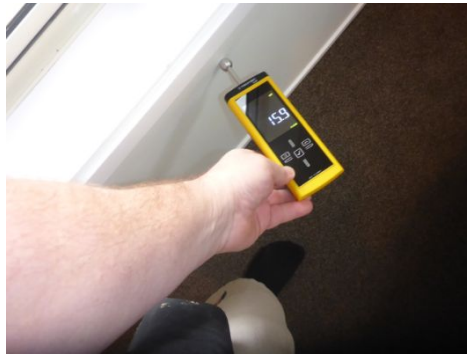
6. Moisture Readings

- Several readings were taken and all were within the acceptable range and indicate the room to be DRY.

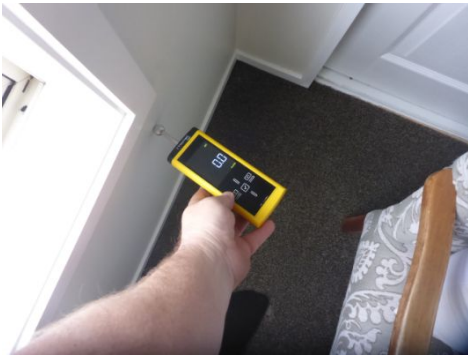
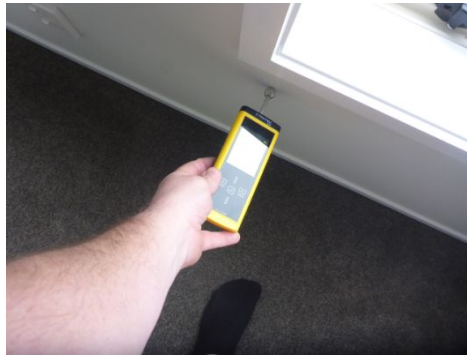
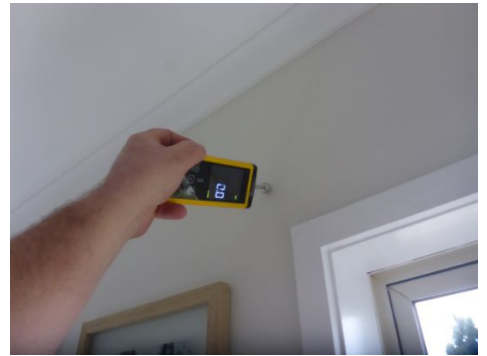
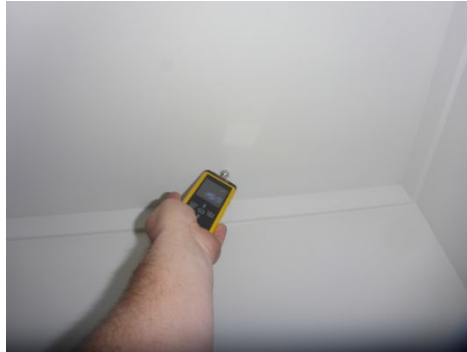
6. Moisture Readings

- Several readings were taken and all were within the acceptable range and indicate the room to be DRY.

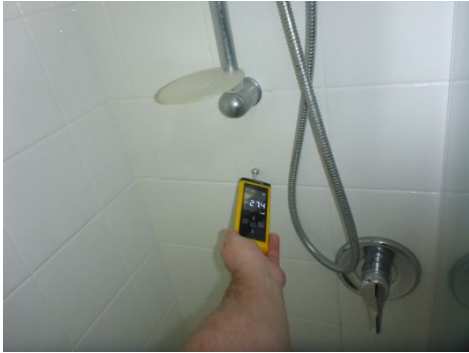
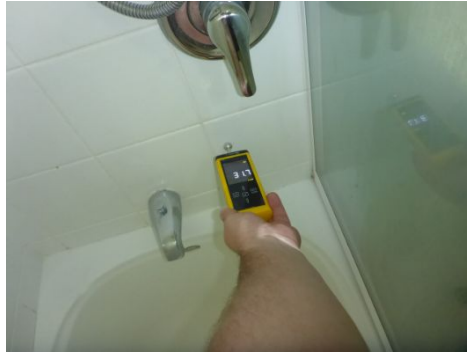
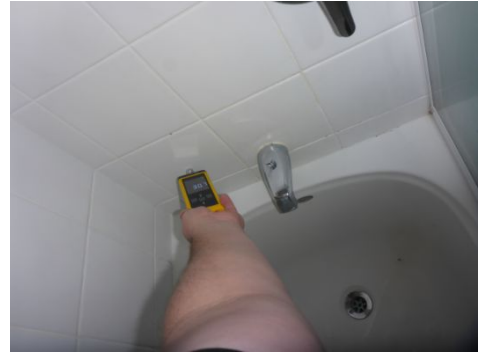
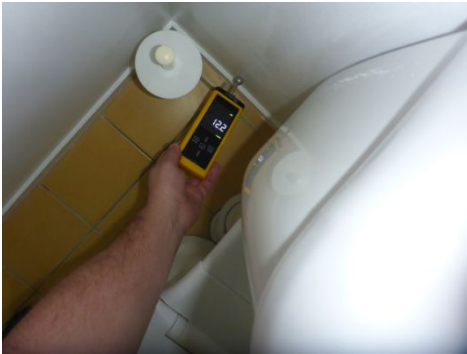
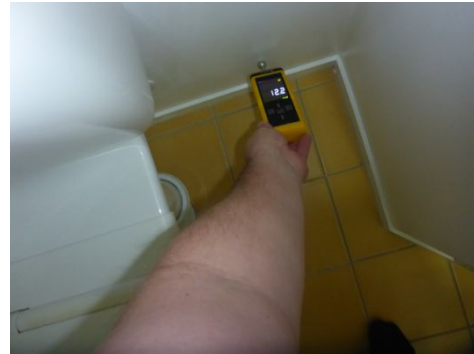
3. Moisture Readings

- Several readings were taken and all were within the acceptable range and indicate the room to be DRY.

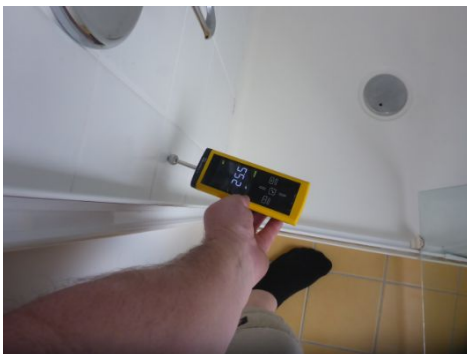
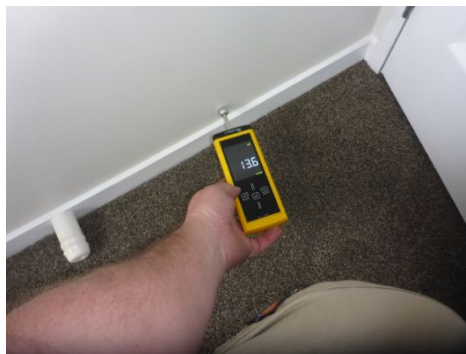
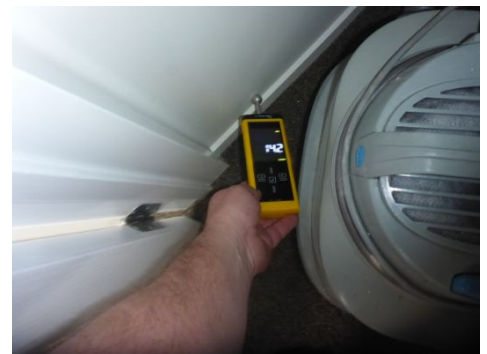
3. Moisture Readings

- Several readings were taken and all were within the acceptable range and indicate the room to be DRY.

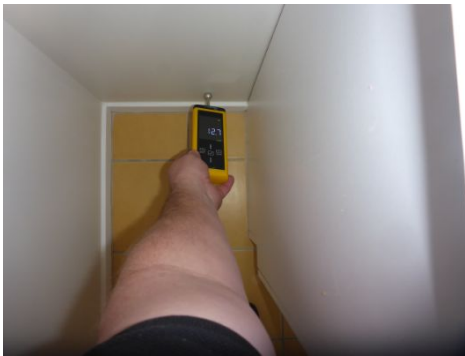
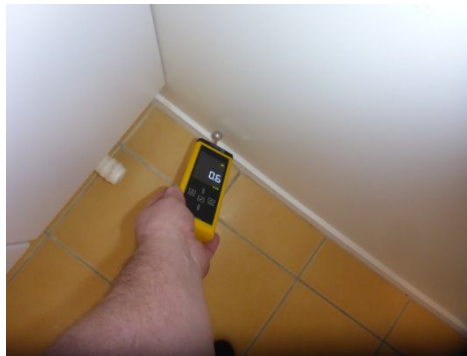
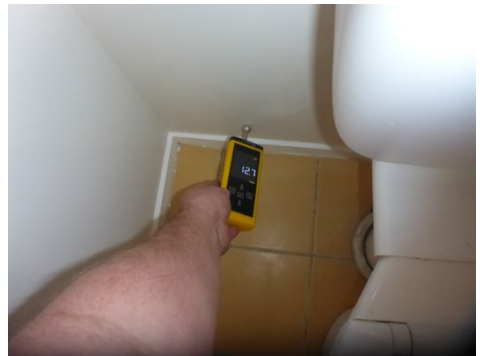
3. Moisture Readings

- Several readings were taken and all were within the acceptable range and indicate the room to be DRY.

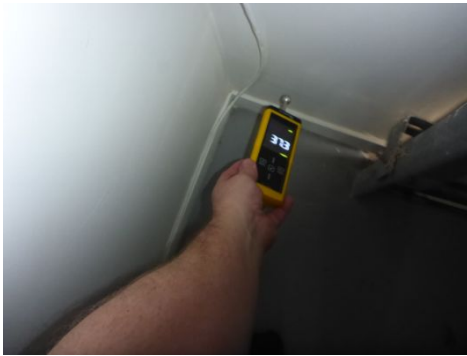
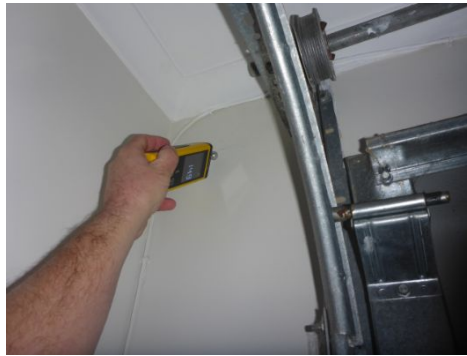
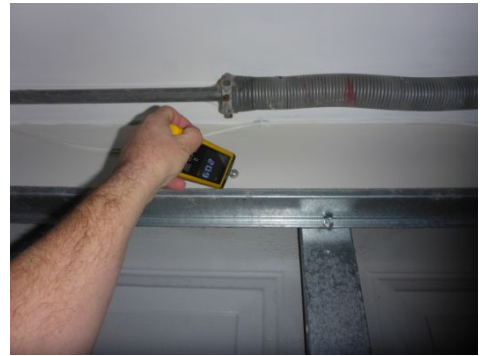
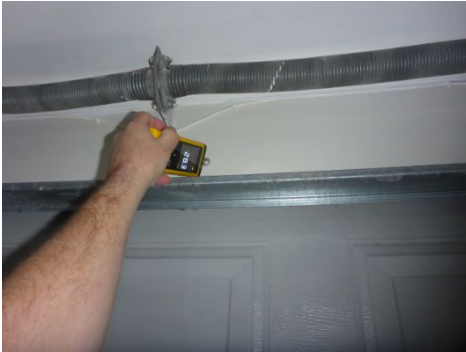
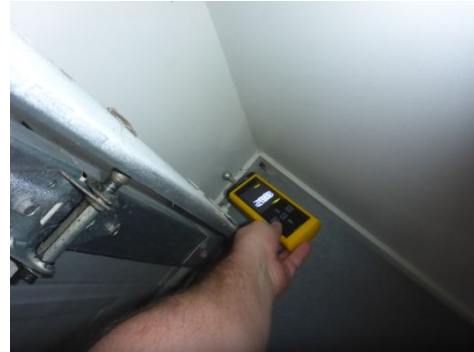
6. Moisture Readings

- Several readings were taken and all were within the acceptable range and indicate the room to be DRY.

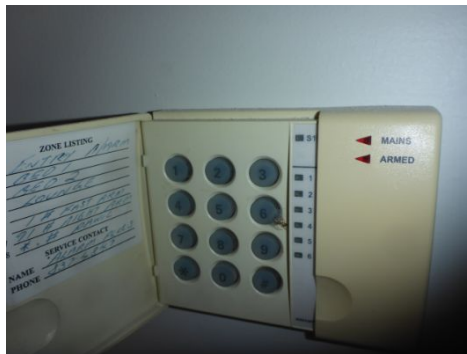
1. Condition

- Does not appear functional

Does not appear functional

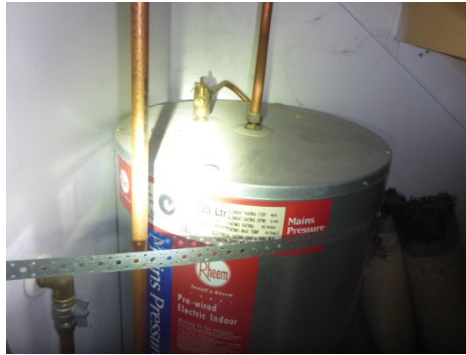
- Hot water cylinder
- The water heater was switched off at the time of inspection (untested)
