## **Non Invasive Cladding Assessment**

**6 Crowther Street  
Blockhouse Bay  
Auckland District**

**Inspection Date: 6/05/2020**

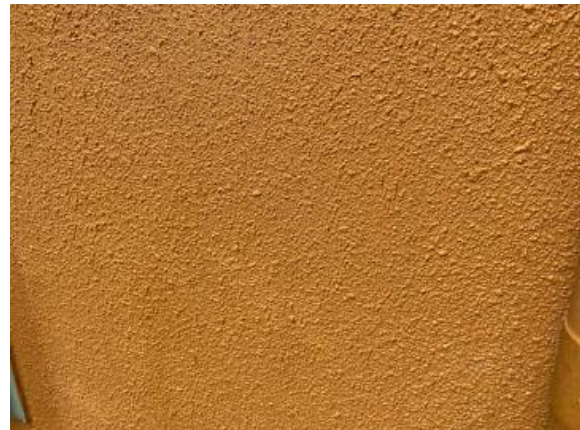
Visible cracks to Monolithic cladding system. Cladding cracks may increase the risk of moisture damage to cladding substrate and internal framing. We recommend engaging the services of a suitably experienced cladding specialist to repair cladding in these areas as required. Unable to confirm the condition of internal framing.

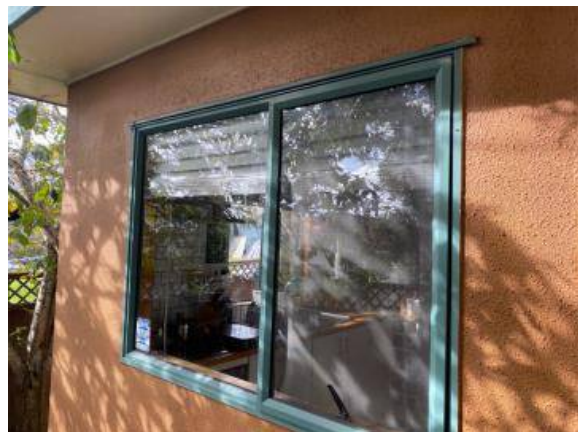
No evidence of a sufficient anti capillary gap above head flashings. A minimum anti capillary gap of 10mm is recommend to reduce the risk of moisture wicking behind cladding by providing adequate drainage. We recommend engaging a cladding specialist to modify this detail where required to meet minimum recommendations.

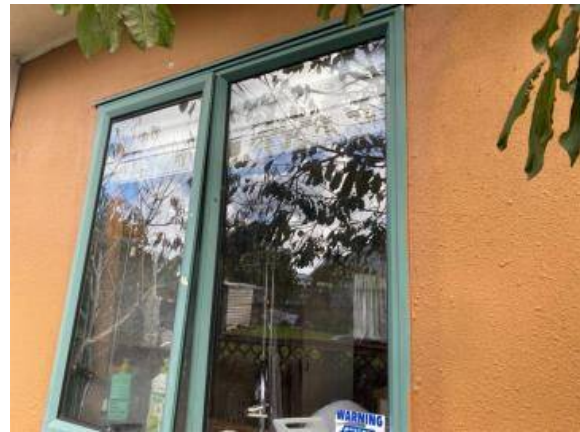
No evidence of a sufficient anti capillary gap above head flashings. A minimum anti capillary gap of 10mm is recommend to reduce the risk of moisture wicking behind cladding by providing adequate drainage. We recommend engaging a cladding specialist to modify this detail where required to meet minimum recommendations.

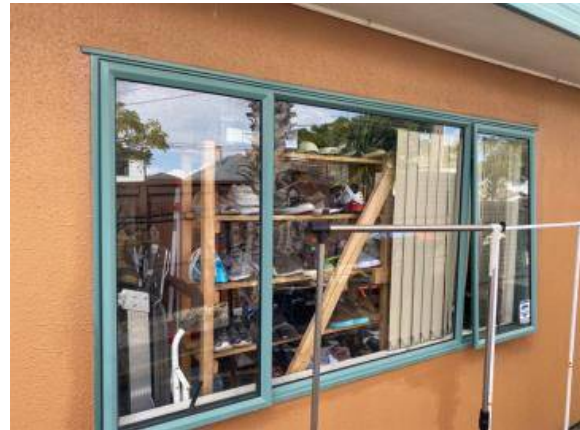
No evidence of a sufficient anti capillary gap above head flashings. A minimum anti capillary gap of 10mm is recommend to reduce the risk of moisture wicking behind cladding by providing adequate drainage. We recommend engaging a cladding specialist to modify this detail where required to meet minimum recommendations.

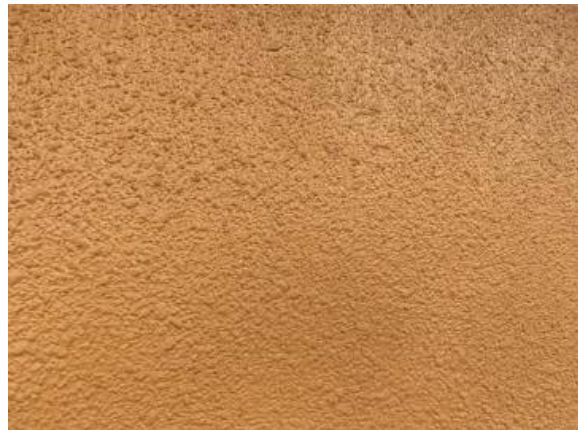
Paved ground level in close proximity to cladding base. A clearance of 100mm is recommended from cladding base to paved ground level to allow adequate cladding drainage. We recommend modifying paving height to meet minimum recommendations and reduce the risk of damage to cladding. Unable to confirm the condition of internal framing in this area at the time of inspection.

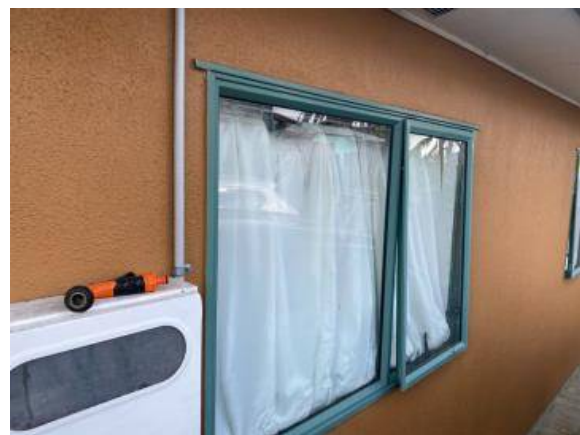
No evidence of a sufficient anti capillary gap above head flashings. A minimum anti capillary gap of 10mm is recommend to reduce the risk of moisture wicking behind cladding by providing adequate drainage. We recommend engaging a cladding specialist to modify this detail where required to meet minimum recommendations.

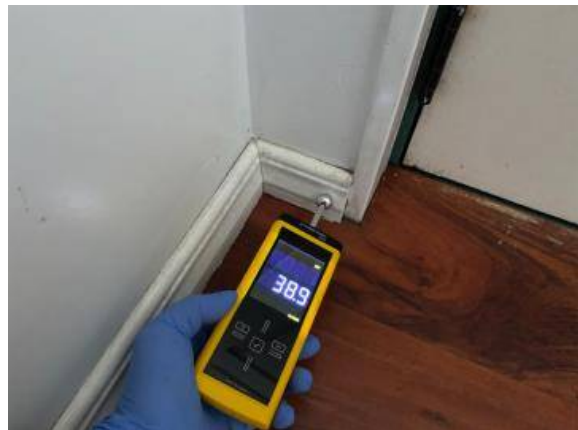
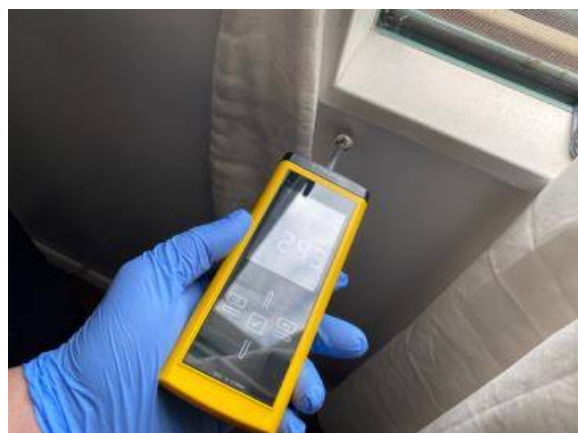
Indicative moisture readings taken to internal wall linings were below 40 digits at the time of inspection. Values below 40 digits are considered dry for typical NZ conditions.

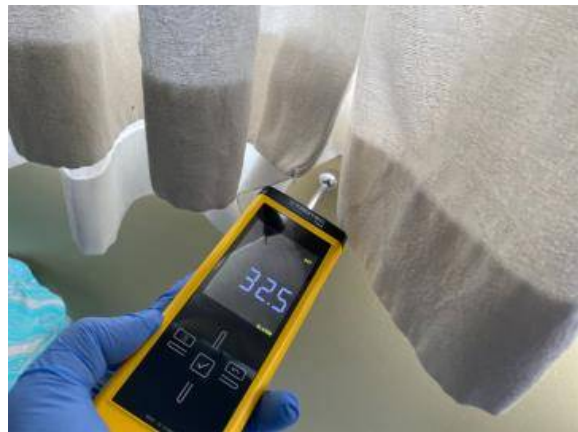
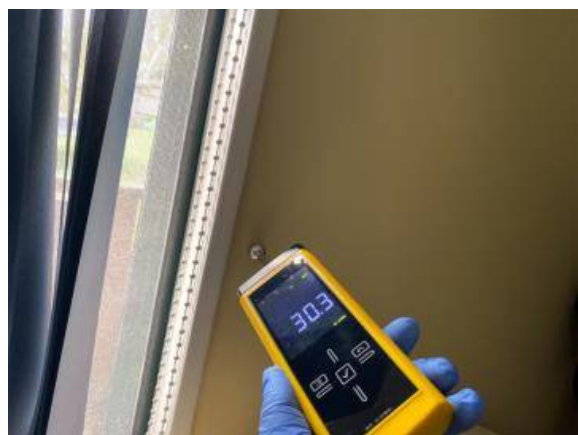
Indicative moisture readings taken to internal wall linings were below 40 digits at the time of inspection. Values below 40 digits are considered dry for typical NZ conditions.

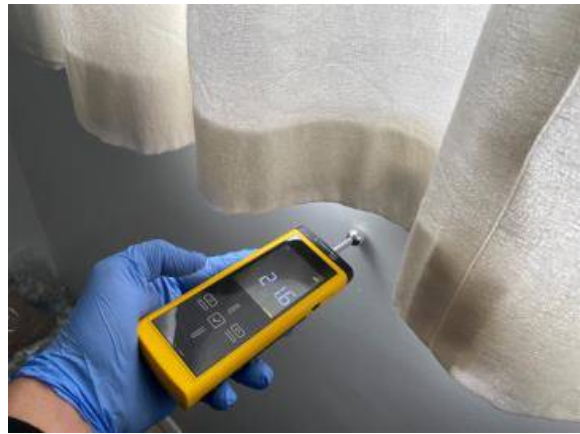
Indicative moisture readings taken to internal wall linings were below 40 digits at the time of inspection. Values below 40 digits are considered dry for typical NZ conditions.

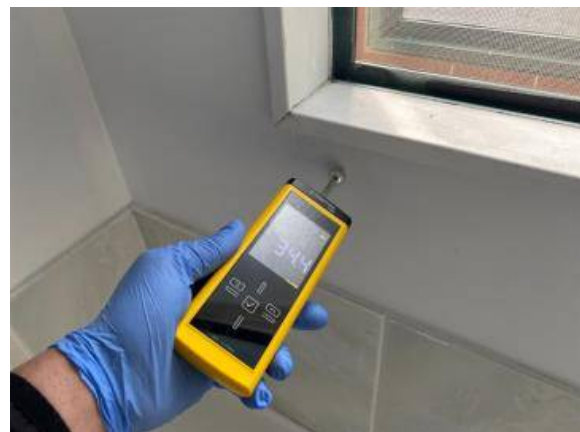
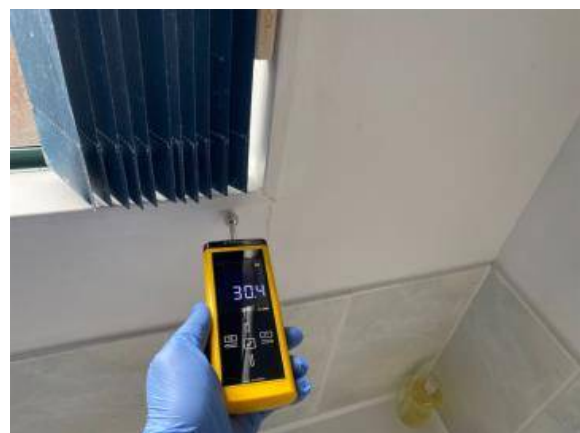
Indicative moisture readings taken to internal wall linings were below 40 digits at the time of inspection. Values below 40 digits are considered dry for typical NZ conditions.

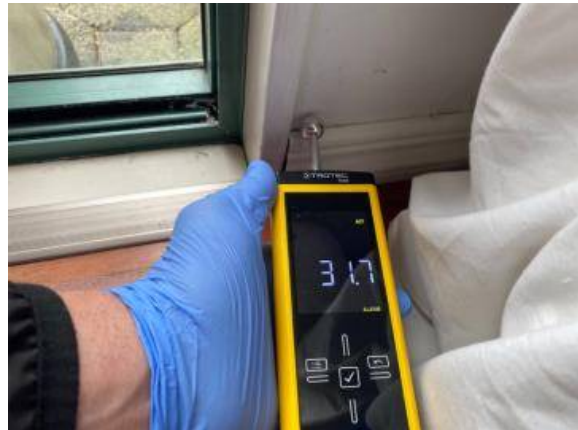
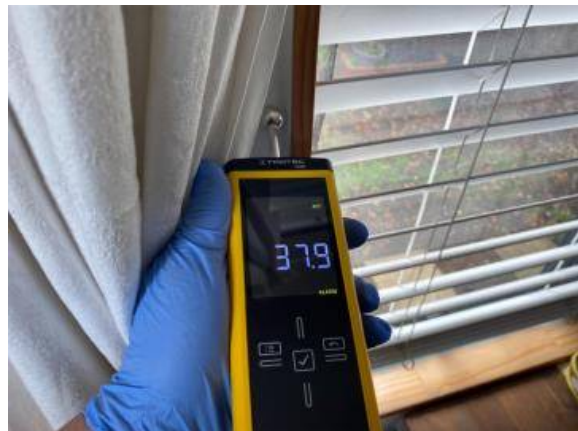
Indicative moisture readings taken to internal wall linings were below 40 digits at the time of inspection. Values below 40 digits are considered dry for typical NZ conditions.

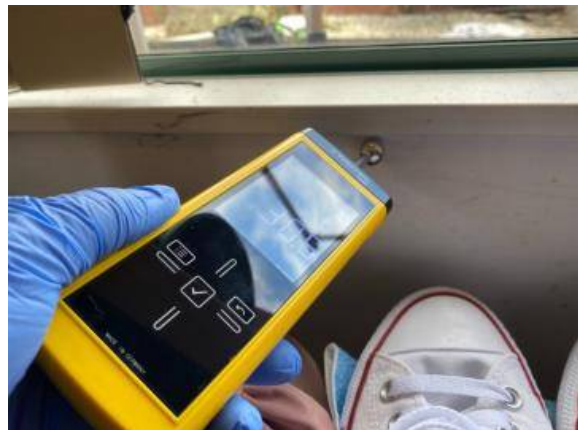
Indicative moisture readings taken to internal wall linings were below 40 digits at the time of inspection. Values below 40 digits are considered dry for typical NZ conditions.
