Guardian Housing Services Ltd

7th May 2020

RE: SAFE AND SANITARY REPORT ON BATHROOM AREA AND ALTERATIONS WITHIN THE LOWER LEVEL OF THE DWELLING AT 10 RAUHUIA ROAD.

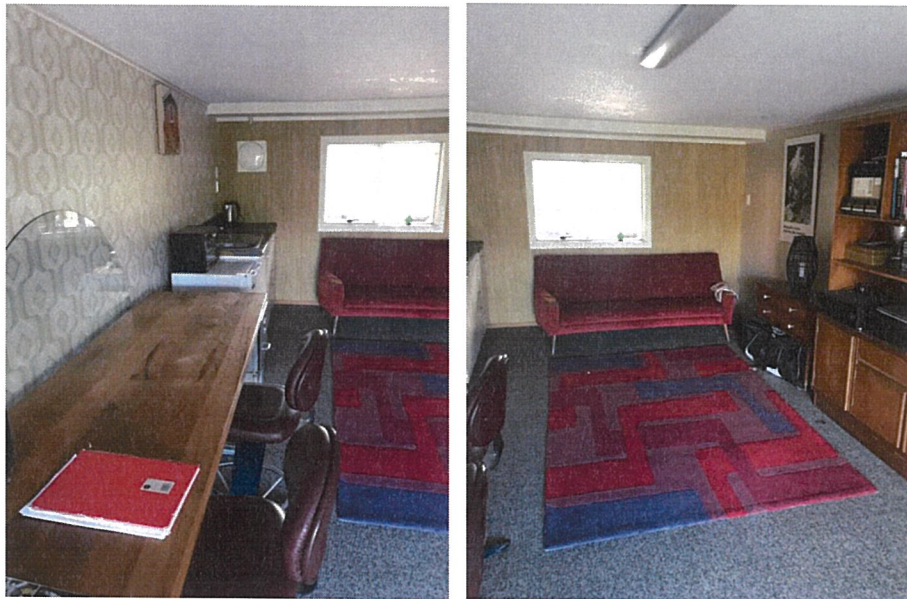
- 3.1 The dwelling was initially constructed circa 1965 and is a two-level home on a sloping site.
- 3.2 At some point in time the garage door has been removed and a set of aluminum doors installed, and the area converted to a open plan room with a small stainless steel bench unit with hot and cold water supply. There were no cooking facilities at the time of this assessment.
- 3.3 This area within the basement cannot be used as a separate household unit due to the absence of any fire separation between levels. Should the need arise in the future to consider this as an option then all the appropriate consents must be first obtained from the council.

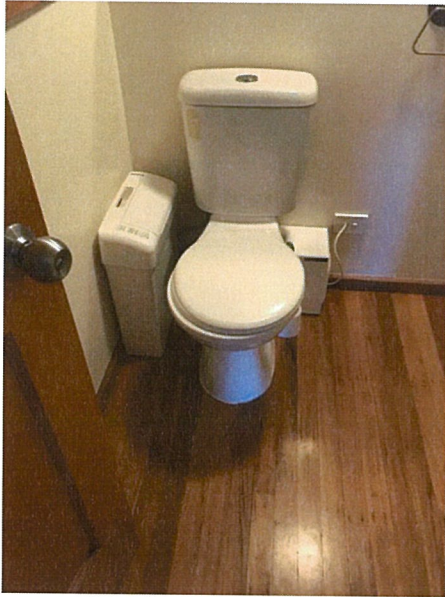
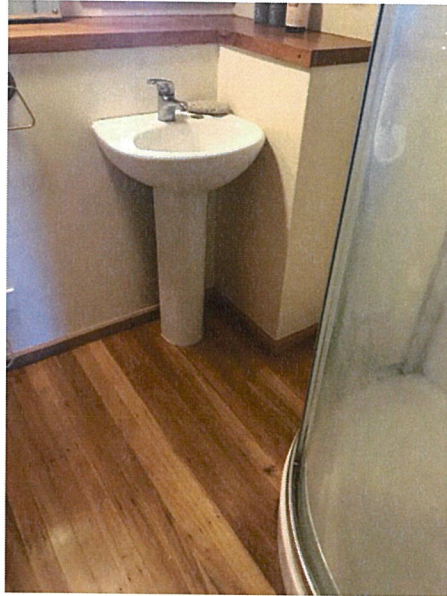
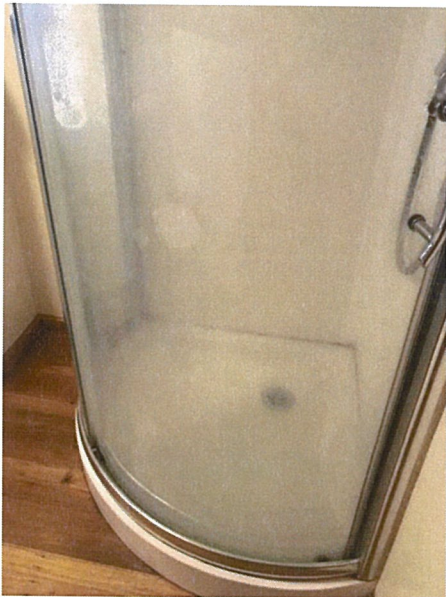
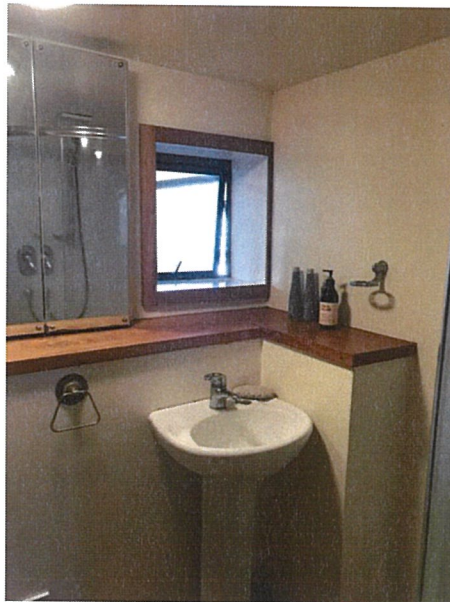
- 3.4 The bathroom consists of a WC, shower and vanity unit. There is a small window that provides natural light and ventilation to this room. All surfaces are finished with impervious materials to resist moisture. The foul water is removed by a Sani Pump and is then discharged into the disposal system. This pump was fully functional at the time of this assessment.

- 3.5 The plumbing system at the time of this visual only assessment appears to be adequate and functional as there were no signs of leakage or system failure.

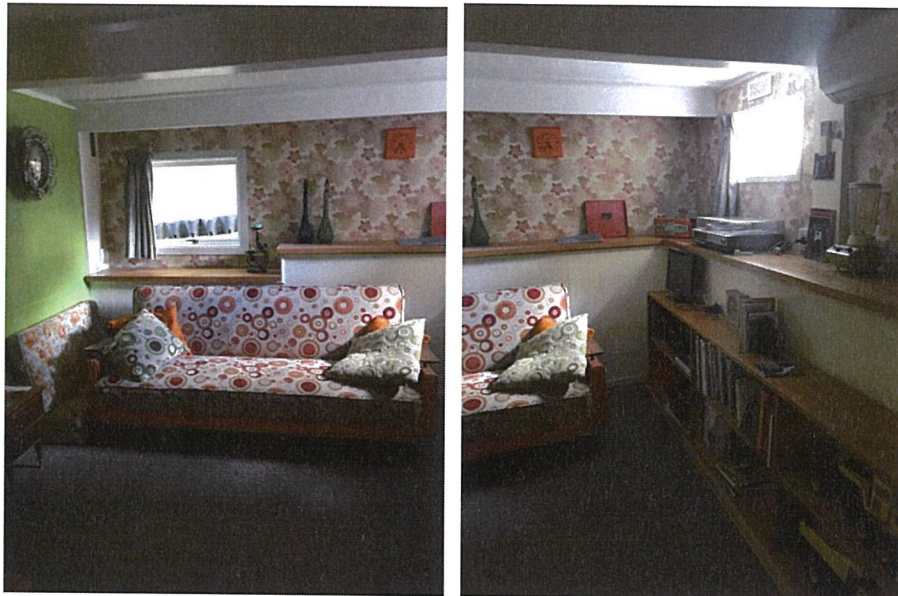
- 3.6 There is a room that has served as a rumpus room (photos below). There are two windows to provide natural light and ventilation.
