Home Inspection Report

11 Western Road, Laingholm, Auckland

Inspection prepared for: Jackie Van Beek
Date of Inspection: 20/3/2020 Time: 9:00 AM
Age of Home: Mixed
Weather: Showers

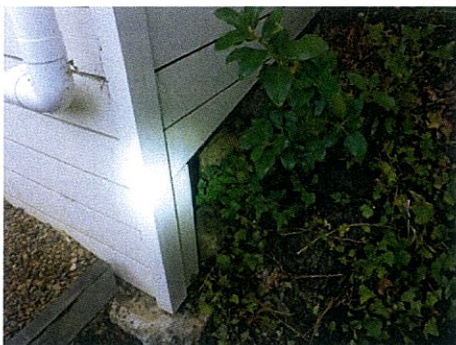
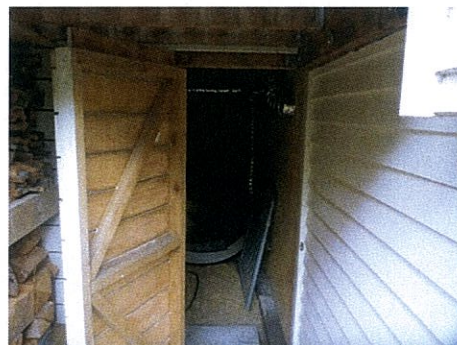
- 50% accessible visually

Limited access

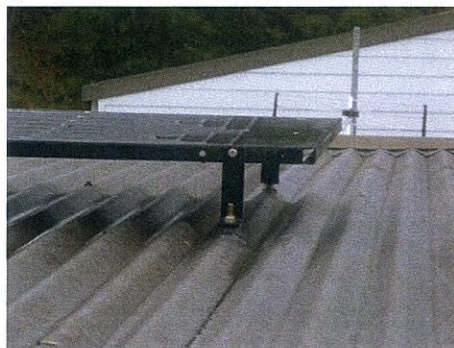
4. Penetrations

- Roof penetrations appear to be fixed well

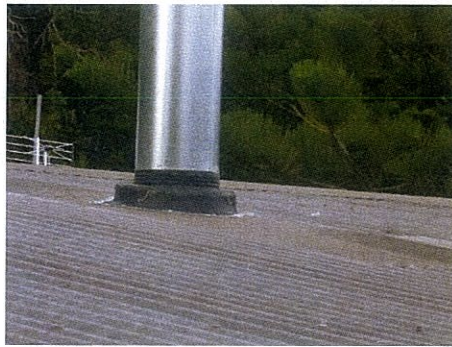
5. Flashings

- Good Condition

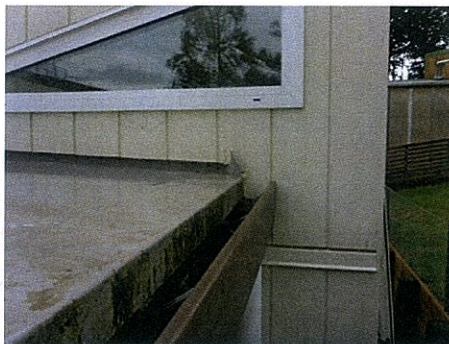
6. Roof to wall junctions

- Satisfactory

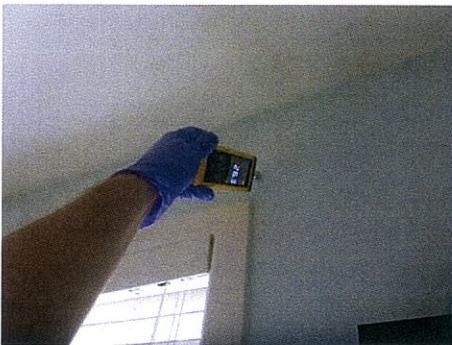
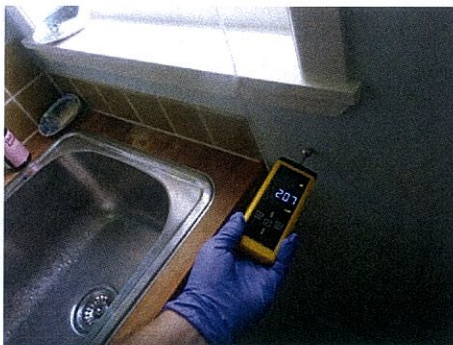
4. Moisture Readings

- Several readings were taken and all were within the acceptable range and indicate the room to be DRY.

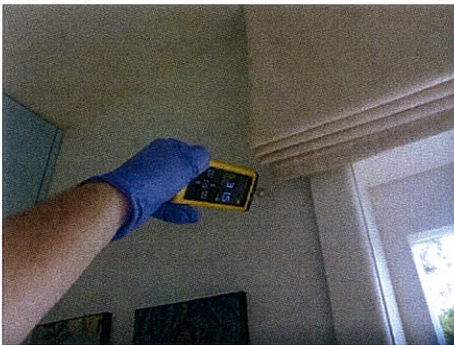
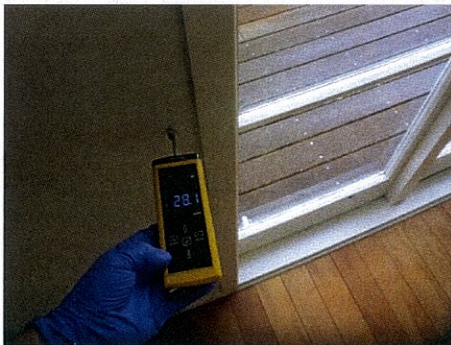
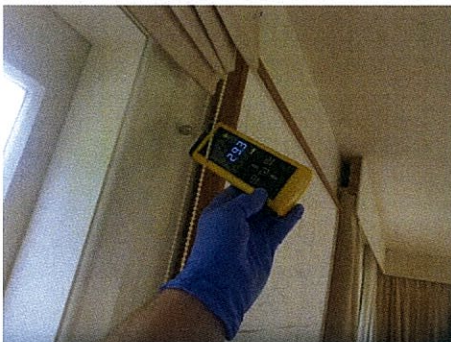
4. Moisture Readings

- Several readings were taken and all were within the acceptable range and indicate the room to be DRY.

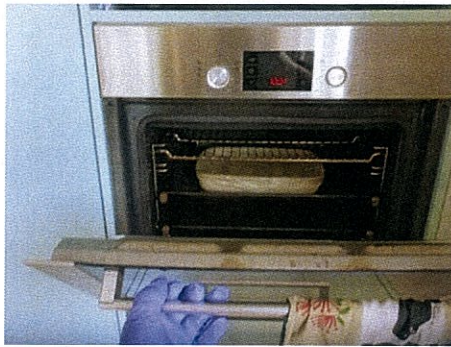
5. Oven

- Visually in good condition with functioning isolating switch, not tested for functionality

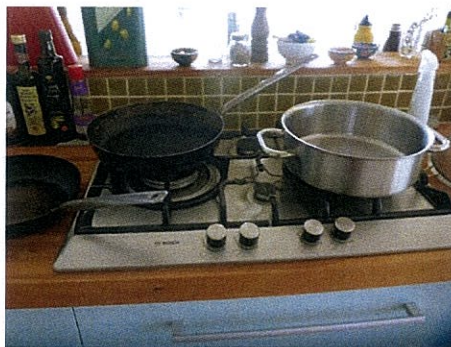
6. Stove Top

- At the time of inspection the stove top appears to be in working order

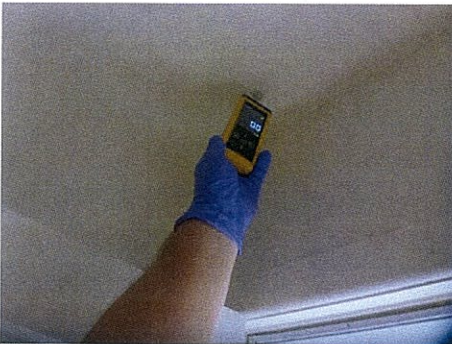
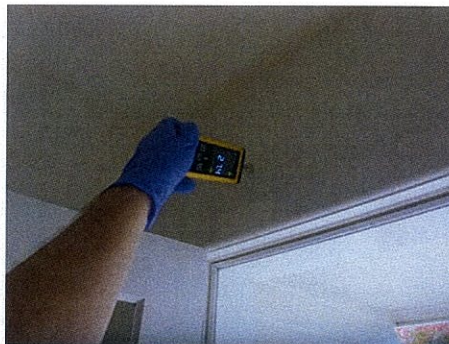
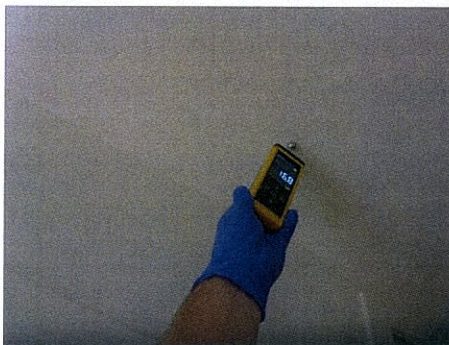
6. Moisture Readings

- Several readings were taken and all were within the acceptable range and indicate the room to be DRY

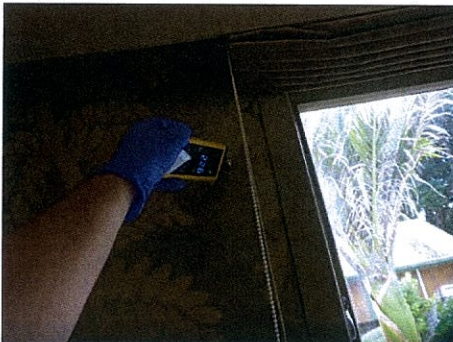
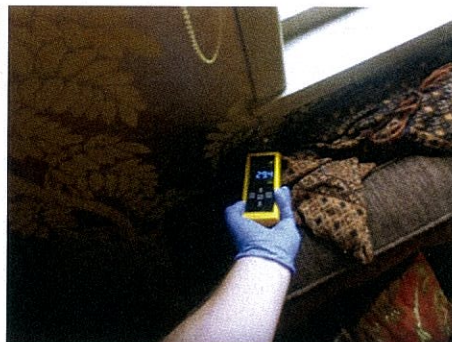
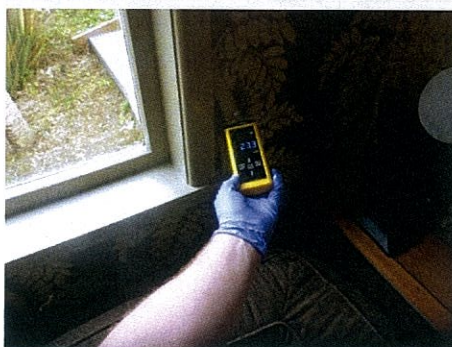
5. Moisture Readings

- Several readings were taken and all were within the acceptable range and indicate the room to be DRY

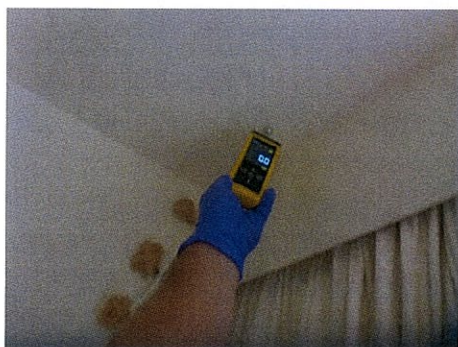
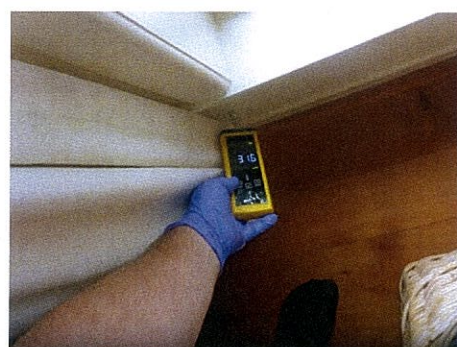
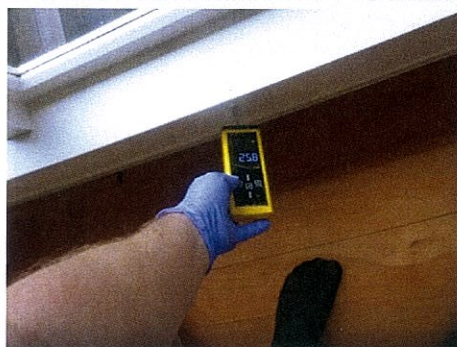
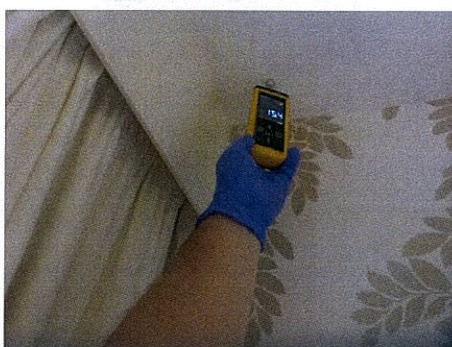
6. Moisture Readings

- Several readings were taken and all were within the acceptable range and indicate the room to be DRY.

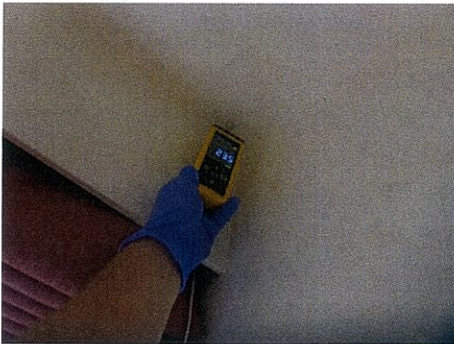
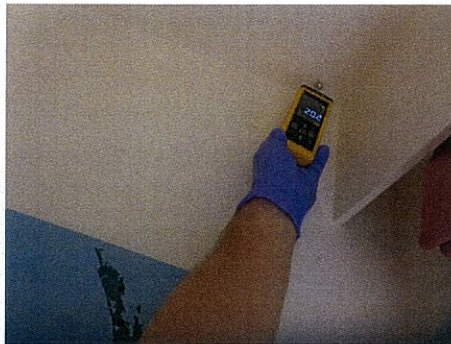
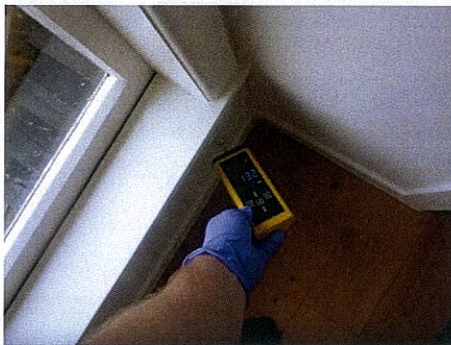
6. Moisture Readings

- Several readings were taken and all were within the acceptable range and indicate the room to be DRY.

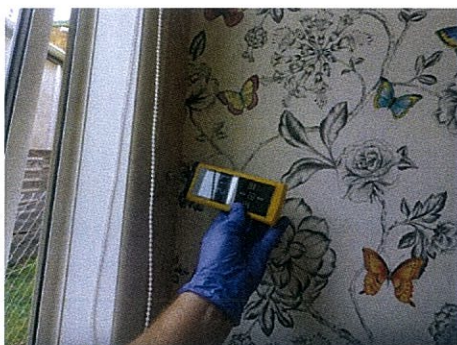
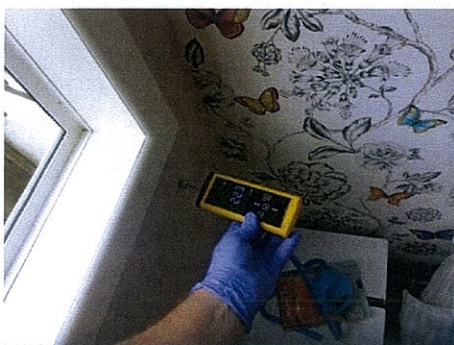
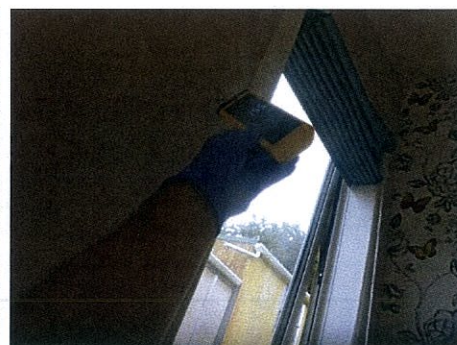
6. Moisture Readings

- Several readings were taken and all were within the acceptable range and indicate the room to be DRY.

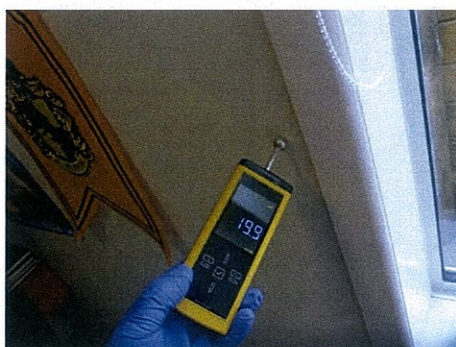
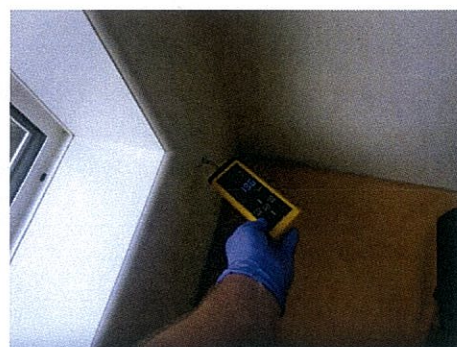
6. Moisture Readings

- Several readings were taken and all were within the acceptable range and indicate the room to be DRY.

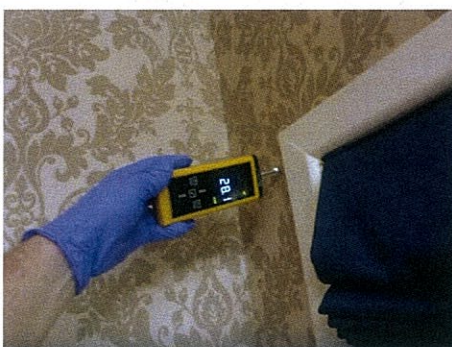
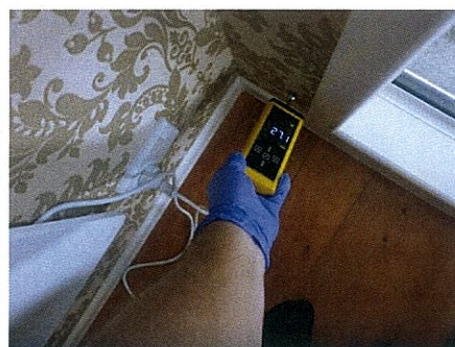
6. Moisture Readings

- Several readings were taken and all were within the acceptable range and indicate the room to be DRY.

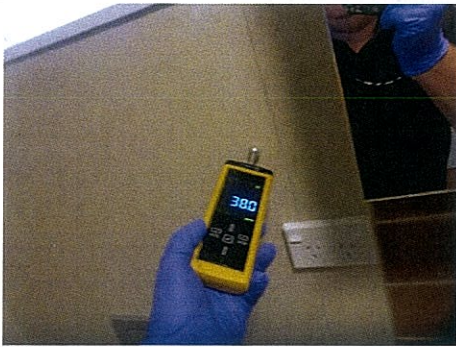
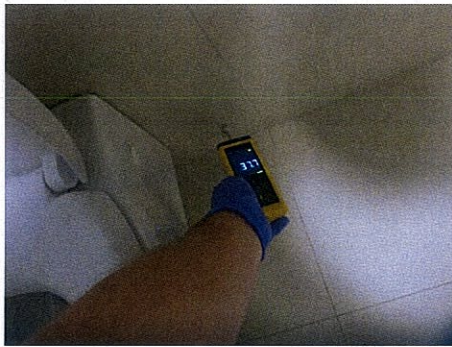
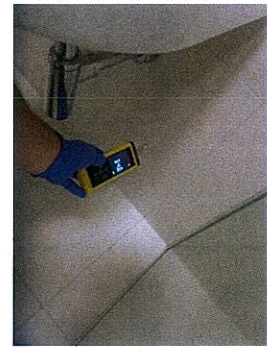
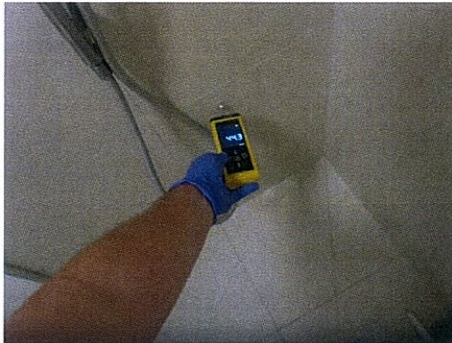
3. Moisture Readings

- Several readings were taken and all were within the acceptable range and indicate the room to be DRY.

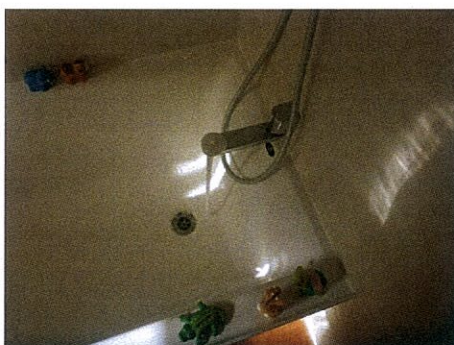
5. Bath/surround

- Good condition

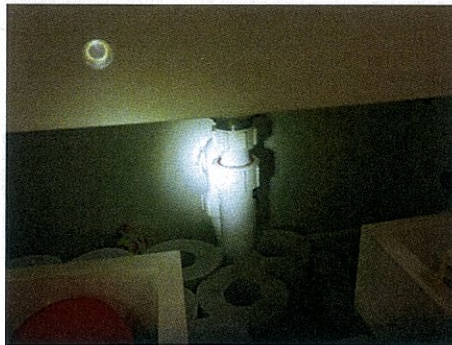
7. Taps & Waste Traps

- Operative

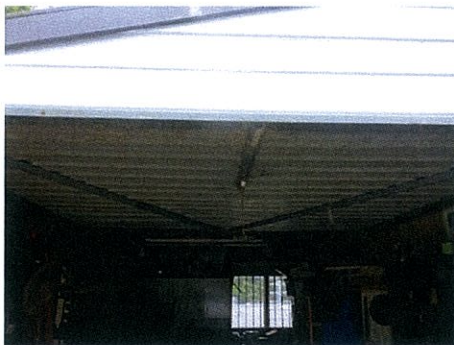
2. Garage door

- Functional condition

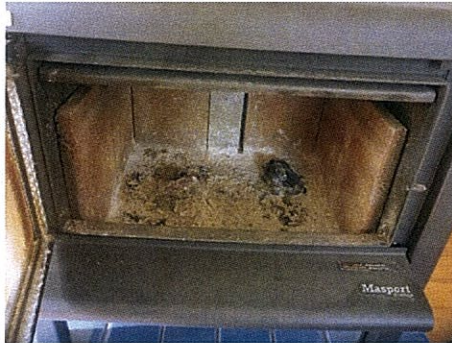
3. Condition

- Good visually, not tested for functionality

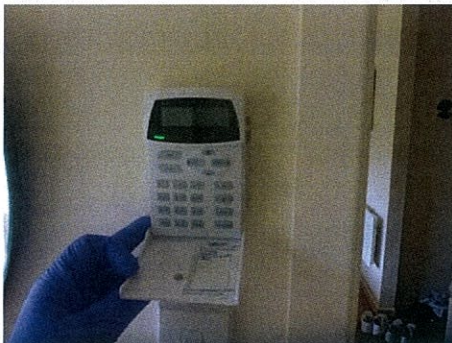
2. Condition

- Appears in good condition, not tested for functionality

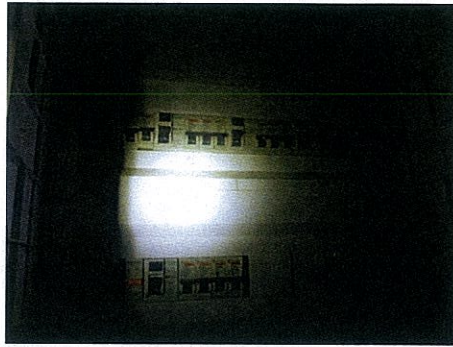
3. Condition

- Good condition

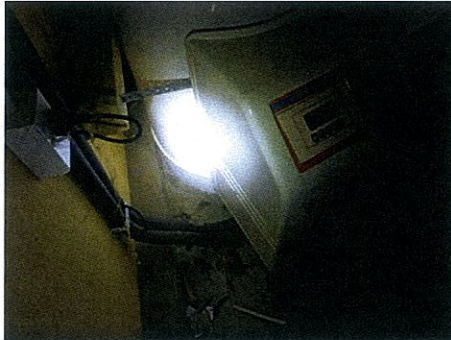
5. Leakage

- None visible

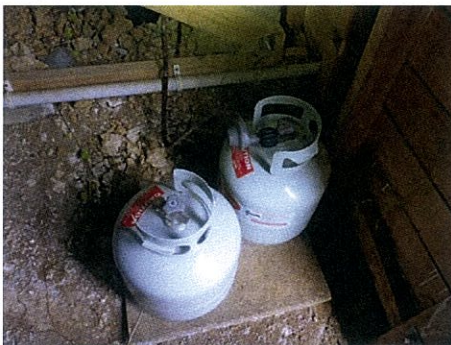
2. Condition

- Appears to be in good condition

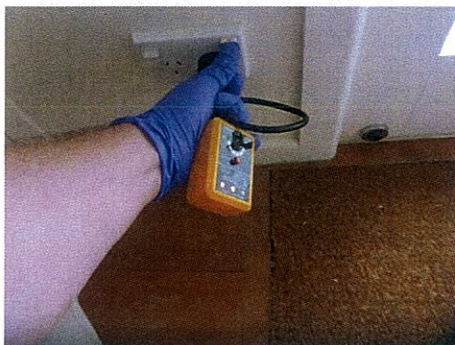
- Functional

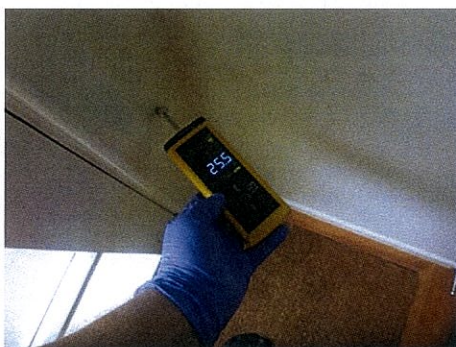
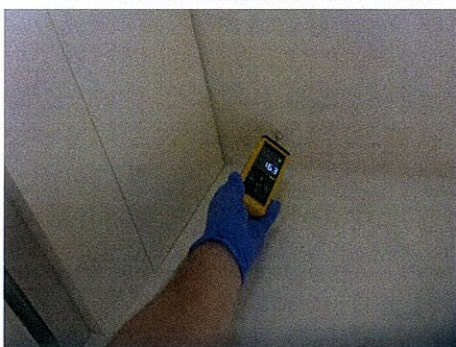
6. Moisture Readings

- Several readings were taken and all were within the acceptable range and indicate the room to be DRY
