Home Inspection Report

14 Hollywood Avenue, Titirangi, Auckland

Inspection prepared for: Alexandre Vartzbed
Date of Inspection: 27/9/2021 Time: 11:00 AM
Age of Home: Mixed, Size: 144m²
Weather: Fine

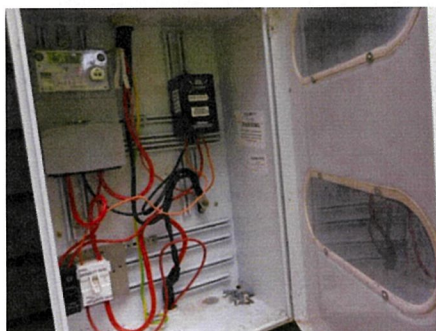
1. Meter box condition

M D NI • Good condition

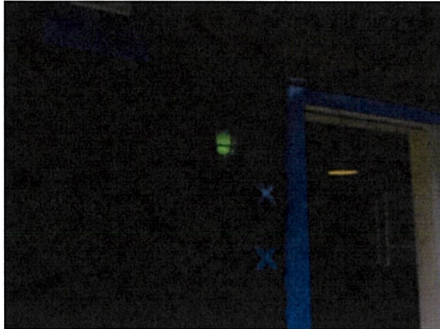
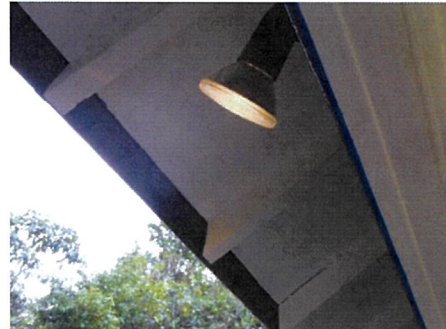
2. Exterior lighting

- M D NI
- Present

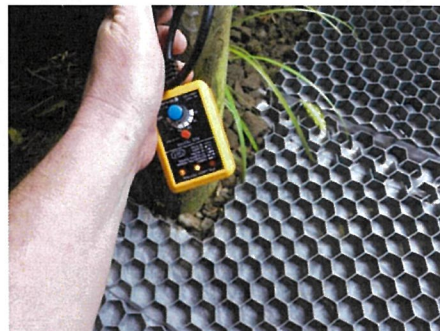
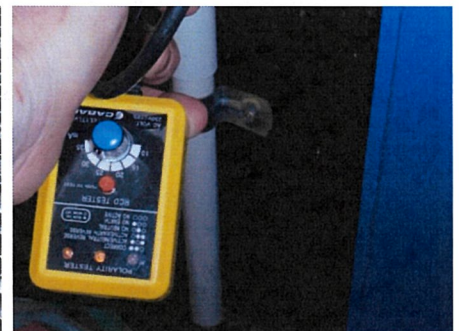
3. Exterior power points

- M D NI
- Functional

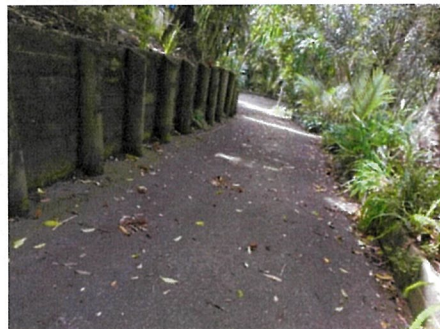
3. Condition

- Average condition

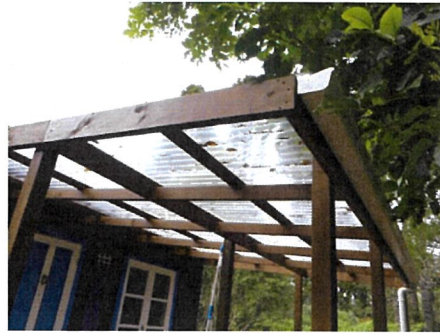
1. Condition

- Appears well constructed and in good condition
-

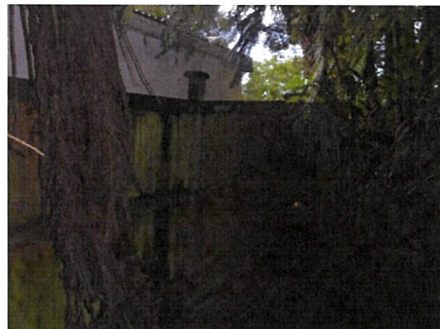
3. Condition

- M D NI • Average condition

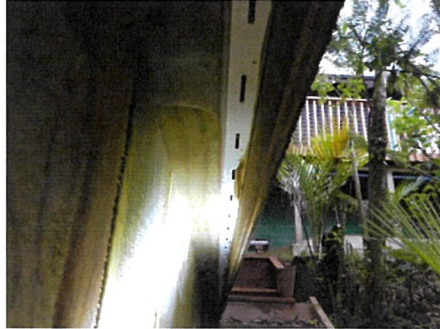
- Cavity system present at the workshops plywood cladding

Present at the workshop

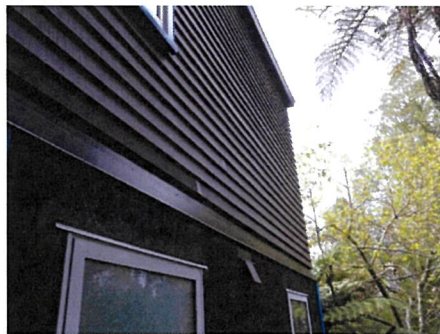
6. Flashings

- Present

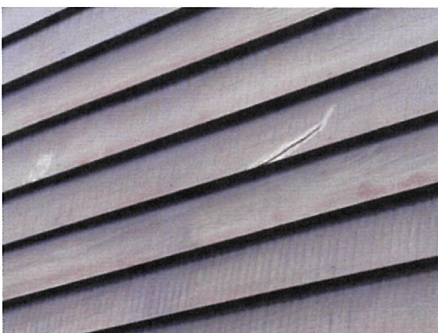
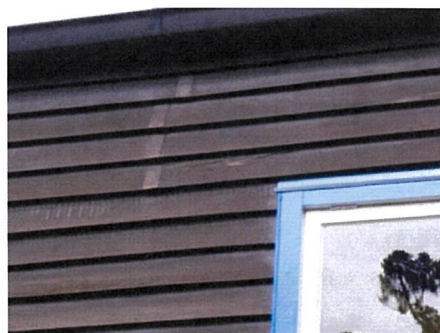
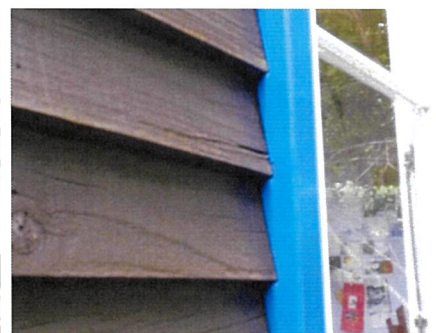
7. Splitting and rot

- No significant splitting or rot apparent

Some splitting present

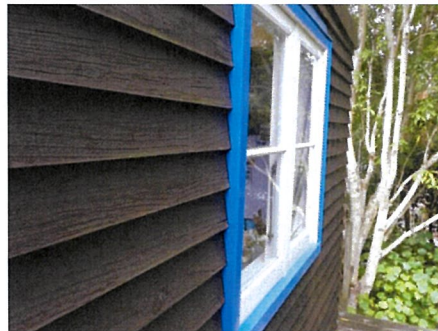
7. Flashings

- M D NI • Present

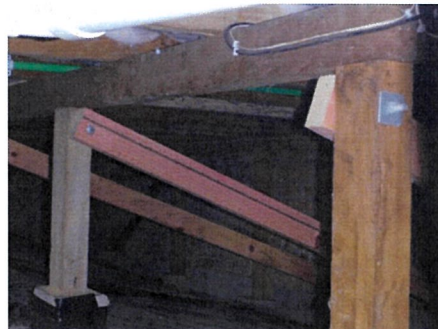
Additional bracing has been installed

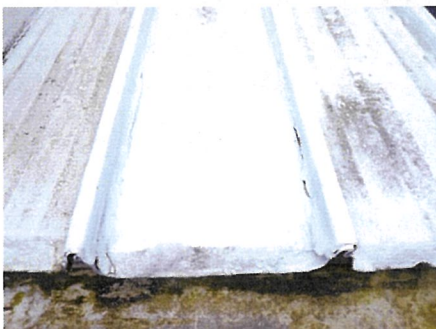
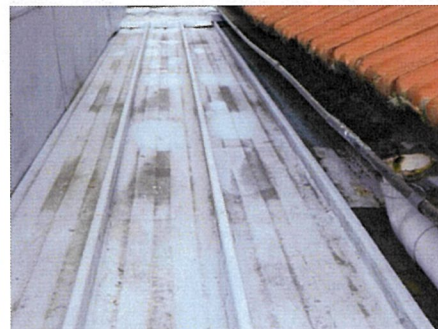
3. Surface damage and deterioration

- The clay tile roofing is in average condition consistent with the age of the home
- The homes metal roofing is showing signs of damage and corrosion, this roof likely has a limited lifespan

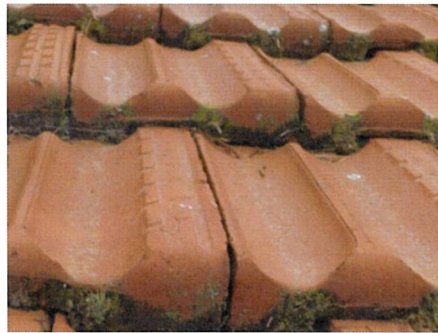
4. Lichen/moss

- There is a considerable amount of lichen/moss present on the roof
- The roof surface would benefit from being cleaned

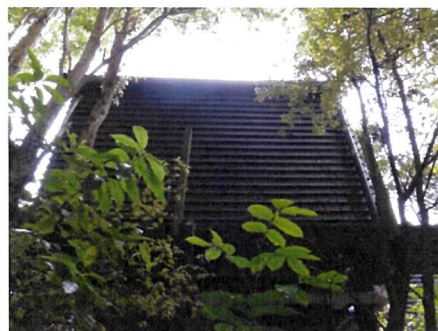
2. Approximate width

- >300mm
- None present in places
- Small or nonexistent eaves are considered a higher risk because they do not provide the protection of traditional eaves

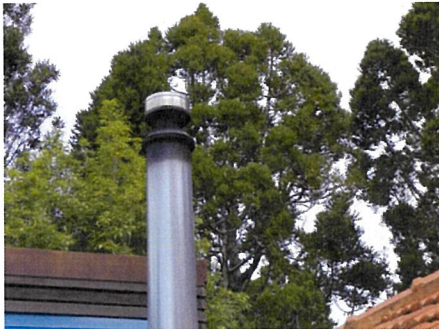
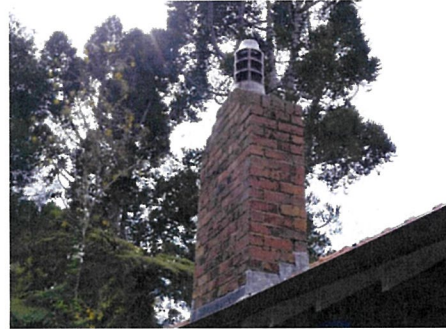
- The chimney chase or outer frame is constructed of masonry and metal

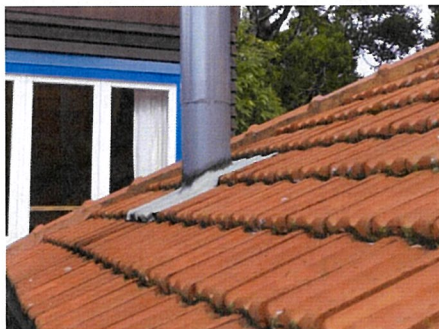
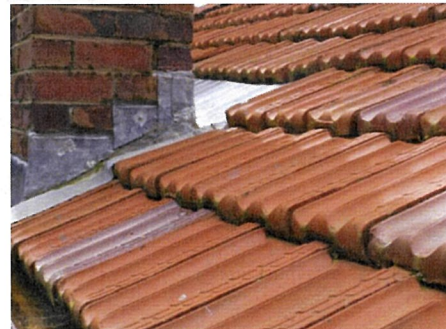
2. Flashings

- Chimney flashing appears to be in place, and well installed

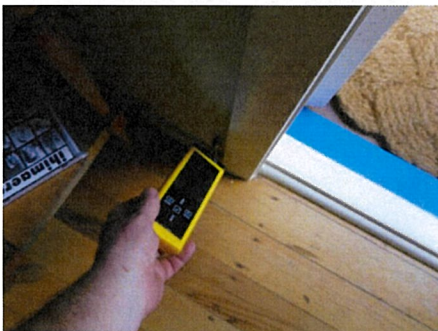
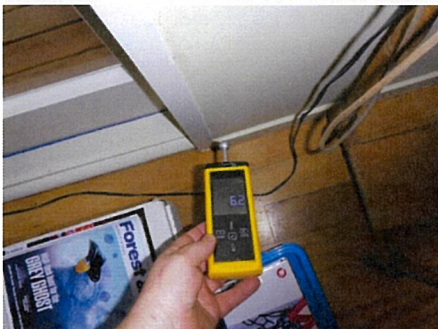
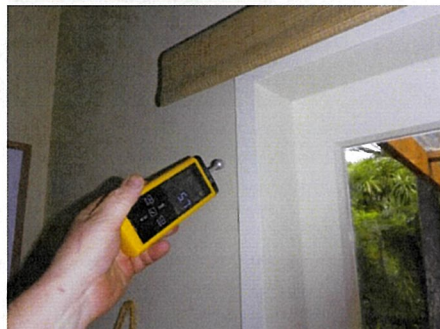
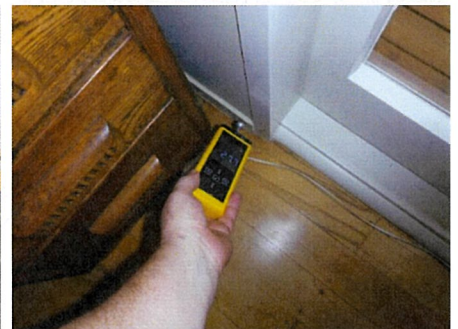
4. Moisture Readings

- Several readings were taken and all were within the acceptable range and indicate the room to be DRY.

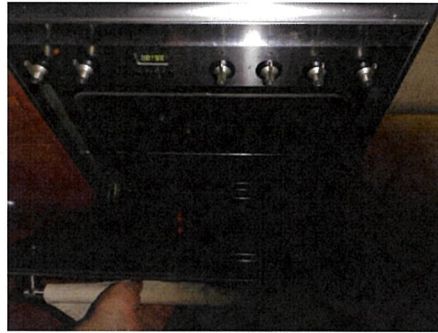
5. Oven

- Visually in good condition with functioning isolating switch, not tested for functionality

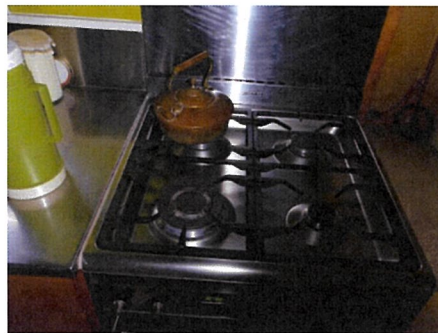
6. Stove Top

- At the time of inspection the stove top appears to be in working order

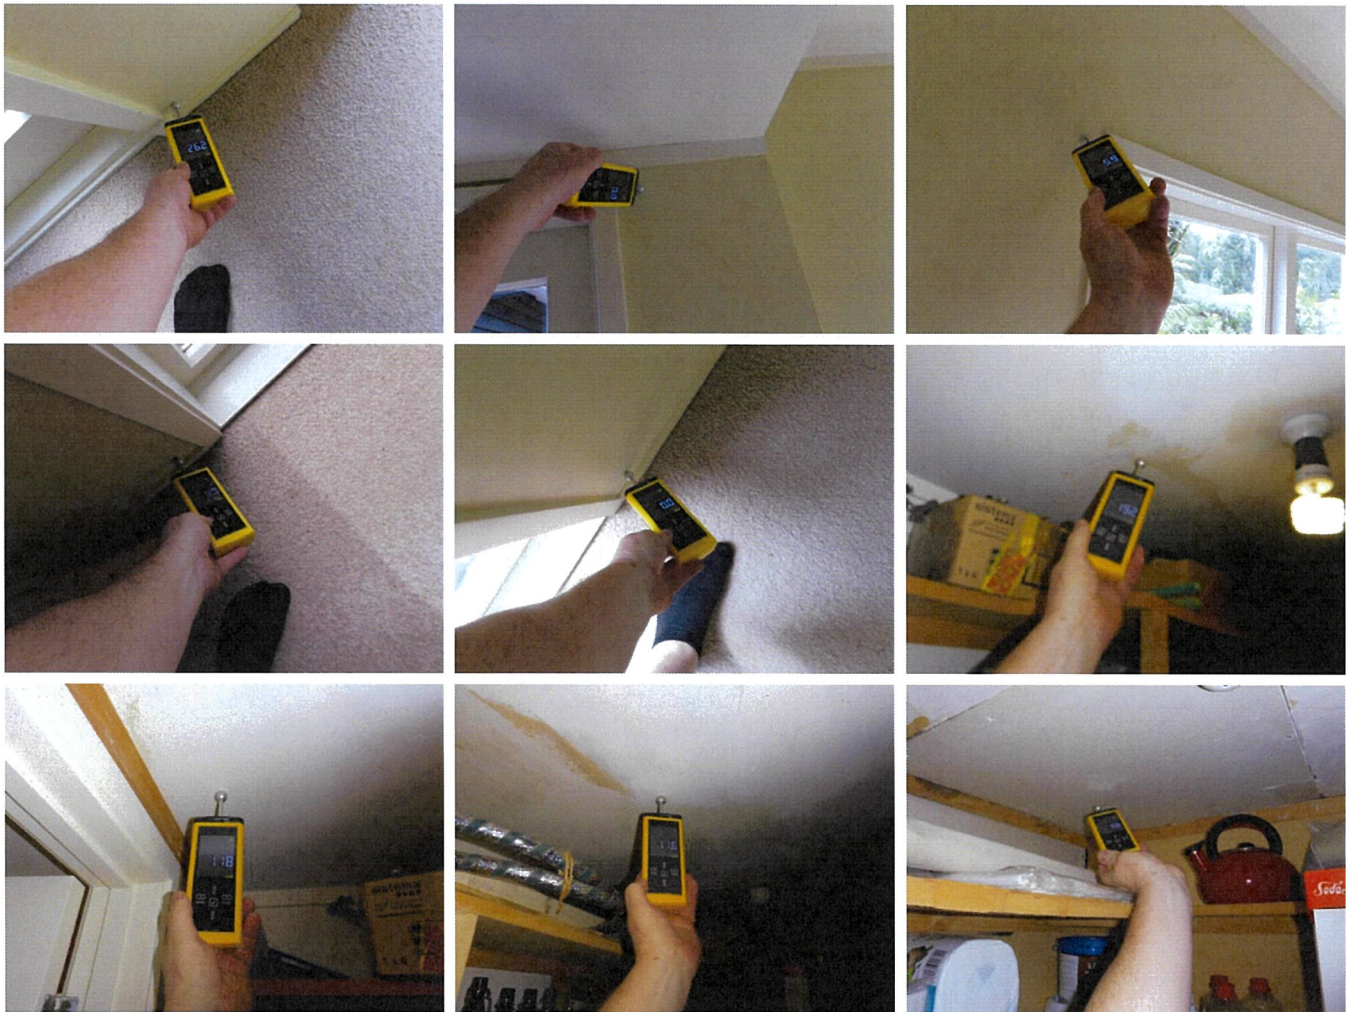
6. Moisture Readings

M D NI • Several readings were taken and all were within the acceptable range and indicate the room to be DRY.

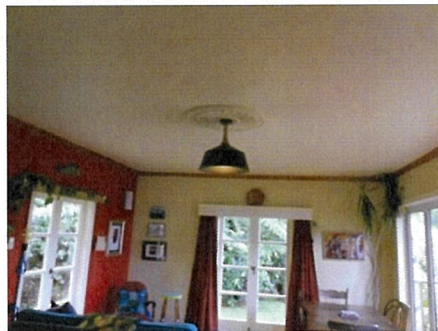
- Functional

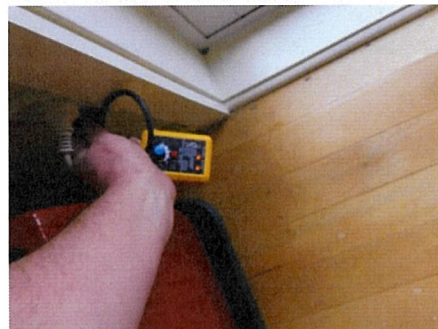
4. Power outlets

- Functional

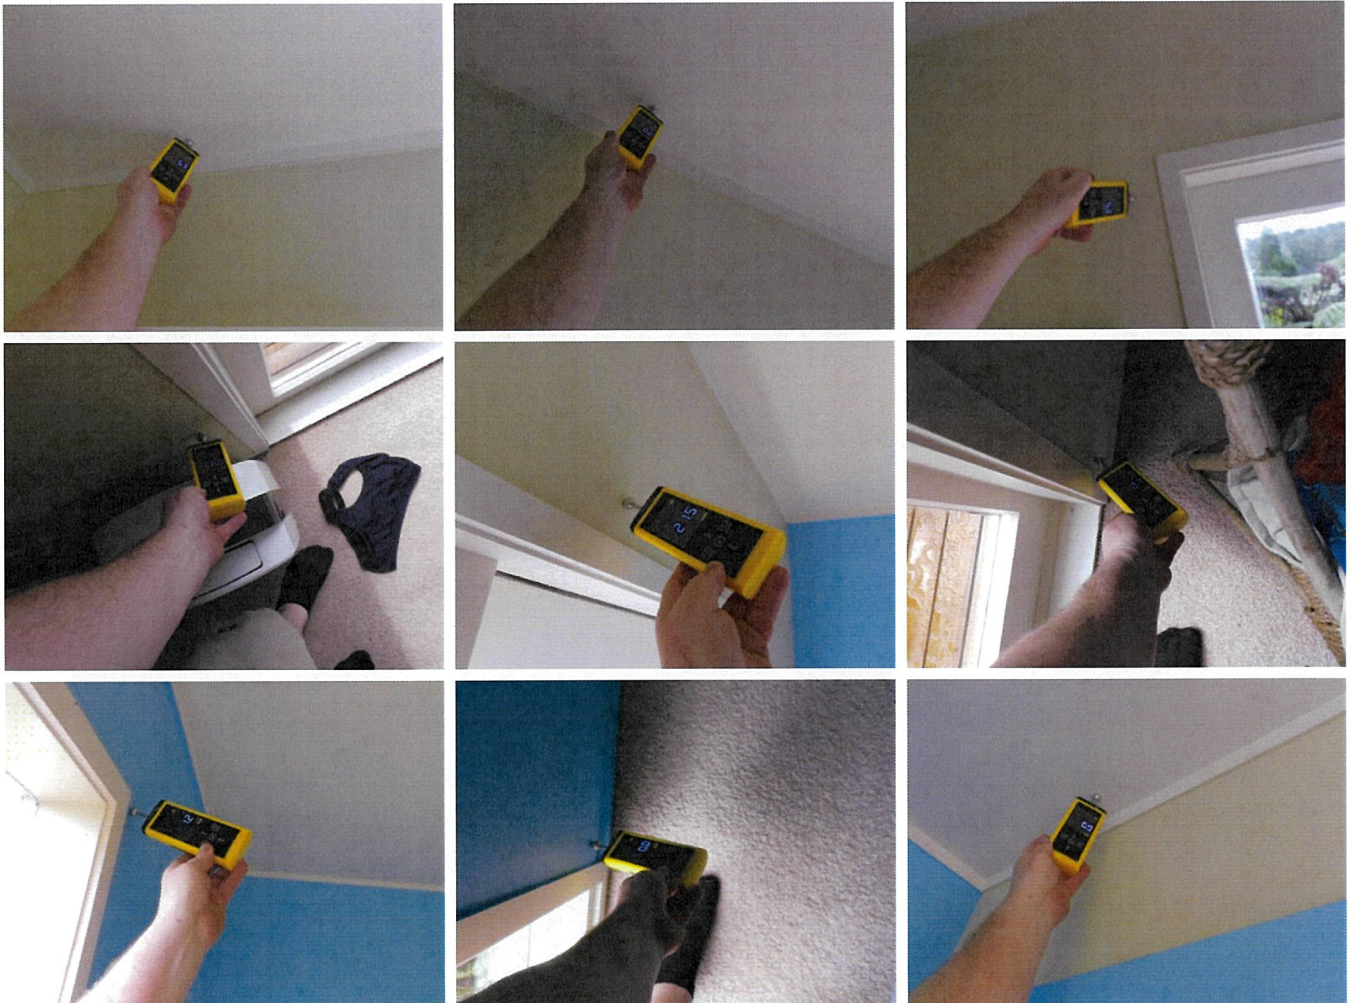
6. Moisture Readings

M D NI • Several readings were taken and all were within the acceptable range and indicate the room to be DRY.

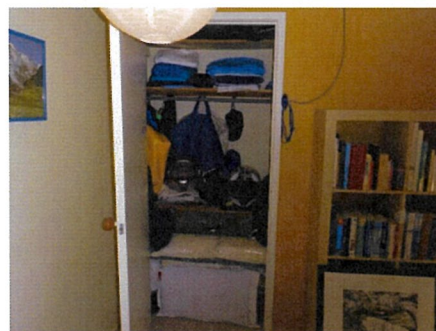
3. Wardrobe

- Present

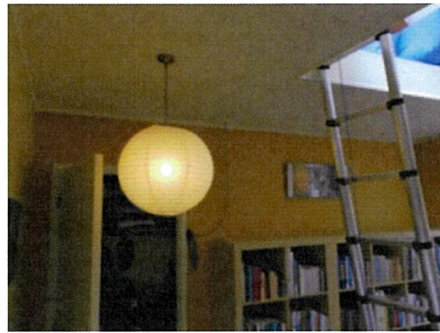
4. Lights and switches

- Functional

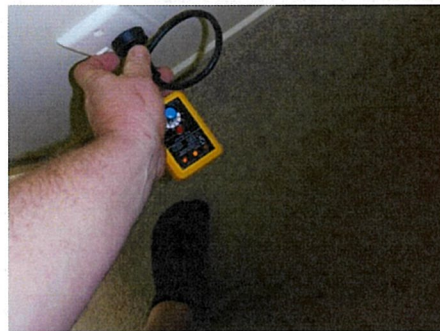
5. Power outlets

- Functional

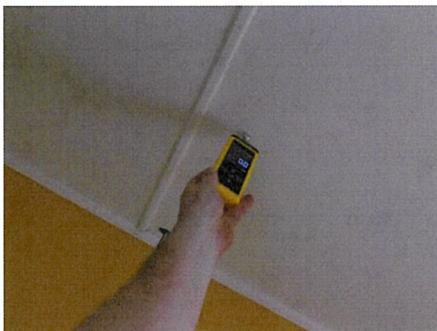
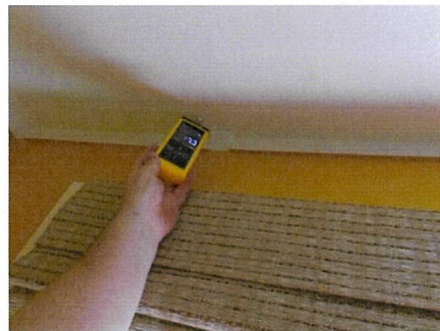
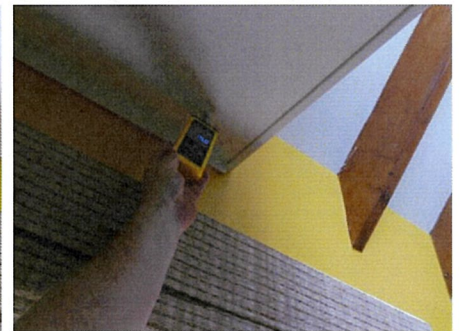
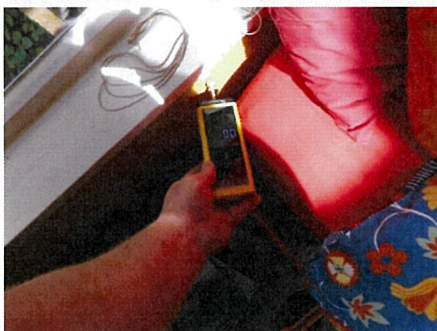
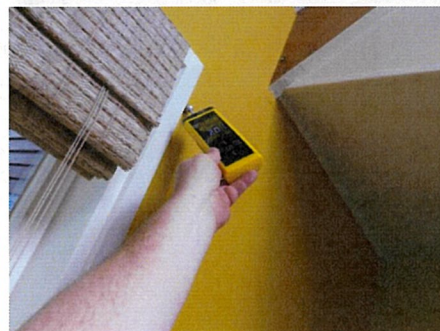
6. Moisture Readings

- Several readings were taken and all were within the acceptable range and indicate the room to be DRY.

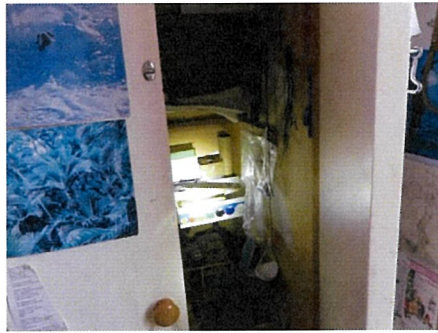
3. Wardrobe

- Present

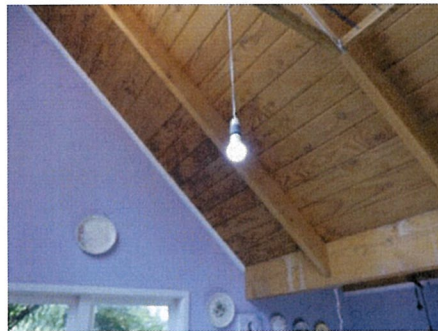
4. Lights and switches

- Functional

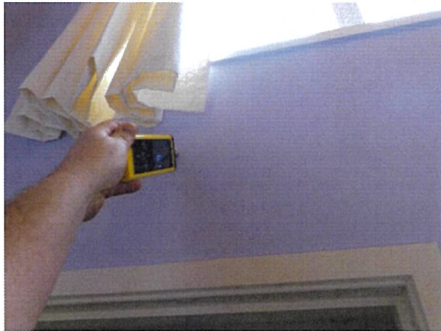
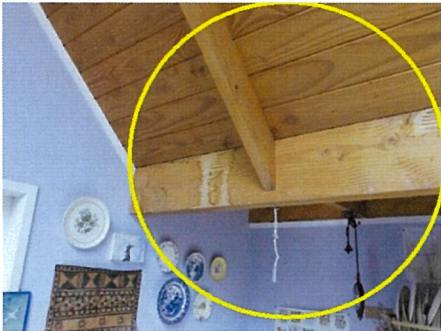
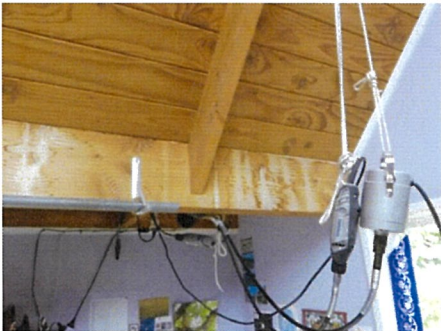
- Several readings were taken and all were within the acceptable range and indicate the room to be DRY however moisture staining on the ceiling may indicate intermittent or historic roof leaks

Water staining

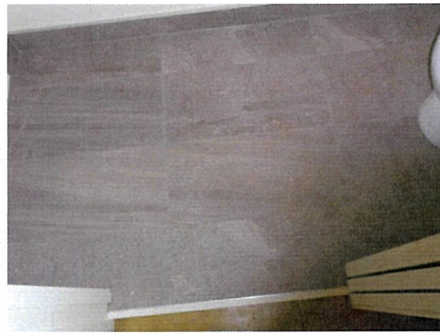
2. Floor

• Tile

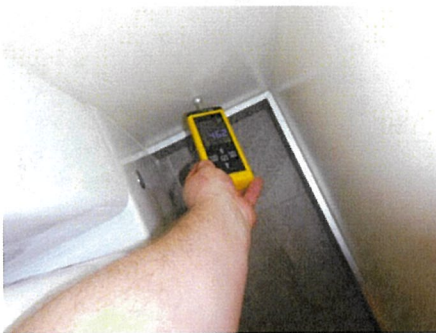
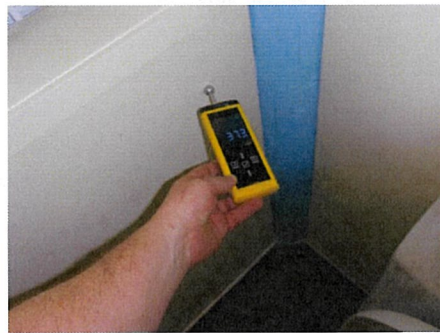
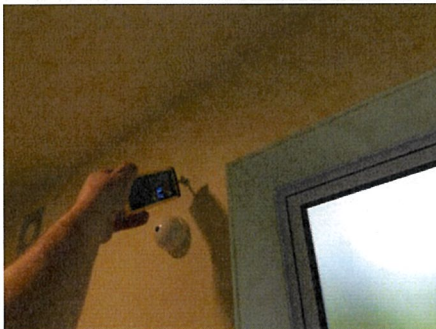
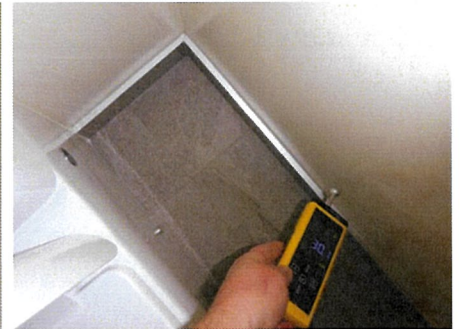
3. Moisture Readings

- Several readings were taken and all were within the acceptable range and indicate the room to be DRY.

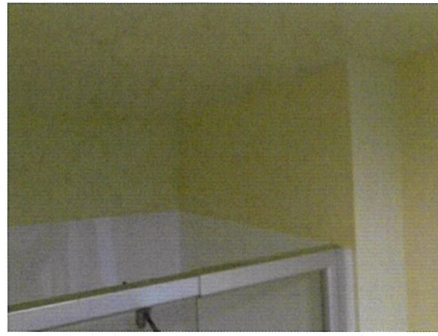
4. Adequately sealed at wall junctions

- The basin, bath and/or shower wall junctions appear adequately sealed

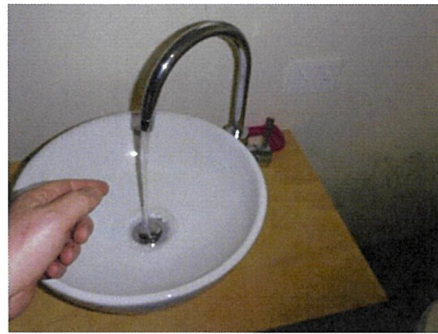
5. Basin

- Good condition

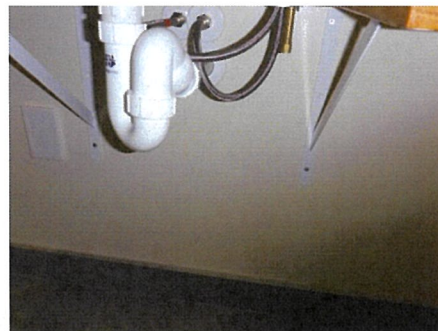
6. Taps & Waste Traps

- Operative

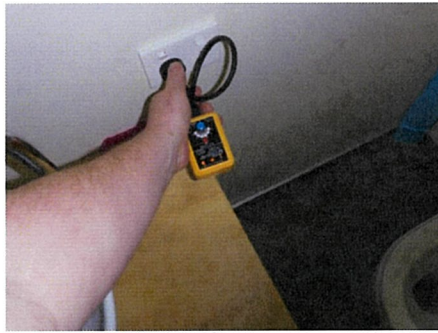
- Functional
- Power outlet is RCD protected

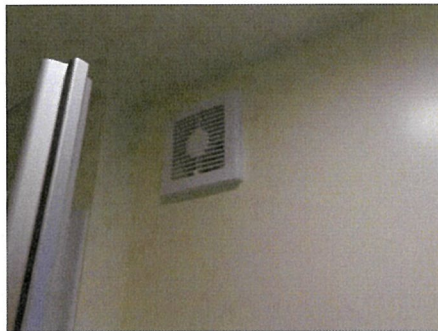
9. Ventilation System

- M D NI • Mechanical

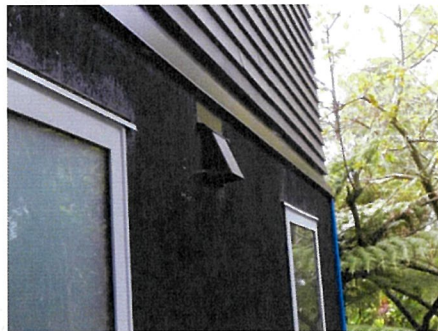
10. Ventilation Point of Discharge

- M D NI • Appears to be venting to the exterior of building

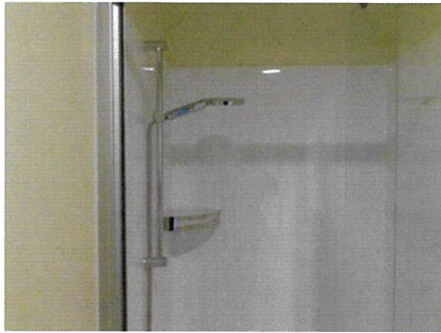
11. Shower/surround

- M D NI • Plastic pan and surround

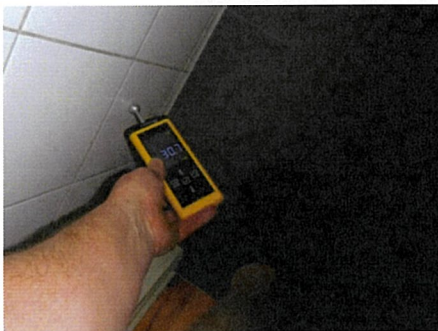
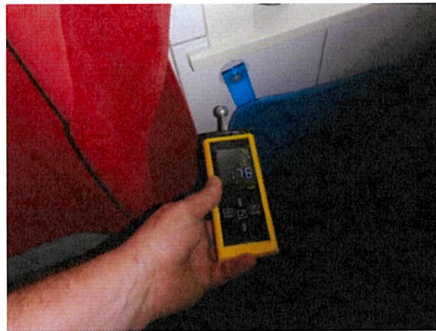
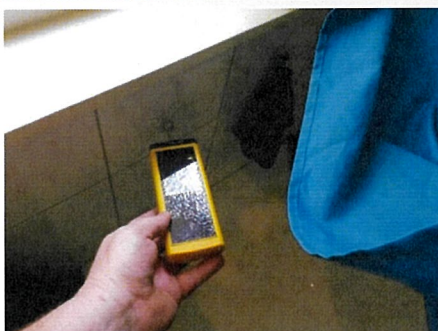
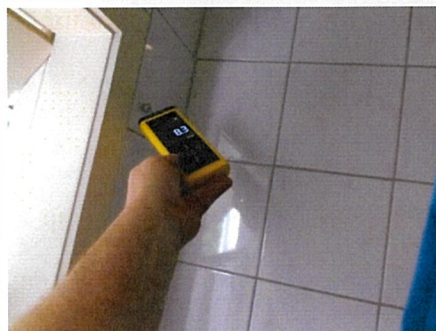
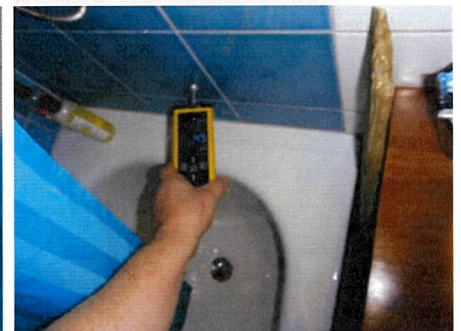
3. Moisture Readings

M D NI • Several readings were taken and all were within the acceptable range and indicate the room to be DRY.

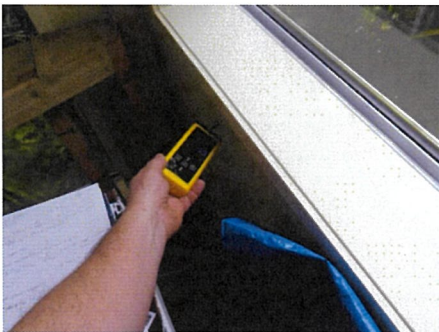
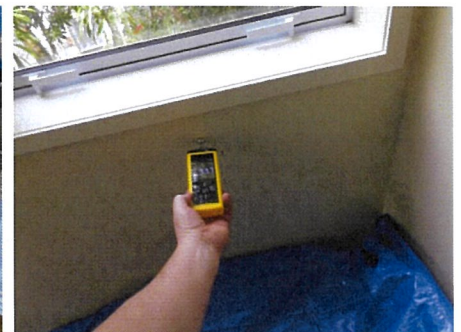
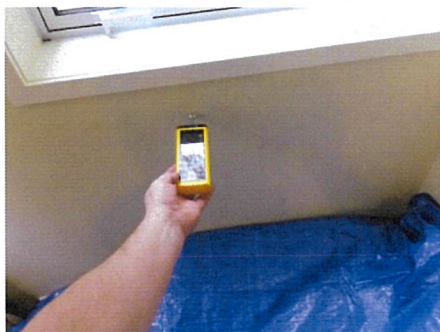
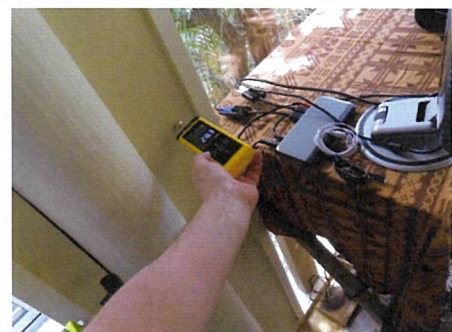
3. Moisture Readings

- M D NI • Several readings were taken and all were within the acceptable range and indicate the room to be DRY.

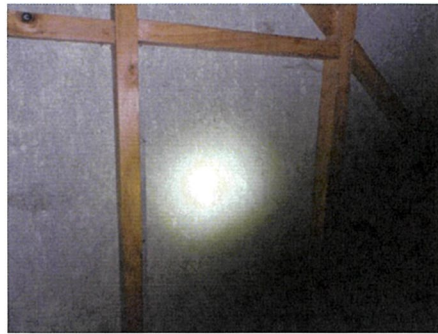
- Fiber cement, due to the age of the home it is possible the fibre cement sheeting contains asbestos. In this form it is not considered a health risk unless disturbed by being sawn, drilled, sanded or water blasted.

Likely contains asbestos
