# Building Report

6 Crowther Street, Blockhouse Bay

# PRE-PURCHASE BUILDING REPORT

Property Address	6 Crowther Street, Blockhouse Bay		
Client	Craig Murphy		
Date of Inspection	26th June 2022	Time	9:00 am
Inspector	Rob Sodeau Peer reviewed by LBP 133644		
LBP Number	Peer reviewed by LBP 133644		
Inspection Type	Pre-Purchase Report		
People Present	Inspector, Owner		
House Occupied	Yes

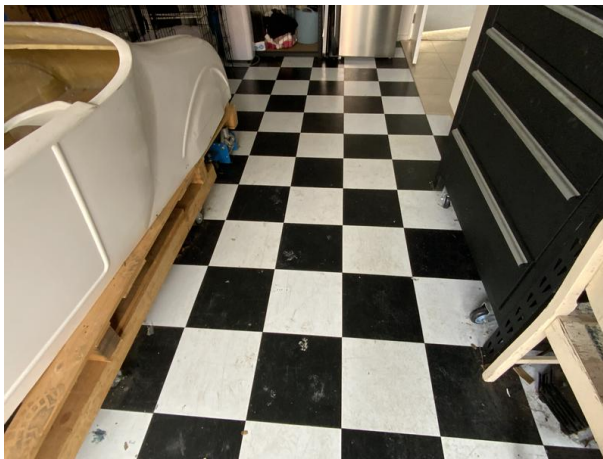
Photo 2

Sample photo of the foundations in the garage with floor covering

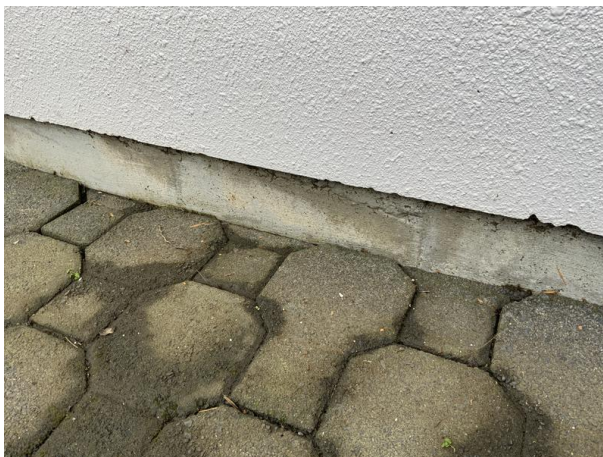
Photo 3

Sample photo of the foundations perimeter wall

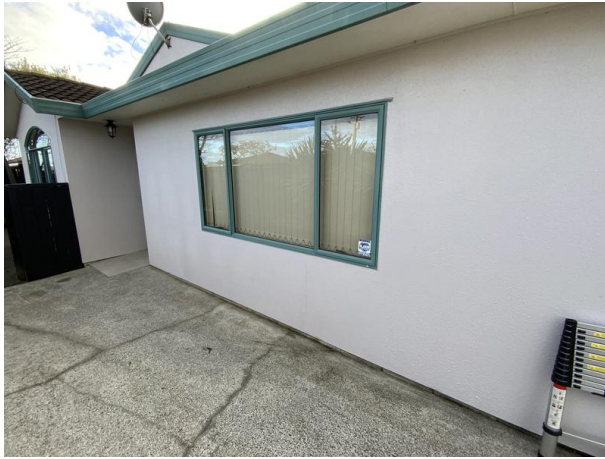
Photo 4

Sample photo of the cladding at the front of the house by the front door on the west side

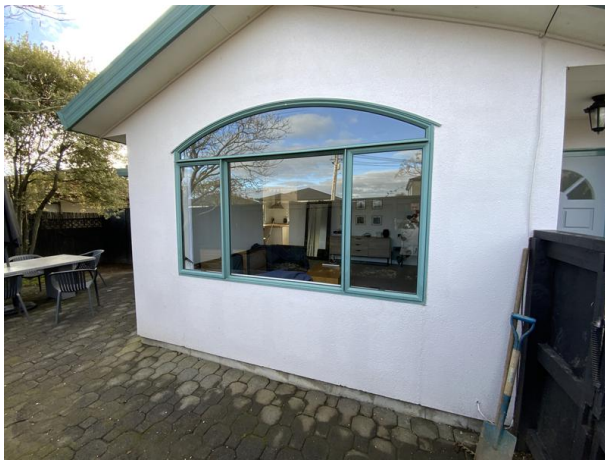
Photo 5

Sample photo of cladding on the west side

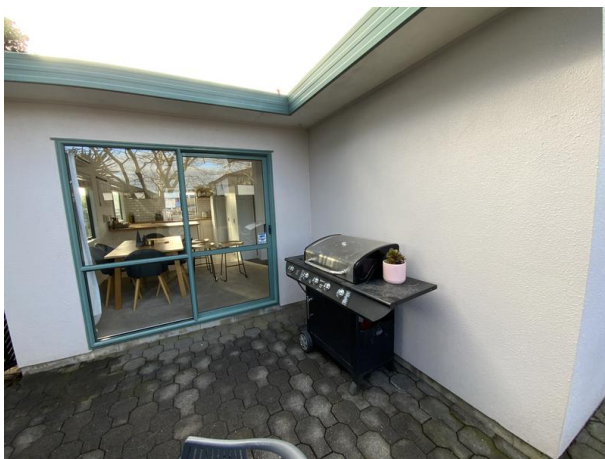
Photo 6

Sample photo of cladding from the dining room on the north west side of the house

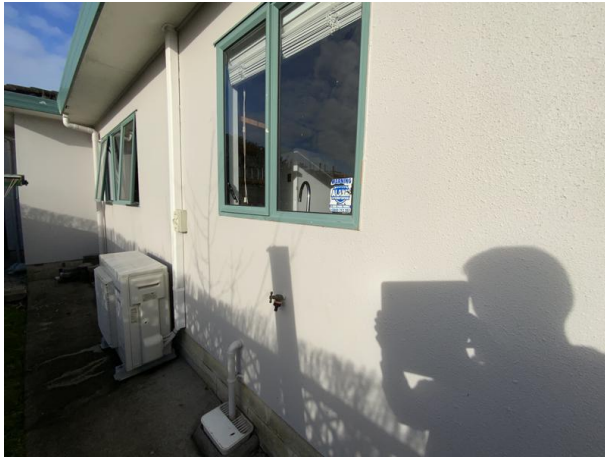
Photo 7

Sample photo of cladding at the back of the property on the east side

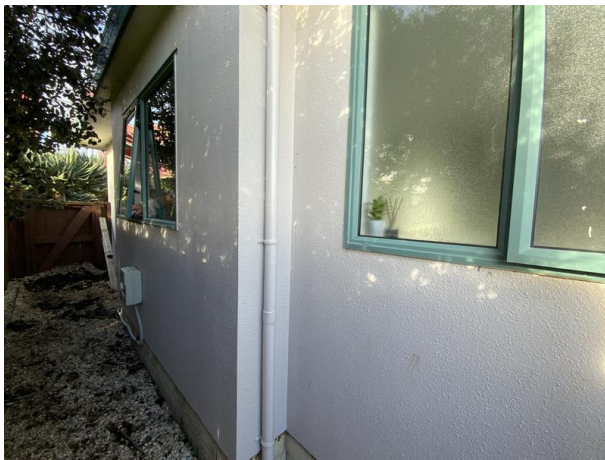
Photo 8

Sample photo of cladding on the east side of the property

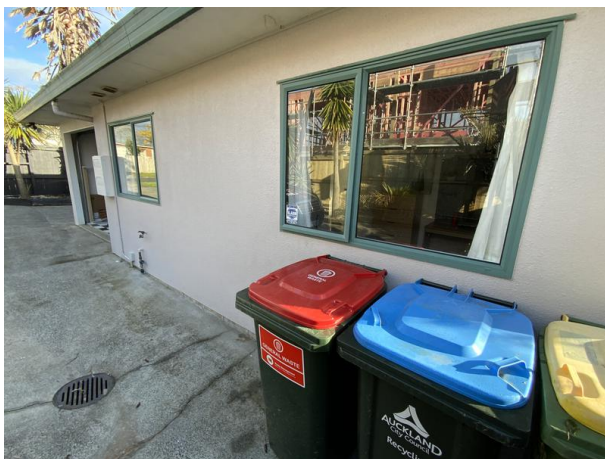
Photo 9

Sample photo of cladding on the south side of the property

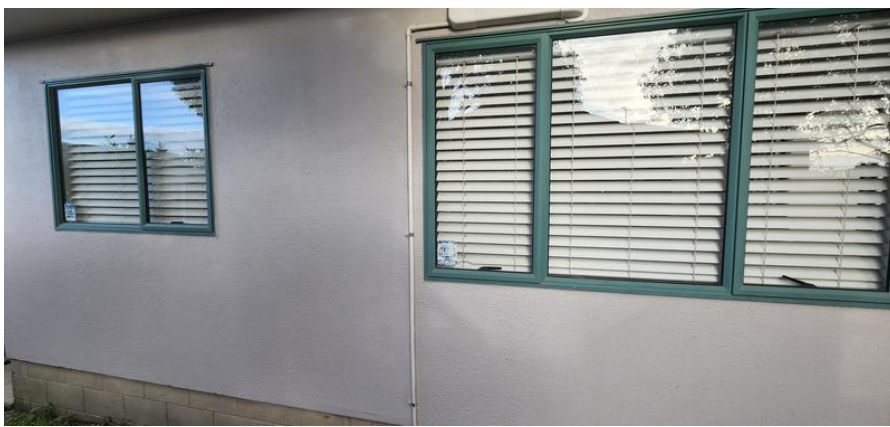
Photo 11

Sample photo of the cladding on the north side

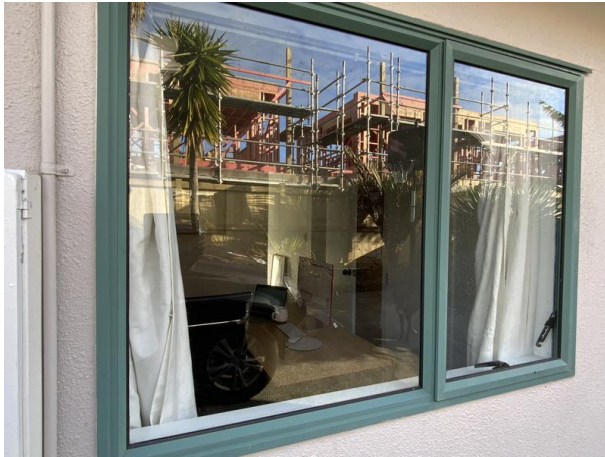
Photo 13

Bedroom joinery on the south side of the property

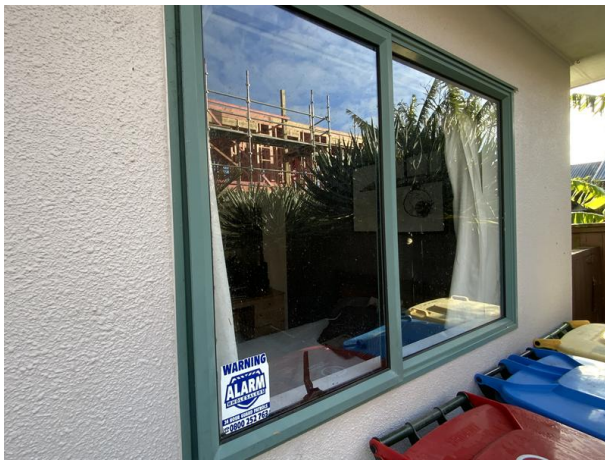
Photo 14

Bedroom joinery on the south side of the property

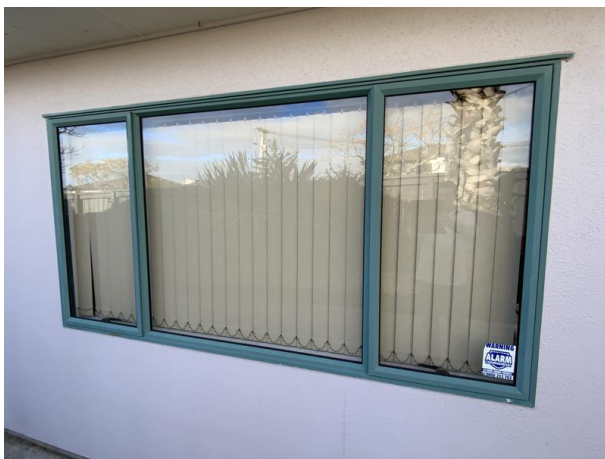
Photo 15

Bedroom joinery on the west side of the property

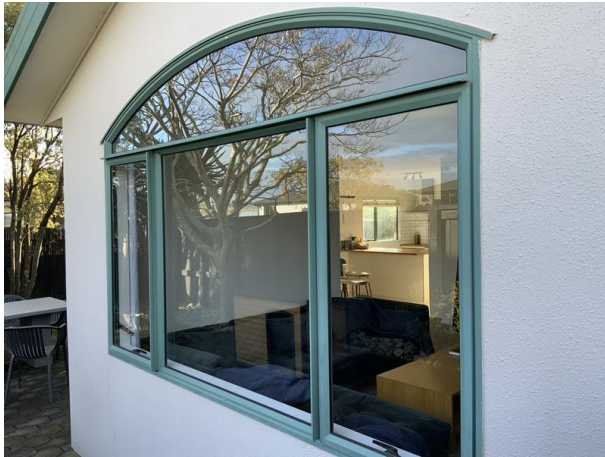
Photo 16

Living room joinery on the west side of the property

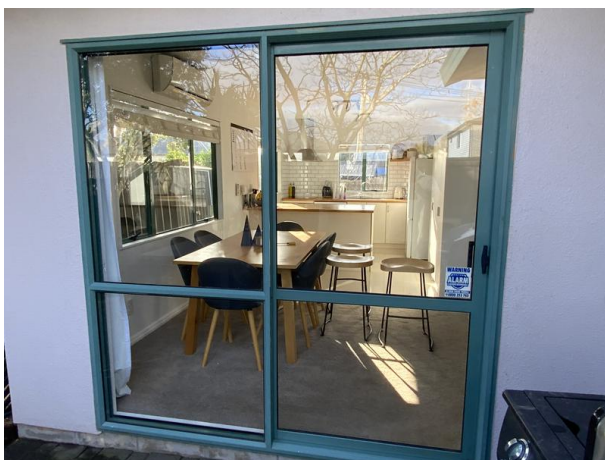
Photo 17

Sliding doors from the dining area

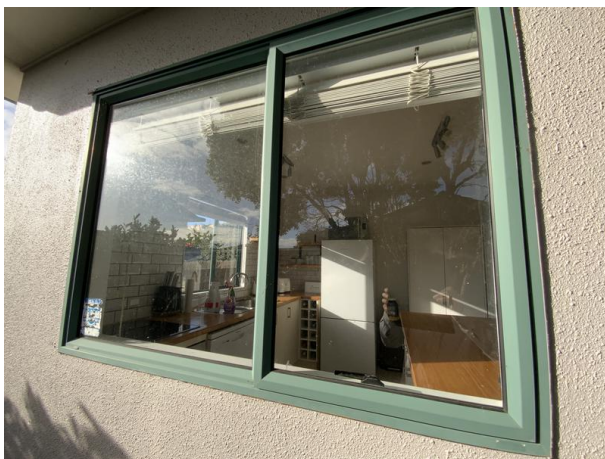
Photo 18

Kitchen joinery on the north side of the property

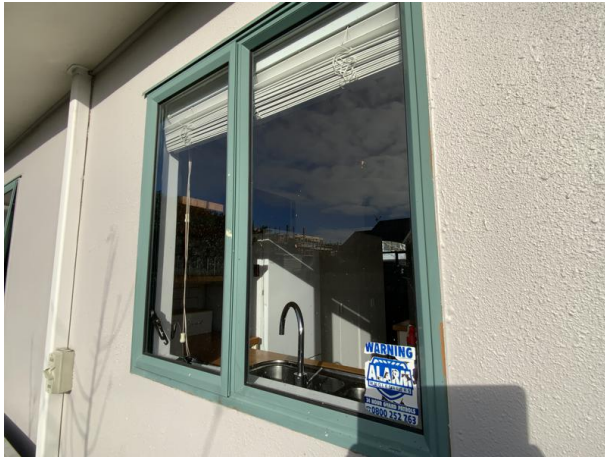
Photo 19

Kitchen joinery on the east side of the property

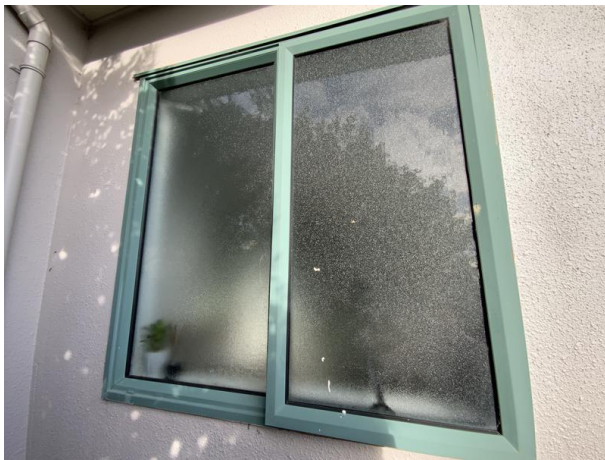
Photo 20

Bathroom joinery on the east side of the property

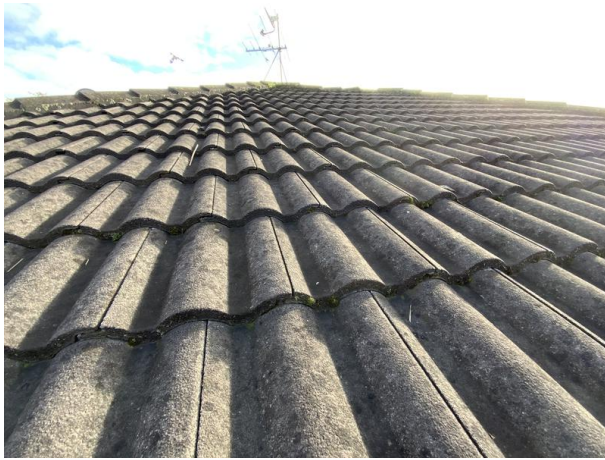
Photo 25

Sample photo of the roof on the south side of the property

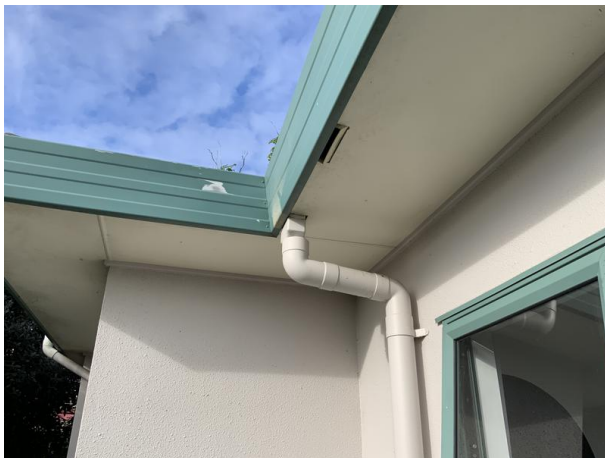
Photo 26

Sample photo of the metal barge flashing downpipe junction gutters overflow and soffit

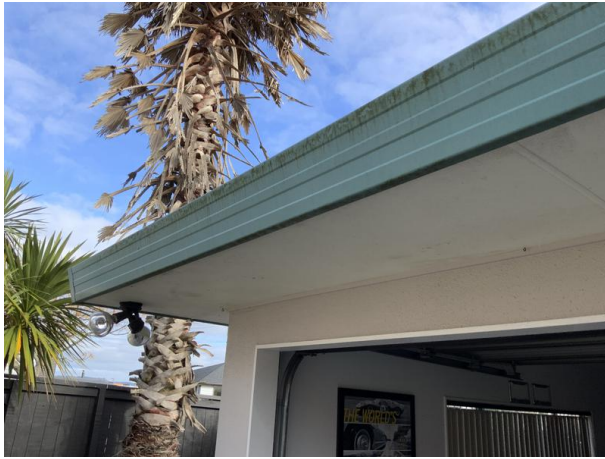
Photo 27

Sample photo of metal bargeboard and soffit

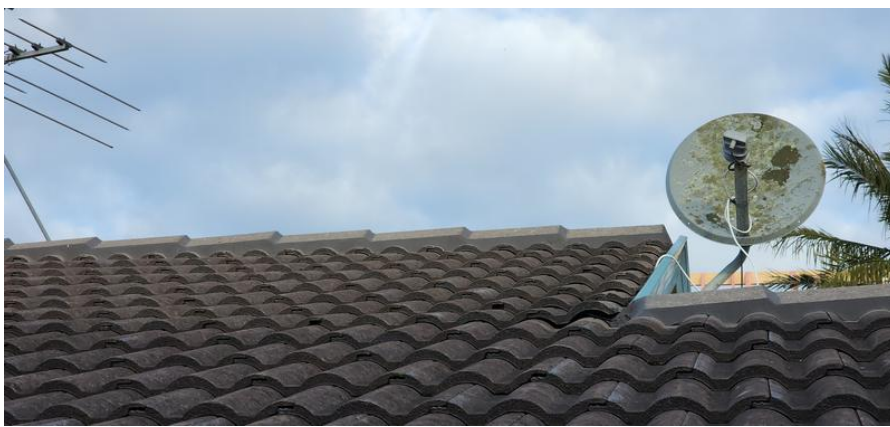
Photo 28

Sample photo of the roof

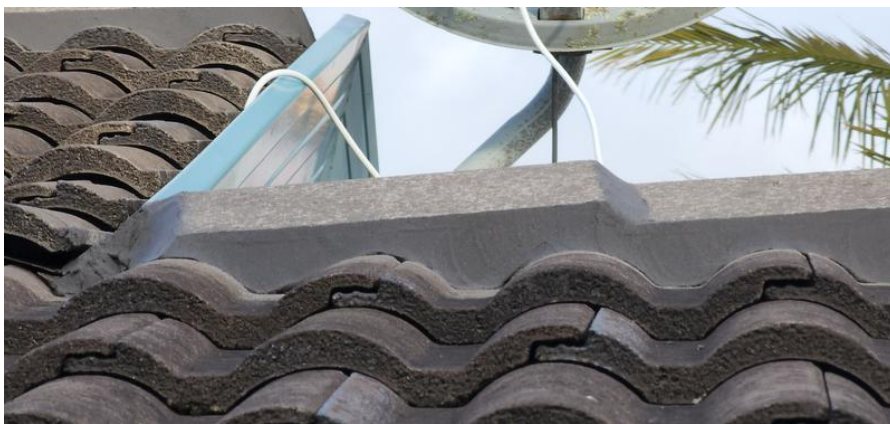
Photo 29

Sample photo of the roof ridge

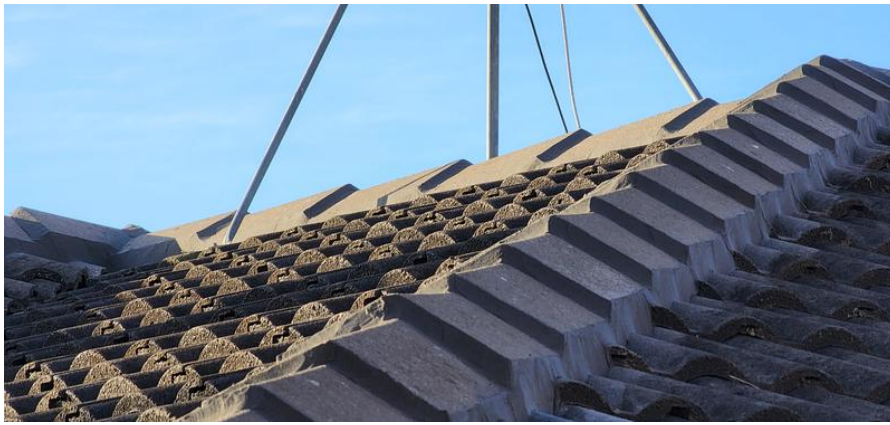
Photo 30

Sample photo of the roof

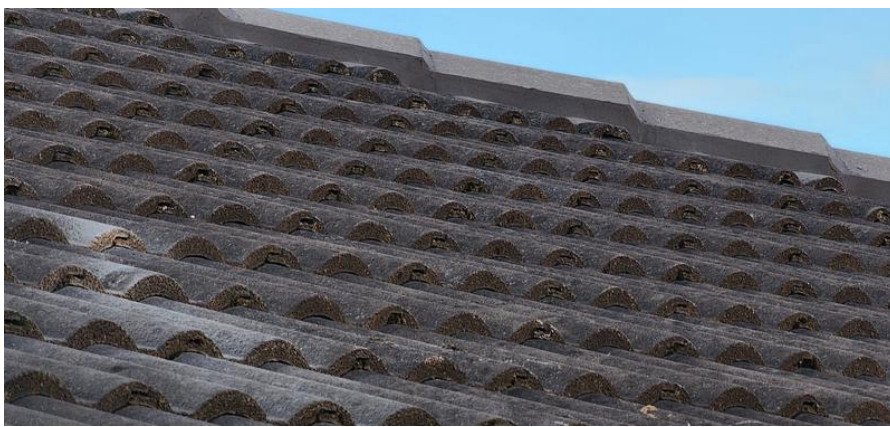
Photo 31

Sample photo of the roof

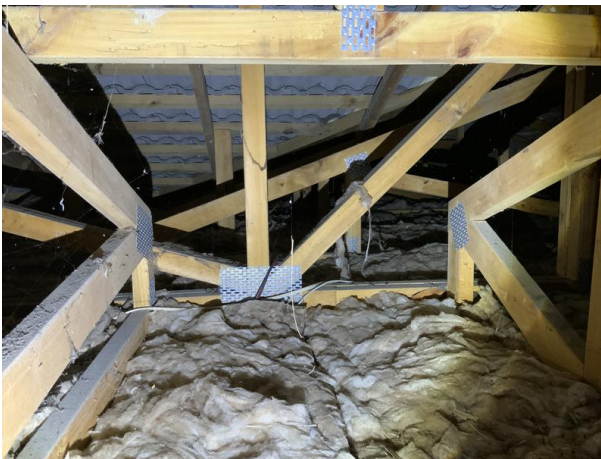
Photo 32

Sample photo of the roof framing and insulation

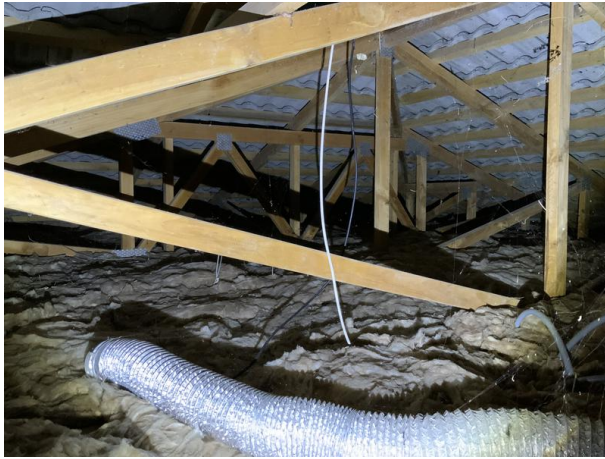
Photo 33

Sample photo of the roof framing and insulation

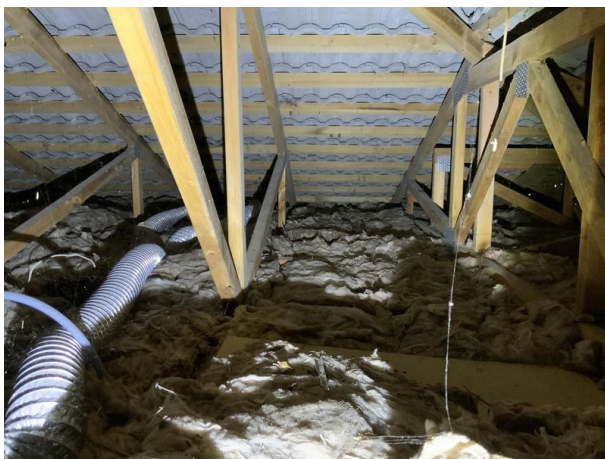
Photo 35

Sample photo of a roof framing and insulation

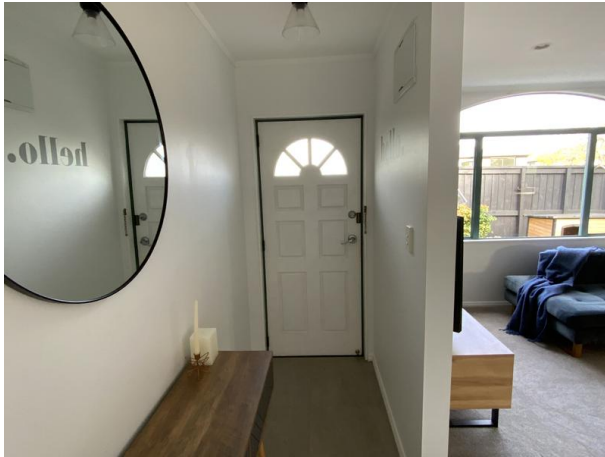
Photo 37

Defects - Elevated moisture reading in the front door trim.

Front door

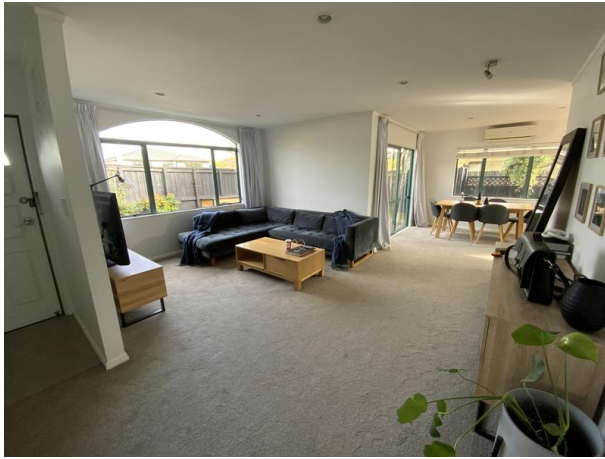
Photo 39

Defects - Elevated moisture reading in the joinery trim.

Living and dining room

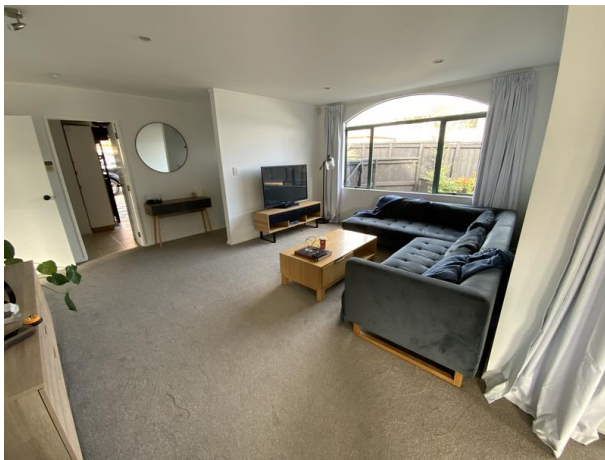
Photo 40

Living room

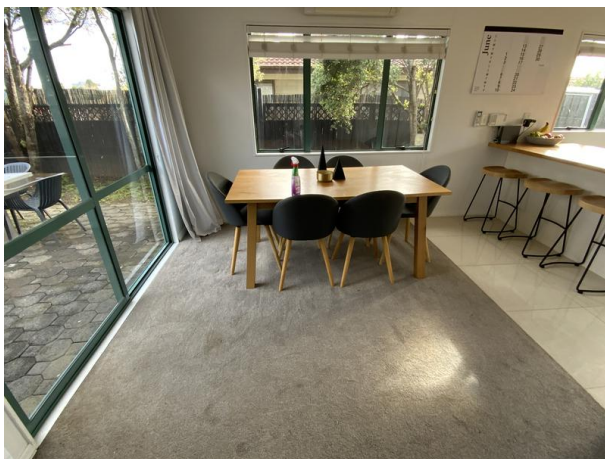
Photo 41

Dining room

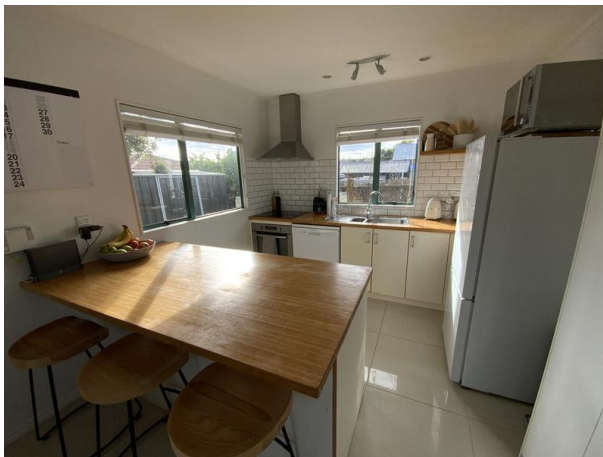
Photo 42

Kitchen

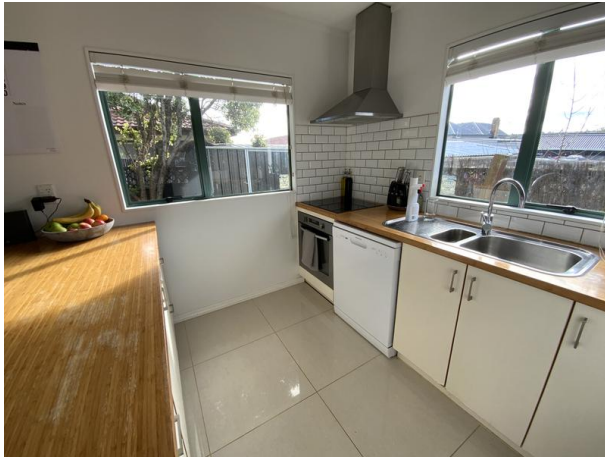
Photo 43

Kitchen

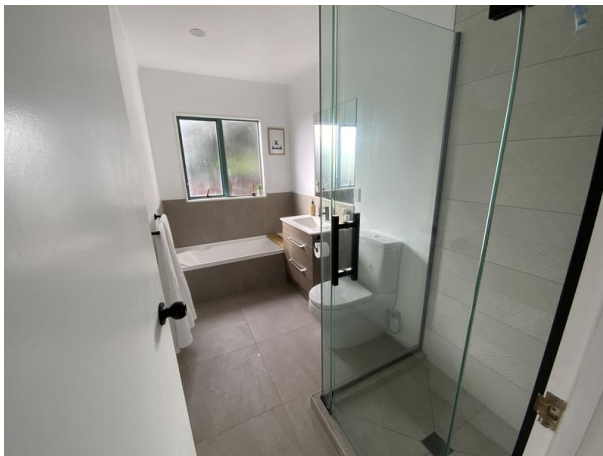
Photo 45

Bathroom

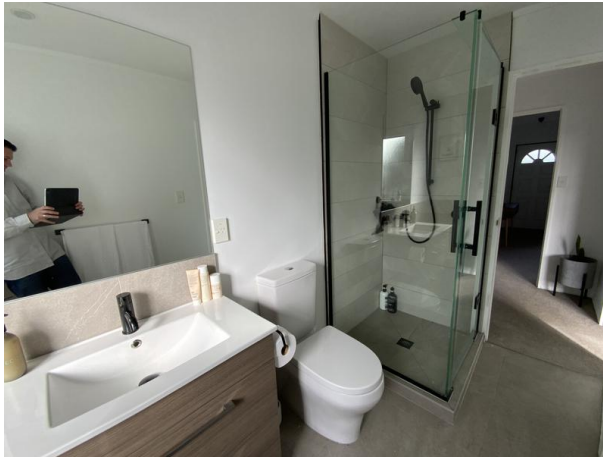
Photo 46

Bathroom

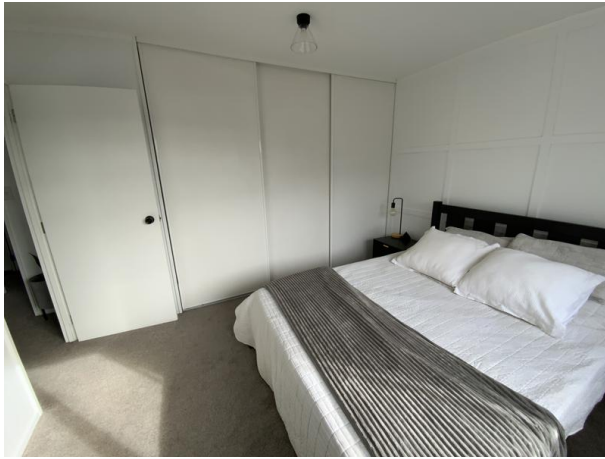
Photo 48

Bedroom one

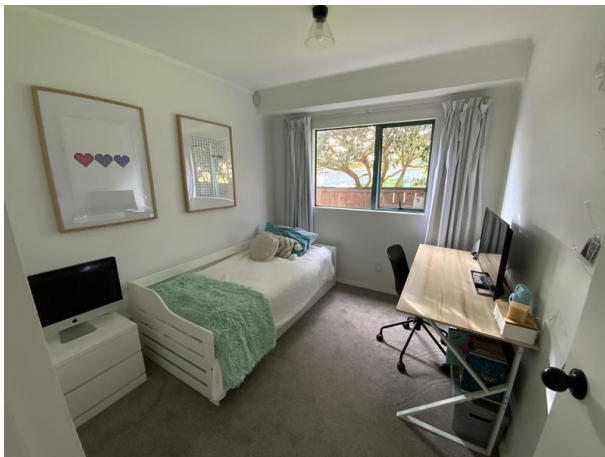
Photo 49

Bedroom two

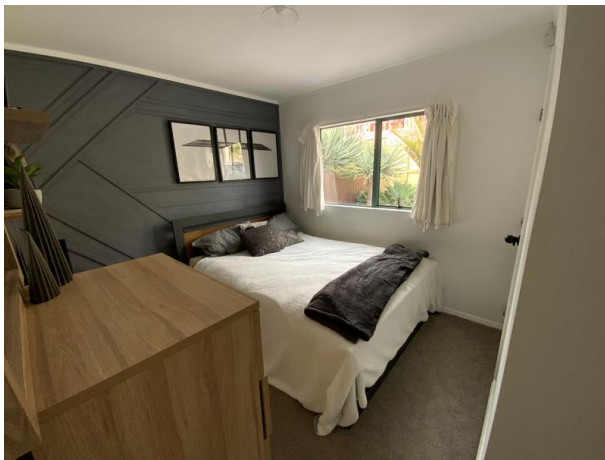
Photo 50

Bedroom two

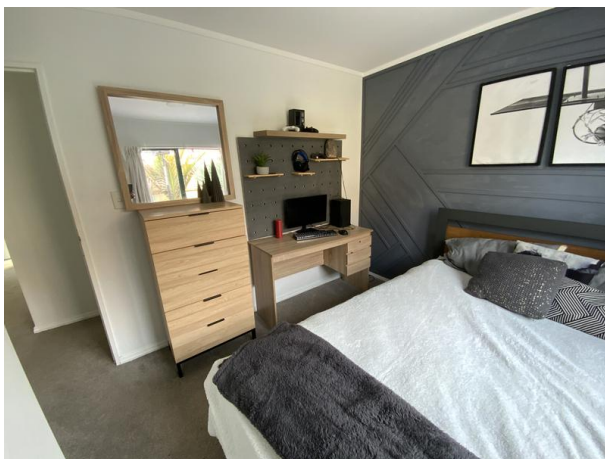
Photo 51

Defects - Elevated moisture readings in bedroom three joinery.

Bedroom three

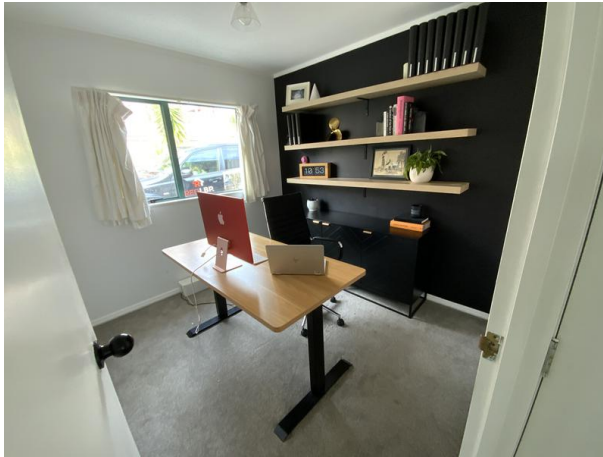
Photo 52

Bedroom three

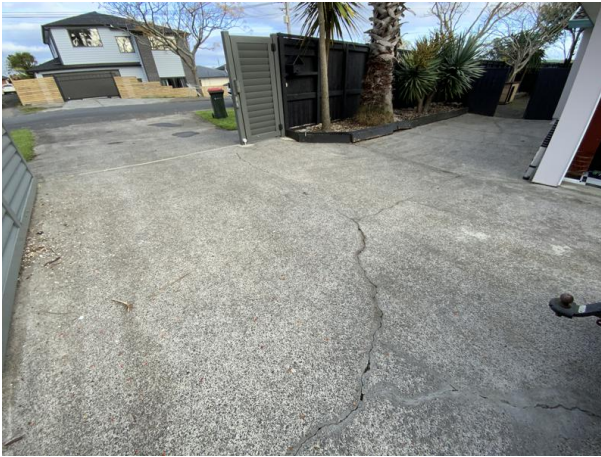
Photo 57

Sample photo of the driveway

General upkeep and maintenance of driveway by cleaning and keeping free of debris. Cracks that would be expected for the property's age are aesthetic issues only.

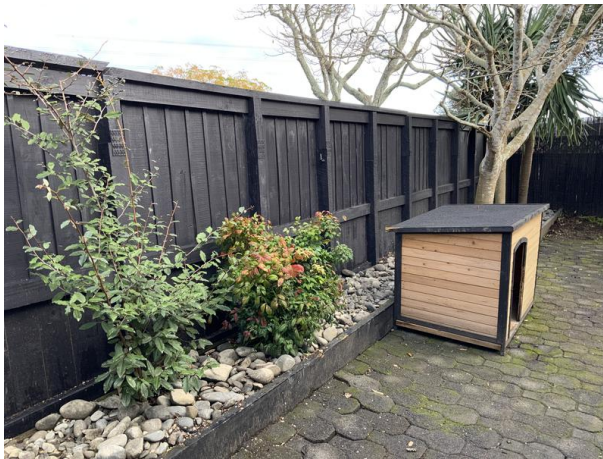
Photo 58

Sample photo of the front fence

The average height of the boundary fencing is approximately 1.8 metres. General upkeep and maintenance, keep vegetation and soils clear of timbers as these timbers are only exterior treated and will rot if vegetation or soils are up against them. Some palings may need replacement.

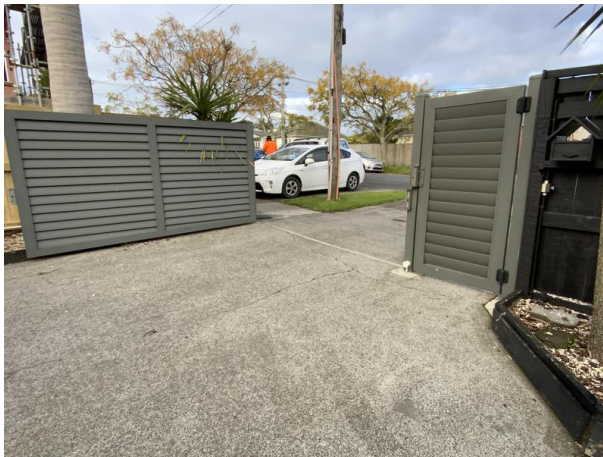
Photo 59

Sample photo of the electric gate

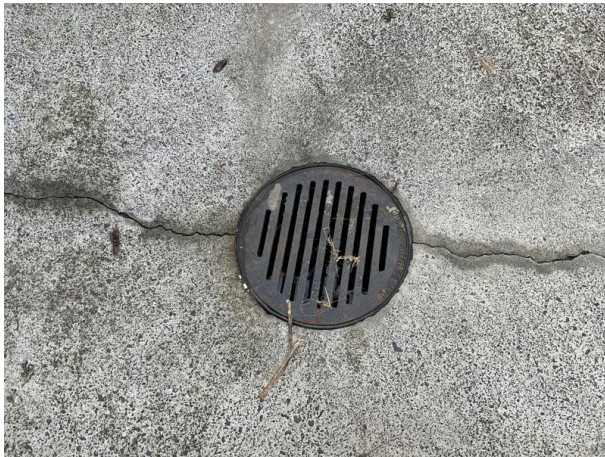
Photo 62

Driveway drainage

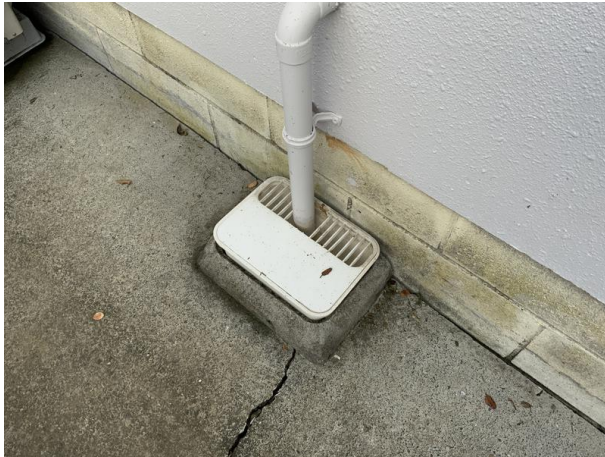
Photo 63

Gully trap

Keep vegetation and soils clear of drainage. Surface water needs to be prevented from flowing into a trap by ensuring that the rim of the gully dish is at least: 25 mm higher than a paved surface and/or 100 mm higher than an unpaved surface. Gully traps should be accessible for cleaning and maintenance.

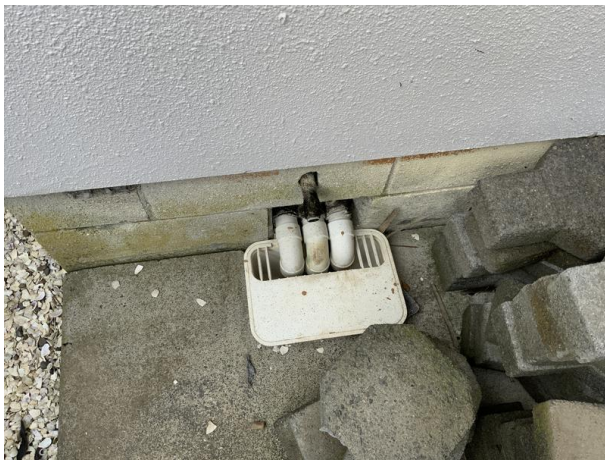
Photo 64

Gully trap

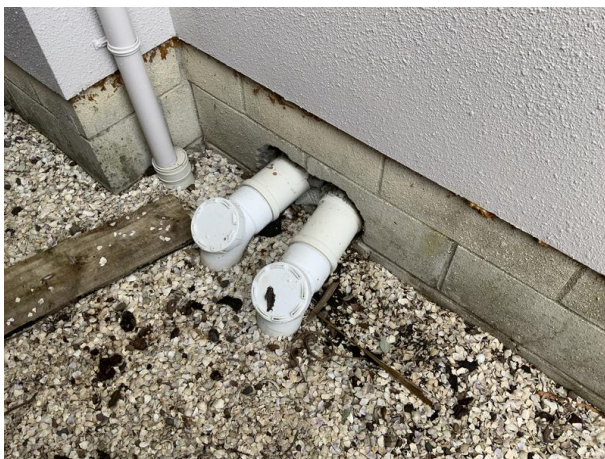
Photo 65

Drainage

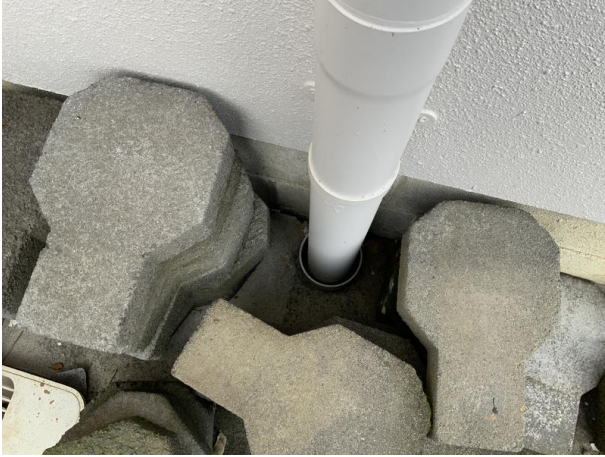
Photo 66

Storm drain connection

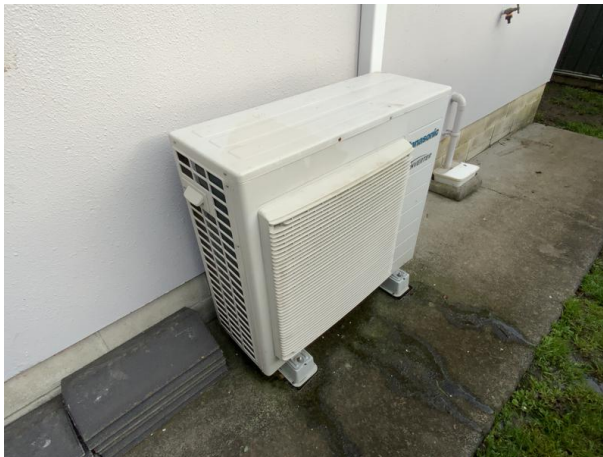
Photo 67

Outdoor heat pump unit

Clean filters every 4 - 12 weeks depending on the placement of the unit.

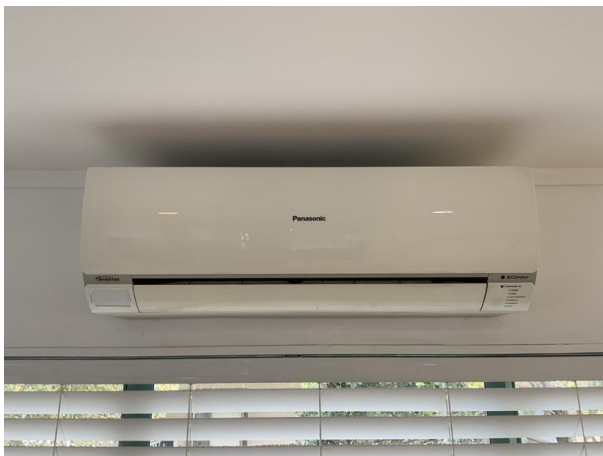
Photo 68

Heat pump indoor unit

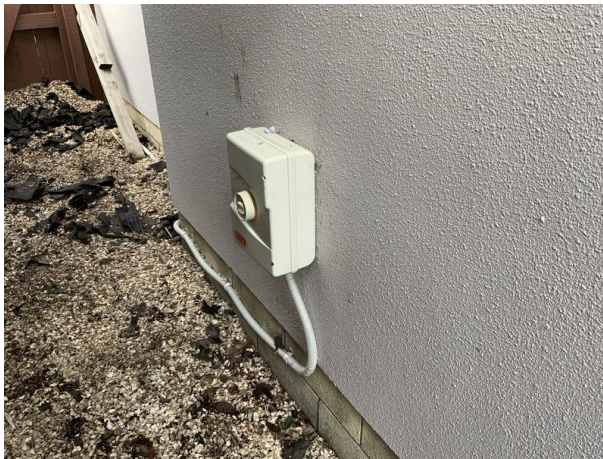
Photo 69

Power control system for the electric gate

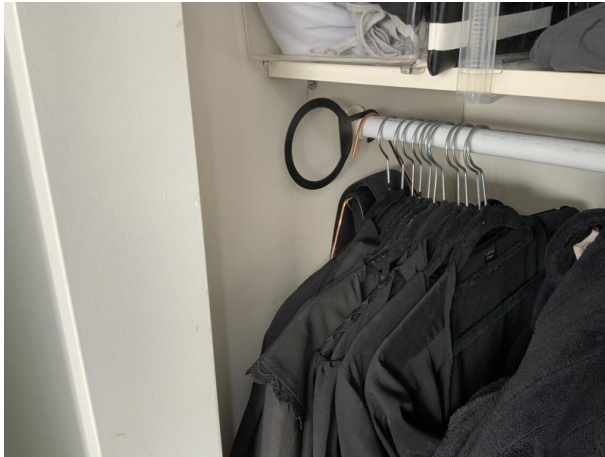
Photo 77

Water heating. Not sited. Recently replaced.

Hot water tank not visible and not inspected

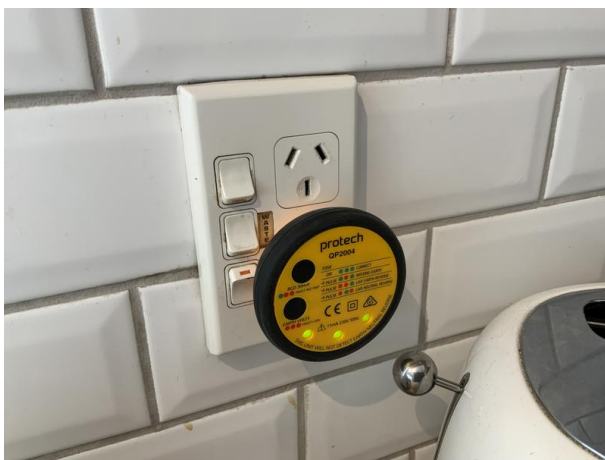
Photo 78

Sample photo of the electrical plug test, all tested plugs passed

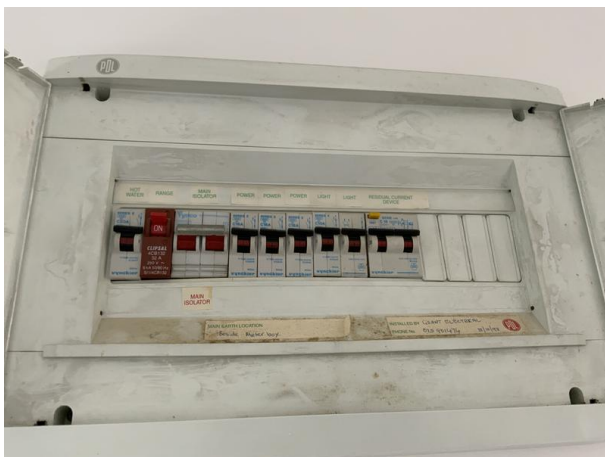
Photo 79

Fuse panel next to the front door
